**A CULVERT SURVEY OF THE ST. MARY'S RIVER, GUYSBOROUGH COUNTY, NOVA
SCOTIA, ASSESSING AND PRIORIZING CULVERTS AS OBSTRUCTIONS TO FISH
PASSAGE.**

Sean C. Mitchell, M.Sc., PhD
SMRA Executive Director

Sept. 15, 2010

St. Mary's River Association Technical Report #008

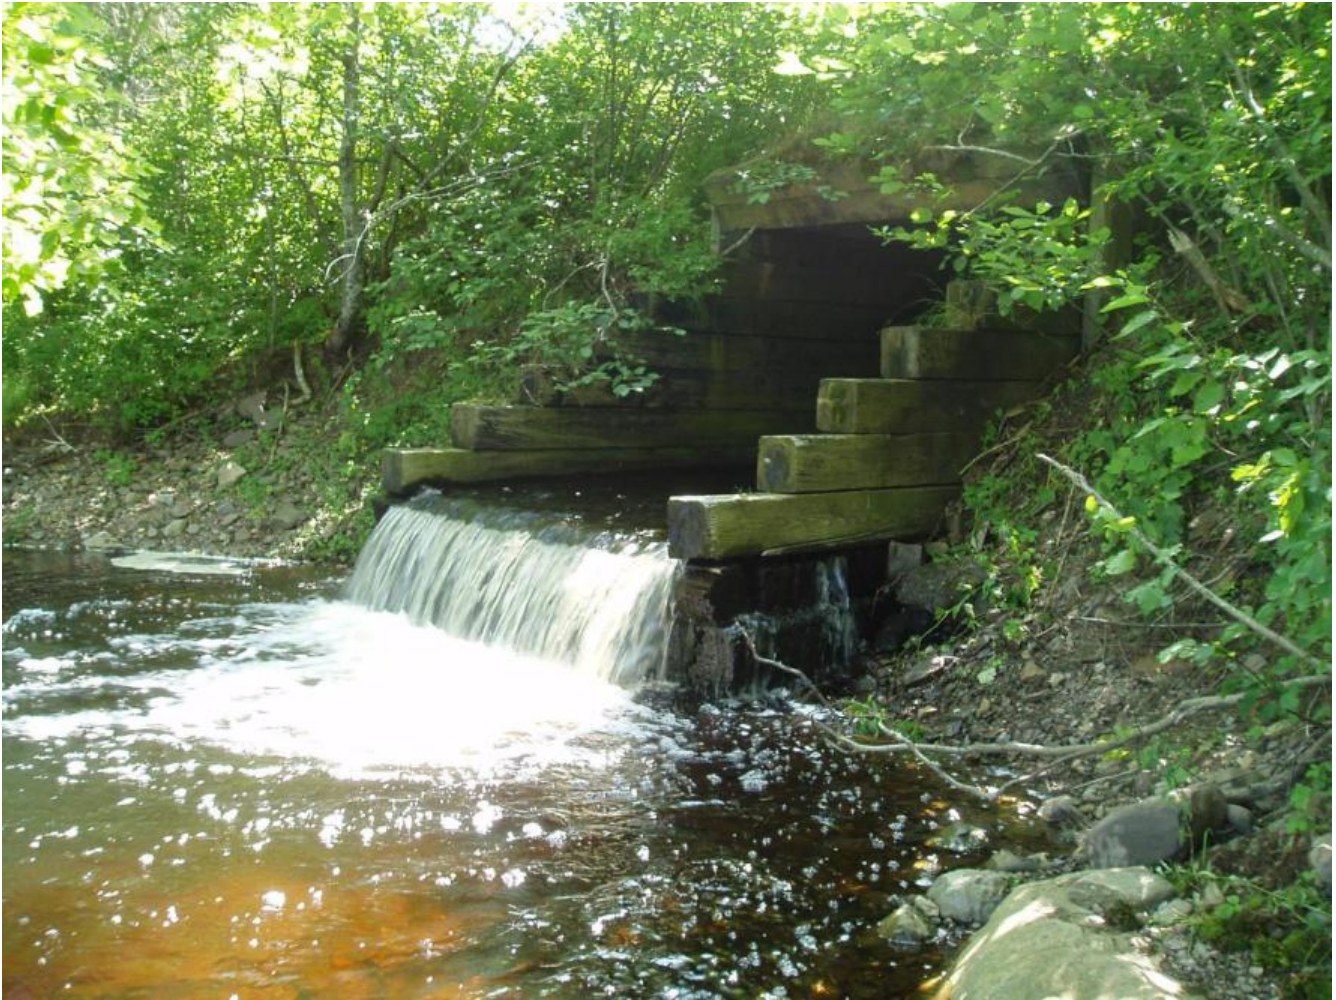
2. The outfall drop of this culvert is problematic as development of an outlet pool to backwater the culvert would be extensive, requiring raising the water level by 0.5 m, and the culvert is effectively at the confluence of McQuarries Brook and the West Branch, St. Mary's River, leaving very little space in which to develop the pool. Further, the existing pool is very large and deep. I recommend that rather than pool development, a small fishway be constructed from the outfall pool into the culvert. The fishway design could be a continuation of the notched weir baffles and also made of treated lumber. Success of this structure to allow fish passage should be monitored (*Recommendation #2*).

Plate 1: Outfall of McQuarries Brook (Culvert #80).

The design fish for this restoration are salmonids, primarily adults, and the restoration concept is resting pools of ≥ 9.0 cm depth, and access between pools via the notch in the weir. This approach of wooden baffles and fishway, constructed and installed by hand, will be less expensive than extensive pool development.

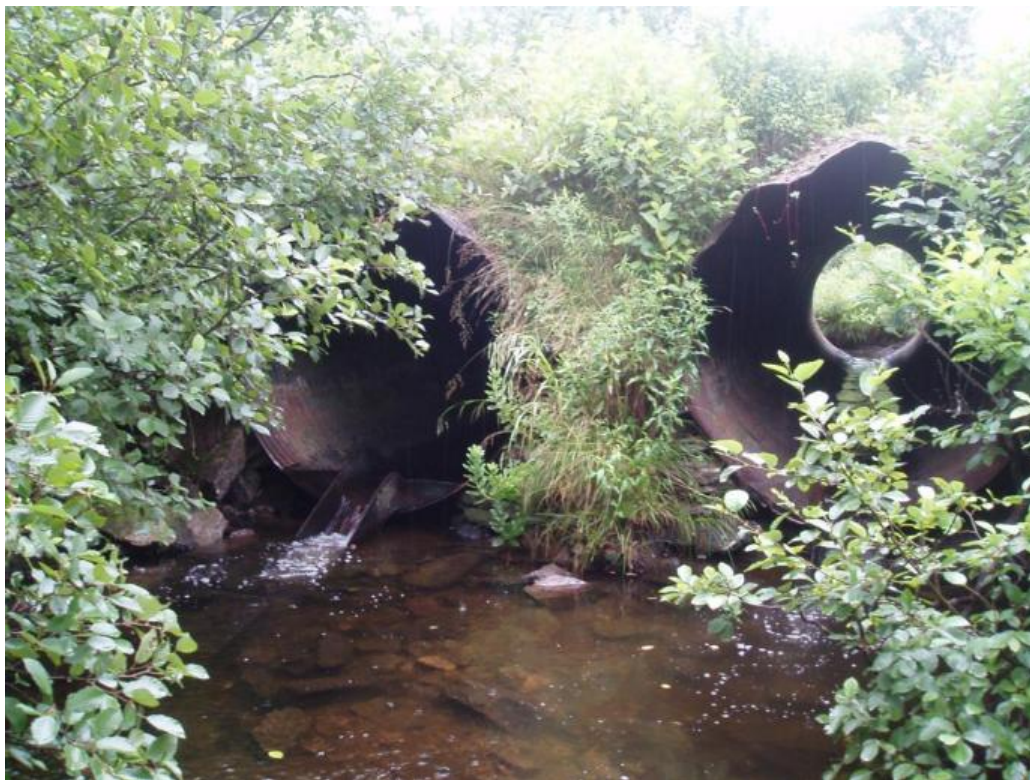
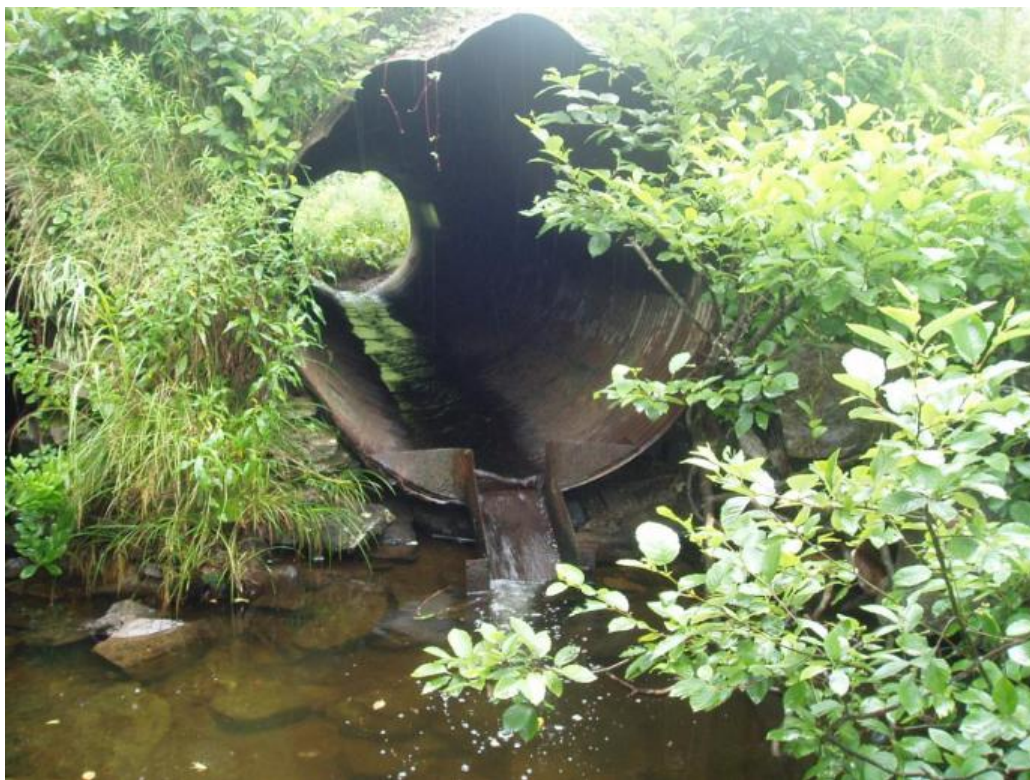
Plate 2: Outflow culvert on Fraser's brook (Culvert #96) at low flow; showing spillway intended for fish passage.

2. Remove existing ineffective plastic weir and metal sluices.
3. In the culvert to which flow is directed, install baffles to reduce velocity. If all flow can be placed in one culvert at low flow there should be sufficient water depth and so the Offset Baffle design would be appropriate. If flow cannot be placed in single culvert, than full-span weir baffles in each culvert are recommended. Specific design of these baffles (number baffles in culvert; height of baffles, distance between them) should be determined in consultation with engineers or restoration experts with experience. These baffles will need to be fabricated of metal and bolted or welded in place, which is more complex than simple wooden baffles.

4. Raise outfall pool by constructing two downstream control weirs of rock. A single weir would result in a large drop and so there should be two, each of lesser drops. Pools should be designed to meet criteria of Gosse et al. (1998), which are more conservative than Adams and Whyte (1990).

The design fish for this restoration is adults and juvenile salmonids; the resulting flow through the culvert, unless extensively backwatered, is expected to remain too great a velocity for weak swimmers (non-salmonids). The restoration concept is to concentrate flow in a single culvert (to provide sufficient depth), reduce velocity (by baffles) and eliminate outfall drop (via pool development). The cost for this restoration will be relatively high due to specialized skills and equipment required for baffle fabrication and installation, and requirement of heavy machinery and supply of rock to construct weirs.

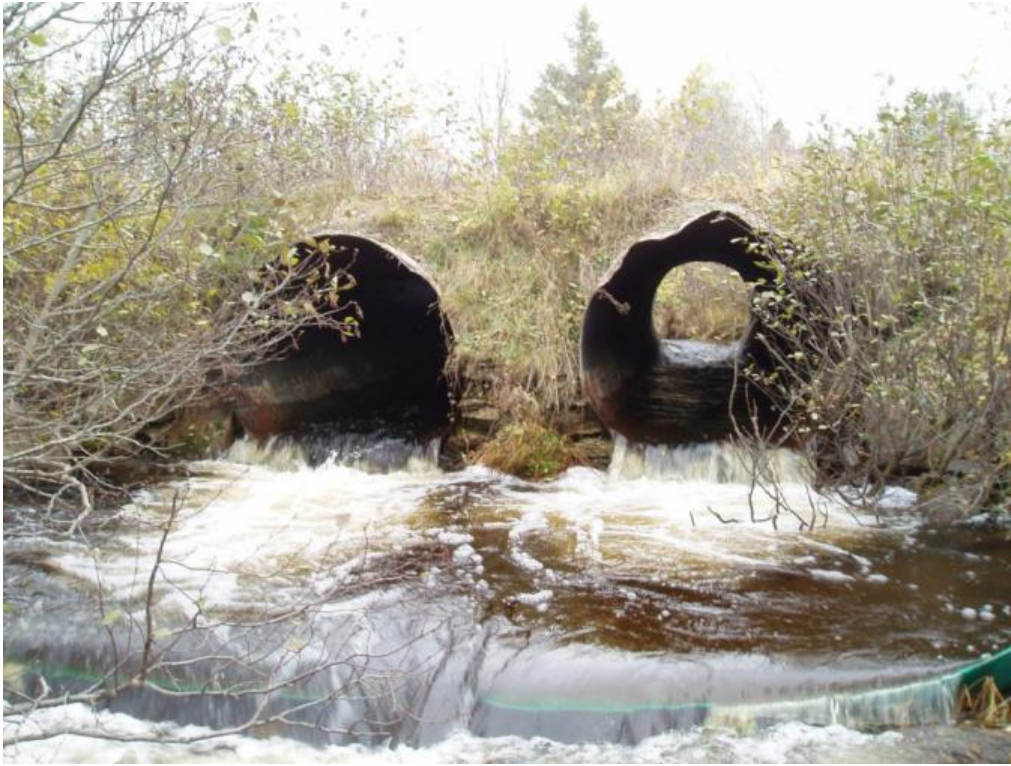
Plate 2 (cont'd): Culvert on Fraser's Brook (Culvert #96) at high flow; Note green plastic weir submerged in flow.

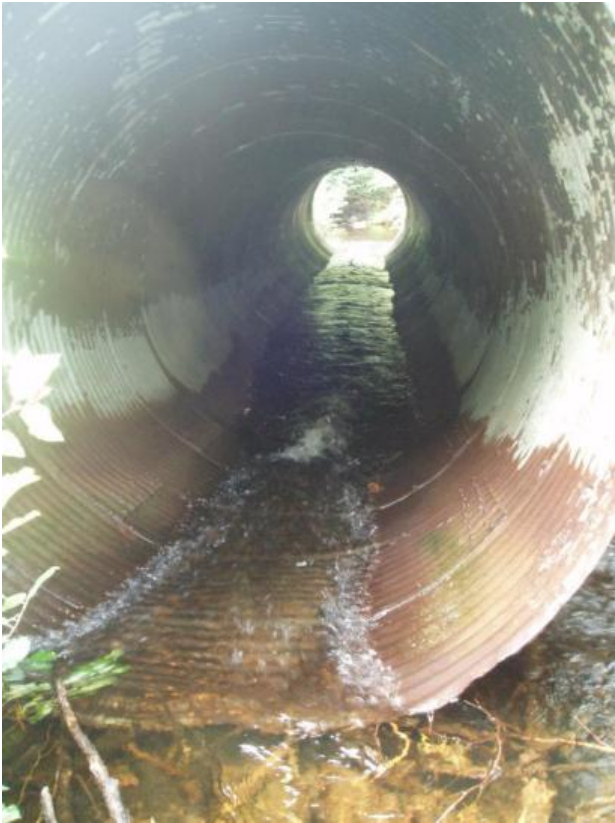
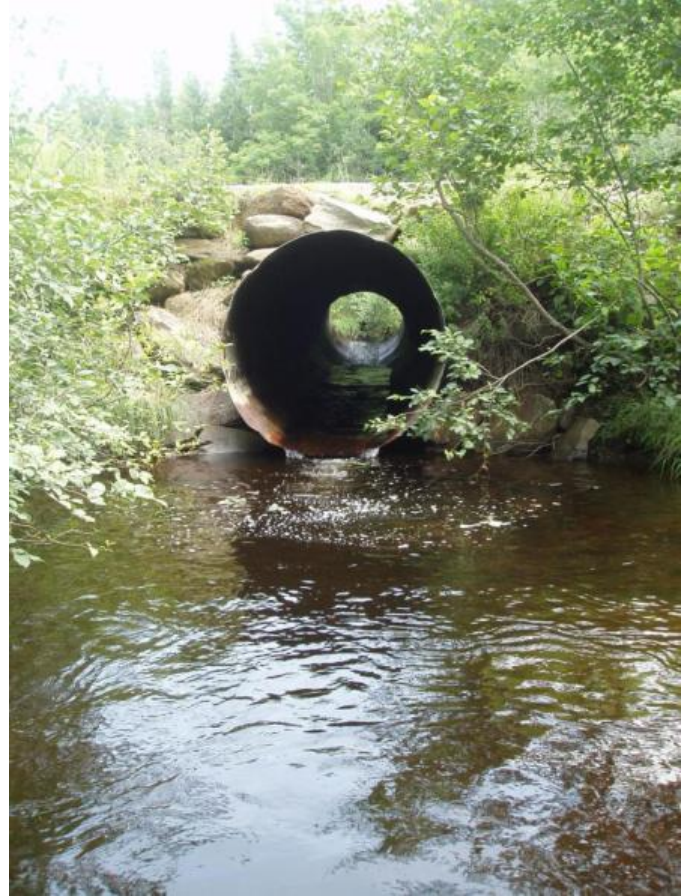
Plate 3: Inflow (left) and outflow (right) of culvert at Boggs Brook (Culvert #9).

The cost for this restoration may be relatively high due to specialized skills and equipment required for baffle fabrication and installation, and heavy machinery required to construct rock weir.

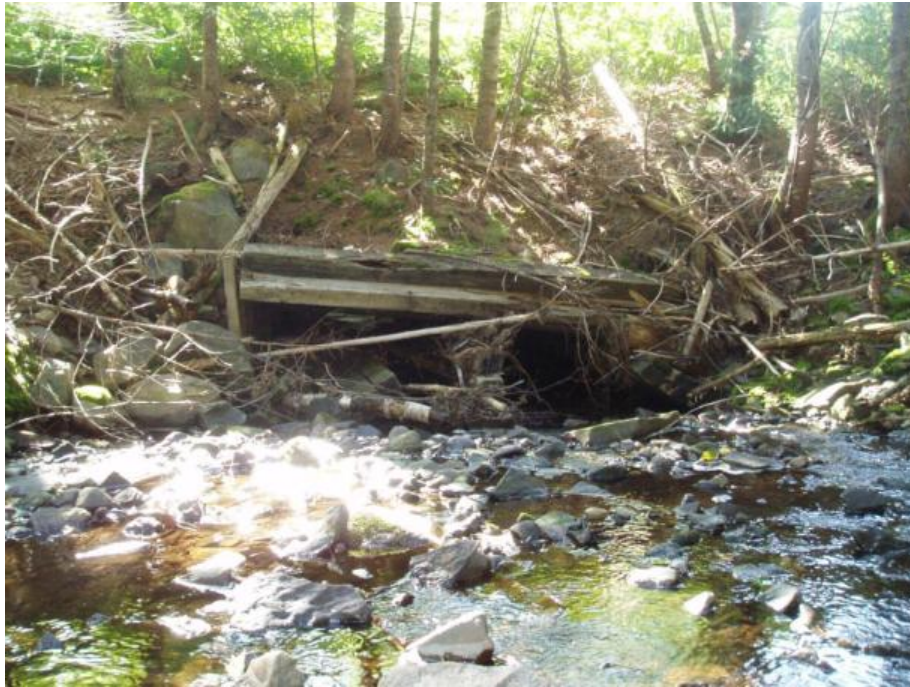
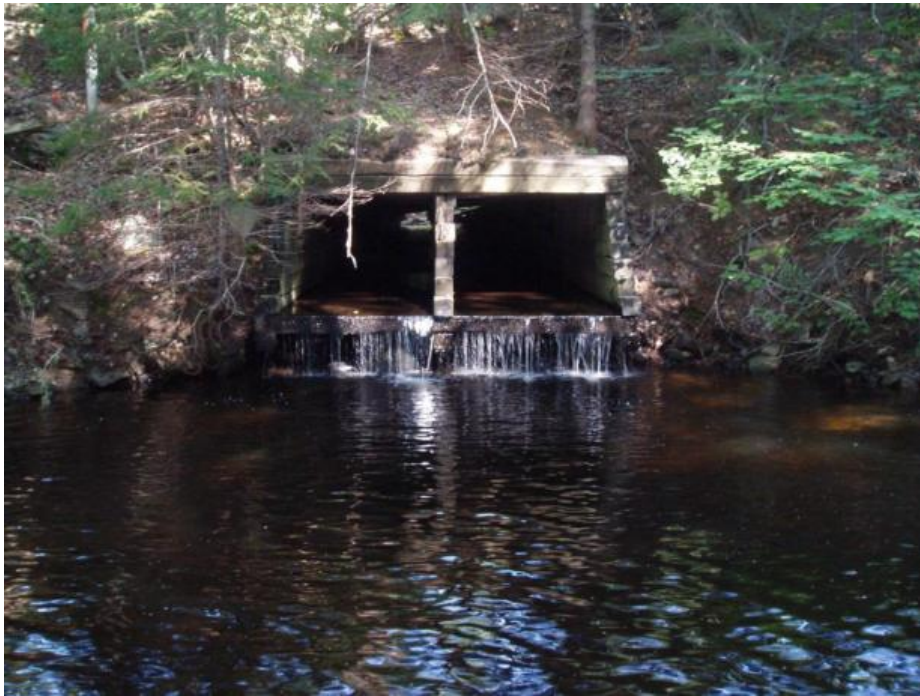
4. The outfall drop of this culvert is problematic as development of an outlet pool to backwater the culvert would be extensive, requiring raising the water level by 0.7 m. I recommend that rather than pool development, a small fishway be constructed from the outfall pool into the culvert, similar to McQuarries Brook. The fishway design could be a continuation of the notched weir baffles and also made of treated lumber. Success of this structure to allow fish passage should be monitored (*Recommendation #2*).

Plate 4: Inflow (upper) and outflow (lower) of culvert on tributary to McLeod Lake (Culvert #55).

1. Removal of debris from upstream end.
2. Assess and determine how culvert may be repaired. Consult with Nova Scotia Department of Transportation and Infrastructure Renewal about options for repair.

3. Installation of wooden baffles, similar to McQuarries Brook (culvert #80) prescription. Each weir should have a notch in the top to allow water to spill through. This work should be relatively easily completed by unskilled labourers using treated 2X6s (which would raise the water to a depth of 14 cm) notched to a depth of 5.0 cm. Moving bedload from upstream may be problematic. These baffles will require more frequent monitoring and repair than those of McQuarries Brook. Specific design of these baffles (number baffles in culvert; distance between them) should be determined in consultation with engineers or restoration experts with experience. The baffles can be installed by pre-drilling the wood and using large lag bolts to hold them in place.

The design fish for this restoration are salmonids, primarily adults, and the restoration concept is resting pools of ≥ 9.0 cm depth and access between pools via the notch in the weir. The cost for this restoration is expected to approximate that of McQuarries Brook. It is recommended that this stream crossing be restored before McQuarries Brook as it is smaller and can be a useful pilot project to work out problems before moving on to the larger, and more distant, McQuarries Brook.

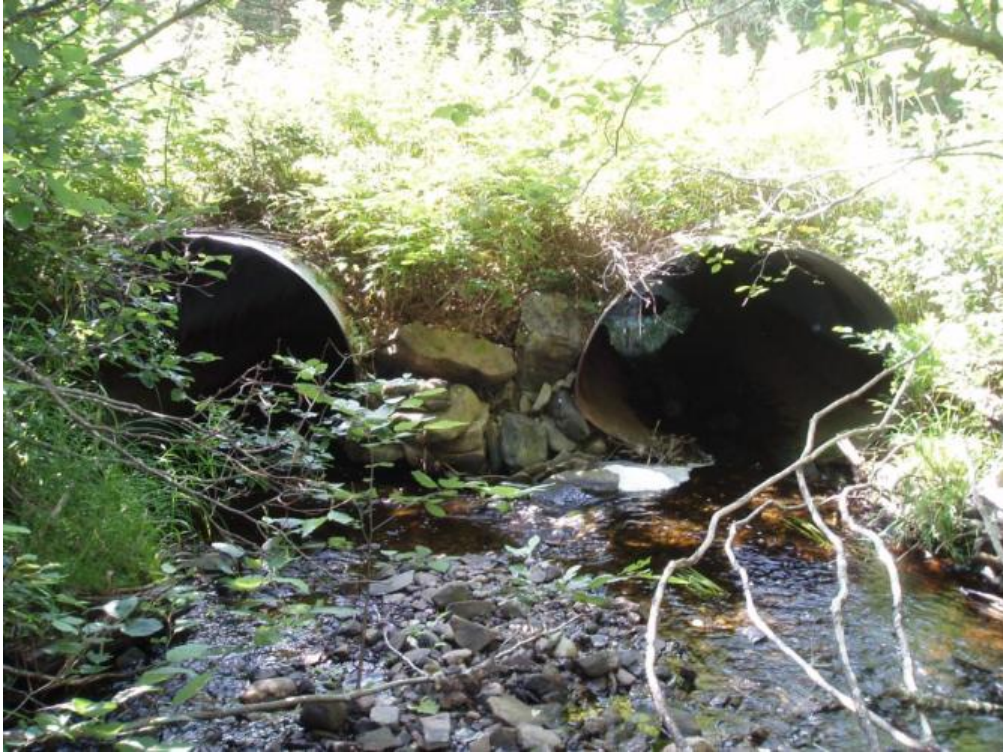
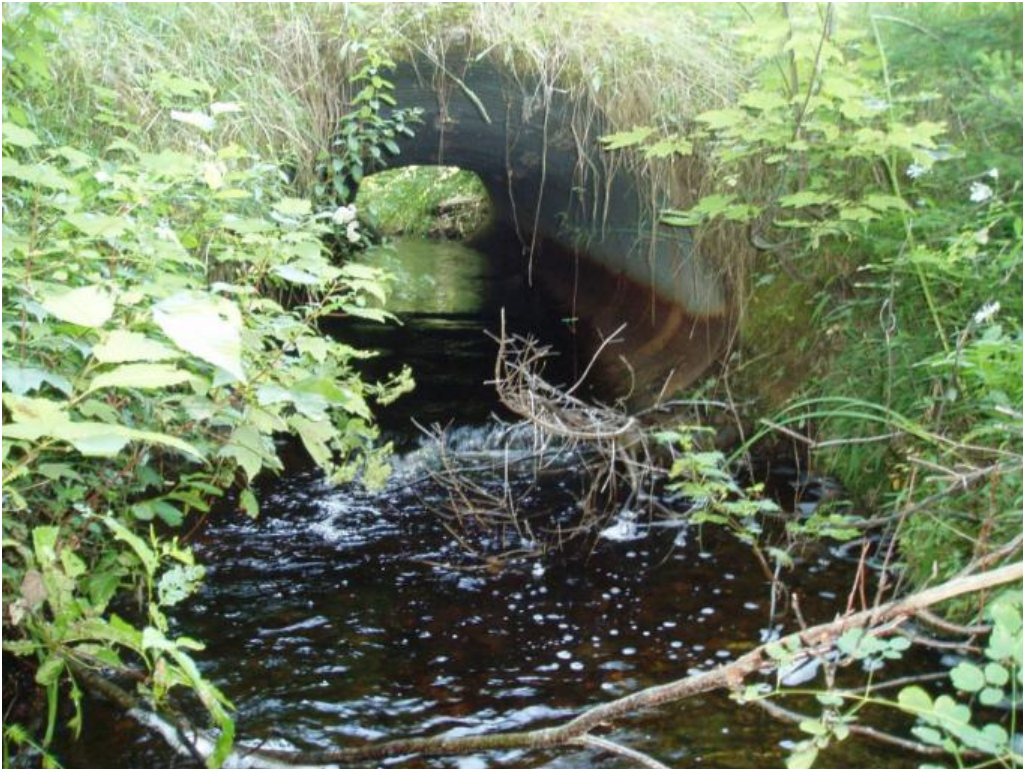
Plate 5: Inlet of paired arch pipe culverts (upper) and outflow of one of these culverts (lower) on Hattie Brook (Culvert #68).

1. Installation of baffles would be problematic in these culverts due to small culvert diameter and difficulty working in confined space. The outfall drop is very small. Outlet pool development of this crossing would backwater the culvert, thereby reducing water velocity and eliminating outfall drop. A single rock control weir to raise the water level should be constructed to backwater the culvert.

The design fish for this restoration are American eel, white sucker, and cyprinids. There is a large amount of habitat upstream of this location, and backwatering the culvert should allow passage for the weak swimmers in addition to the strong swimming salmonids. The cost for this restoration should be at a low-medium level due to requirement for rock and heavy machinery, but the required weir is small size and could be rapidly and easily constructed.

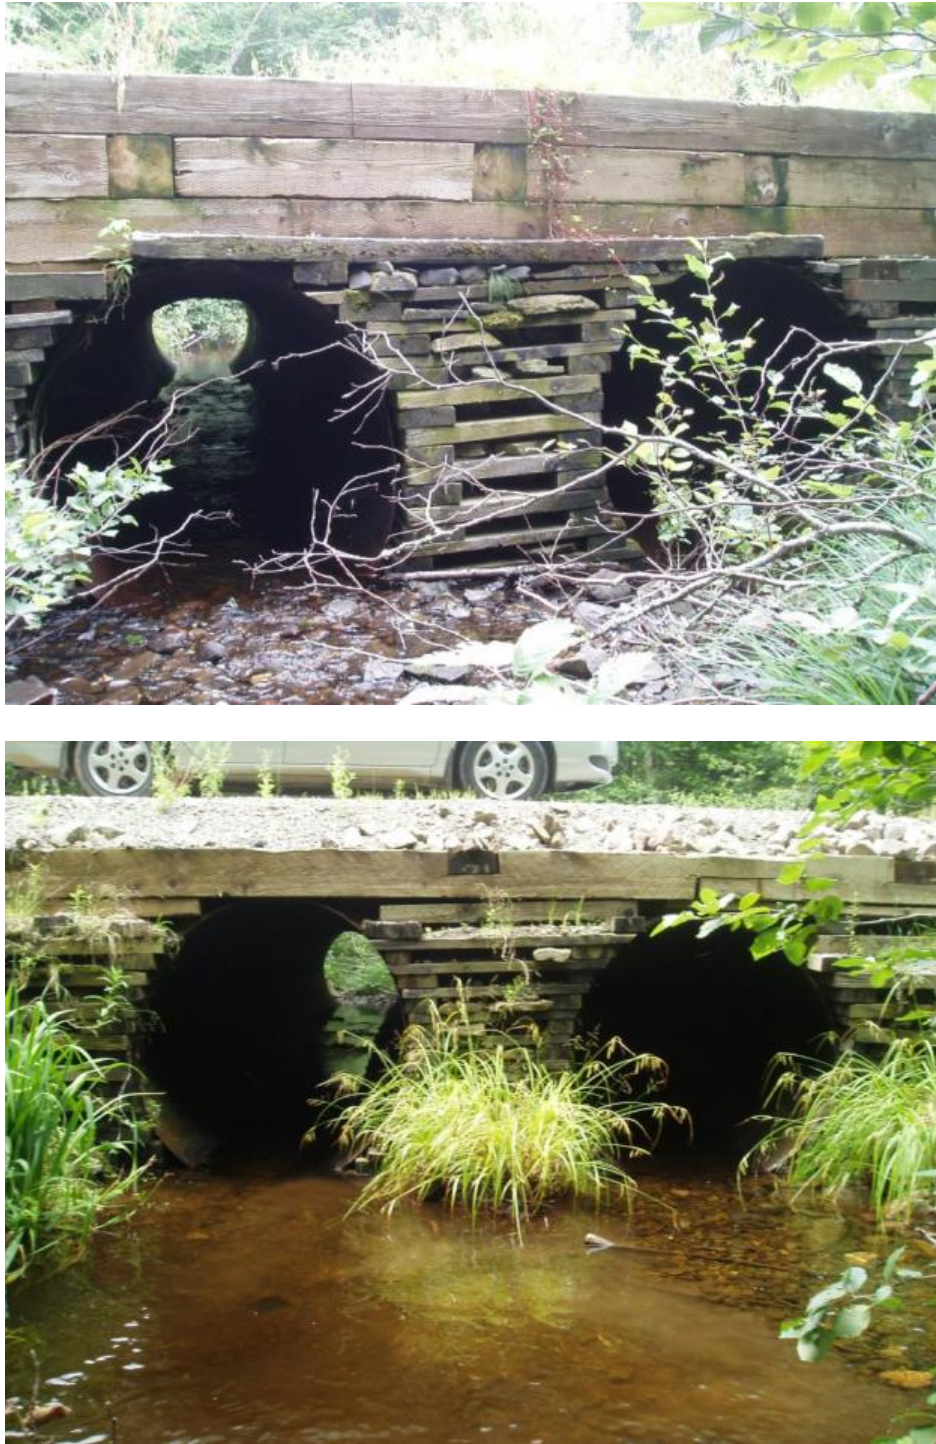
Plate 6: Inflow (upper) and outflow (lower) of Bryden Brook (Glenelg) to paired culverts (Culvert #13).

1. Placement of baffles (notched weir) to decrease velocity and also increase water depth. As with Fraser's Brook (culvert #96) these baffles will need to be of metal and bolted or welded in place, which is more complex than simple wooden baffles. Each weir should have a notch in the top to allow water to spill through. These should be quite low-head weirs as there is evidence of a great deal of substrate movement in this stream and the objective is to minimize extent to which substrate is trapped in the culvert. Specific design of these baffles (number baffles in culvert; height of baffle, distance between them) should be determined in consultation with engineers or restoration experts with experience. Baffles will have to be robust to withstand impacts of moving bedload. Substrate accumulation will have to be monitored and removed on a regular (multi-year) basis (see *Recommendation #3*).

The design fish for this restoration are salmonids, primarily adults, and the restoration concept is resting pools of ≥ 9.0 cm depth and access between pools via the notch in the weir. The cost for this restoration may be relatively high due to specialized skills and equipment required for baffle fabrication and installation, and need to build very strong due to the dynamic nature of the streambed.

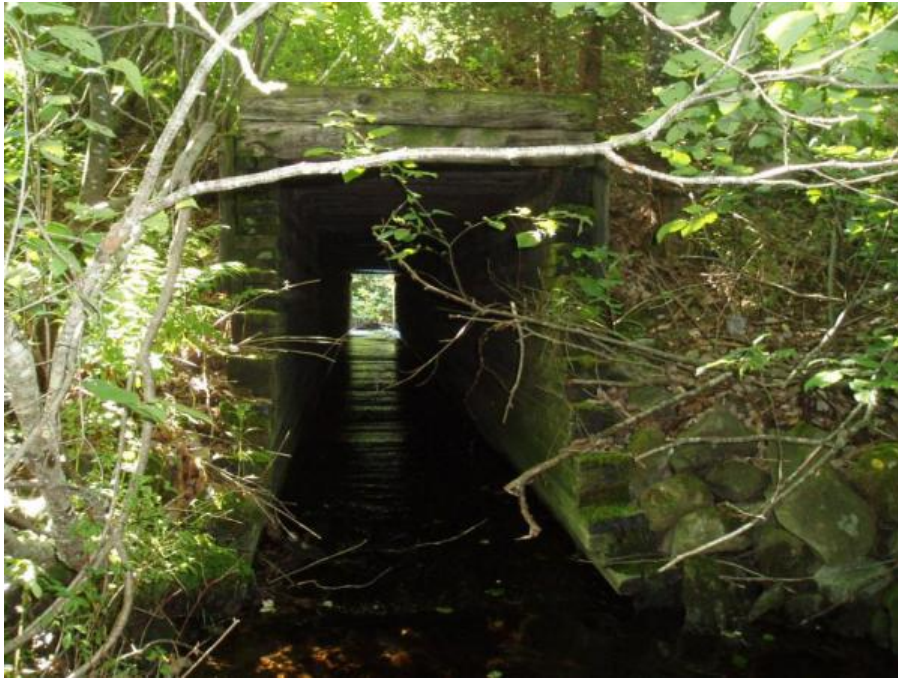
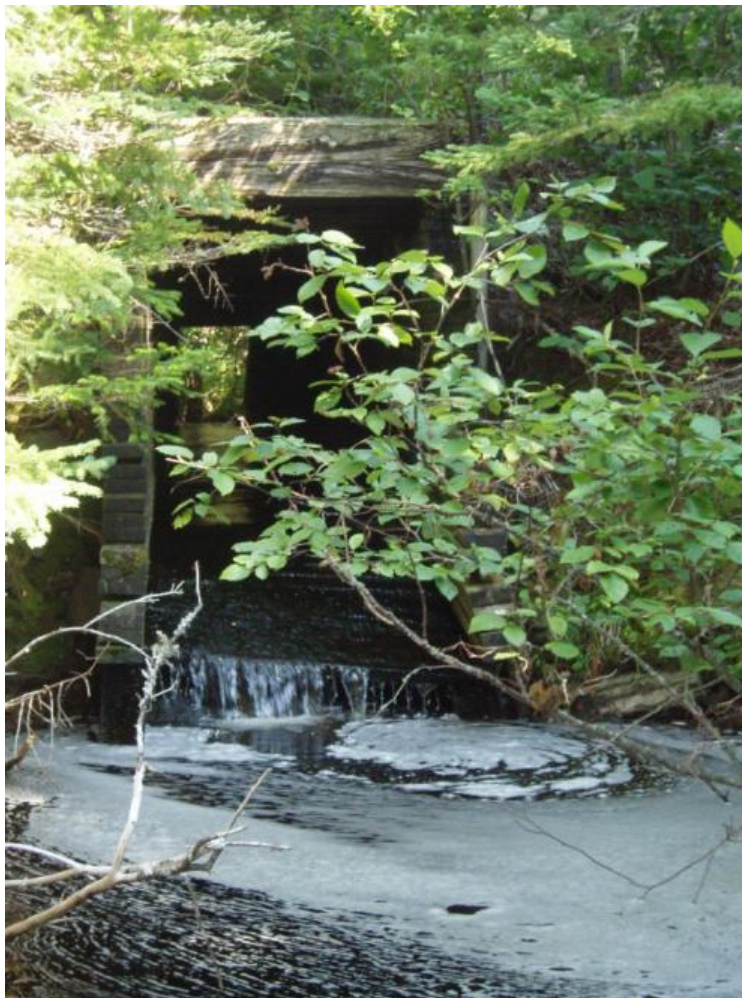
Plate 7: Inflow (upper) and outflow (lower) of unnamed tributary to Indian Man pool (Culvert #57).

3. If the outlet pool is deemed not feasible, a small fishway be constructed from the outfall pool into the culvert, similar to McQuarries Brook. The fishway design could be a continuation of the notched weir baffles and also made of treated lumber.

The design fish for this restoration are salmonids, primarily adults, and the restoration concept is resting pools of ≥ 9.0 cm depth and access between pools via the notch in the weir. The outfall drop must be overcome to allow access upstream. The cost for this restoration will depend upon the option chosen. The wooden baffles will be inexpensive; the fishway relatively inexpensive, and pool development expensive due to need for heavy machinery and rock. Overall cost is classified as medium-high.

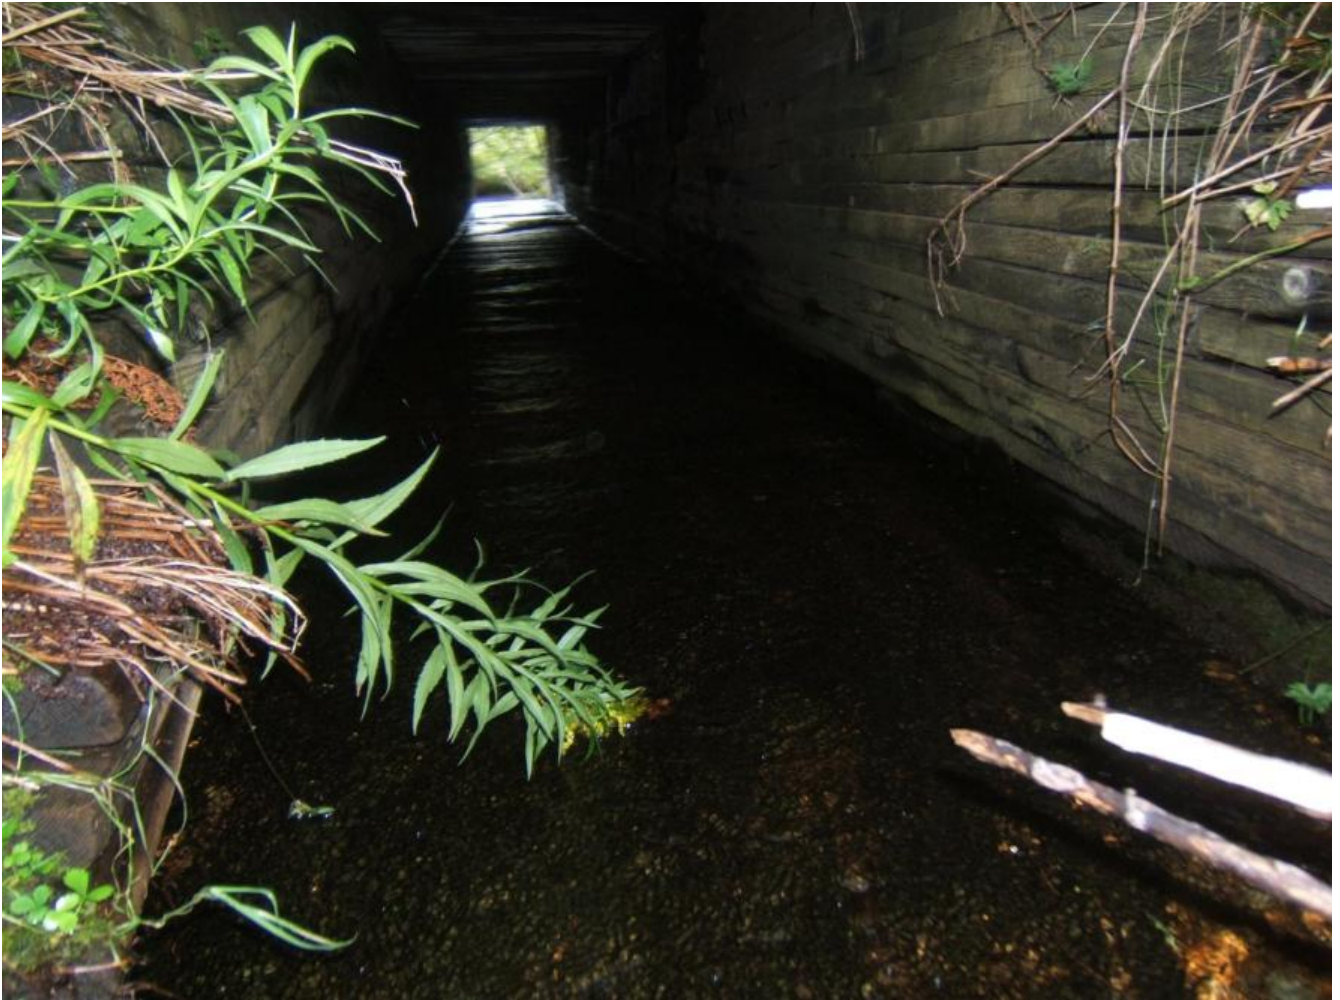
Plate 8: Inflow of unnamed tributary at Rocky Mountain (Culvert #25).

3. If the outlet pool is deemed not feasible, the second option is a small fishway be constructed from the outfall pool into the culvert, similar to McQuarries Brook. The fishway design could be a continuation of the notched weir baffles and also made of treated lumber.

The design fish for this restoration are salmonids, primarily adults, and the restoration concept is resting pools of ≥ 9.0 cm depth and access between pools via the notch in the weir. The cost for this restoration will depend upon the option chosen. The wooden baffles will be inexpensive; the fishway relatively inexpensive, and pool development expensive due to need for heavy machinery and rock. Overall cost is classified as medium-high.
