St. Mary's River Association

Habitat Assessment and Restoration Plan

East River St. Mary's

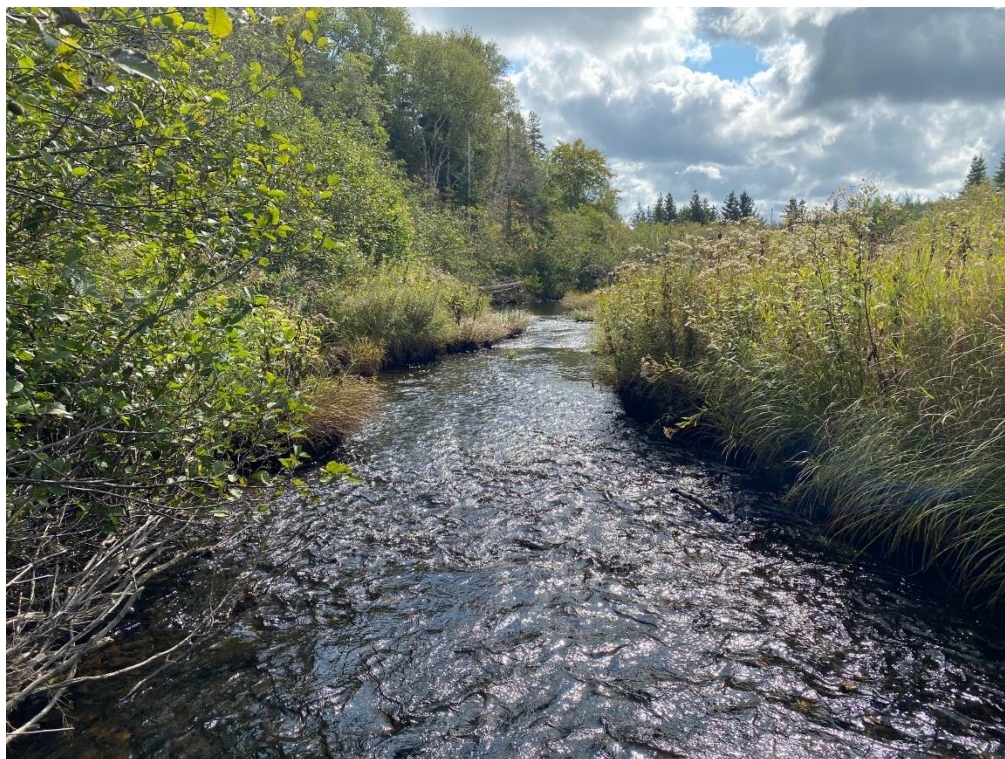
Figure 6: Many sections of Moose River in reach #2 appeared to be narrowing naturally as indicated by the vegetated gravel bars.

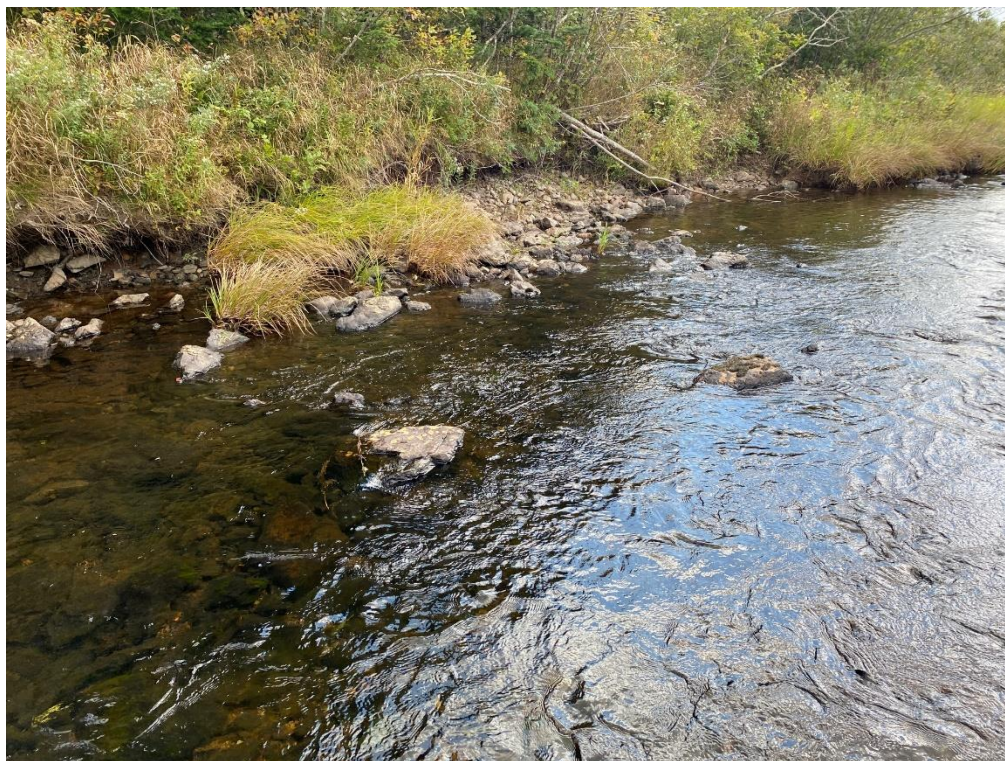
Figure 7: Controlled stream bank erosion above a section of bedrock bottomed stream.

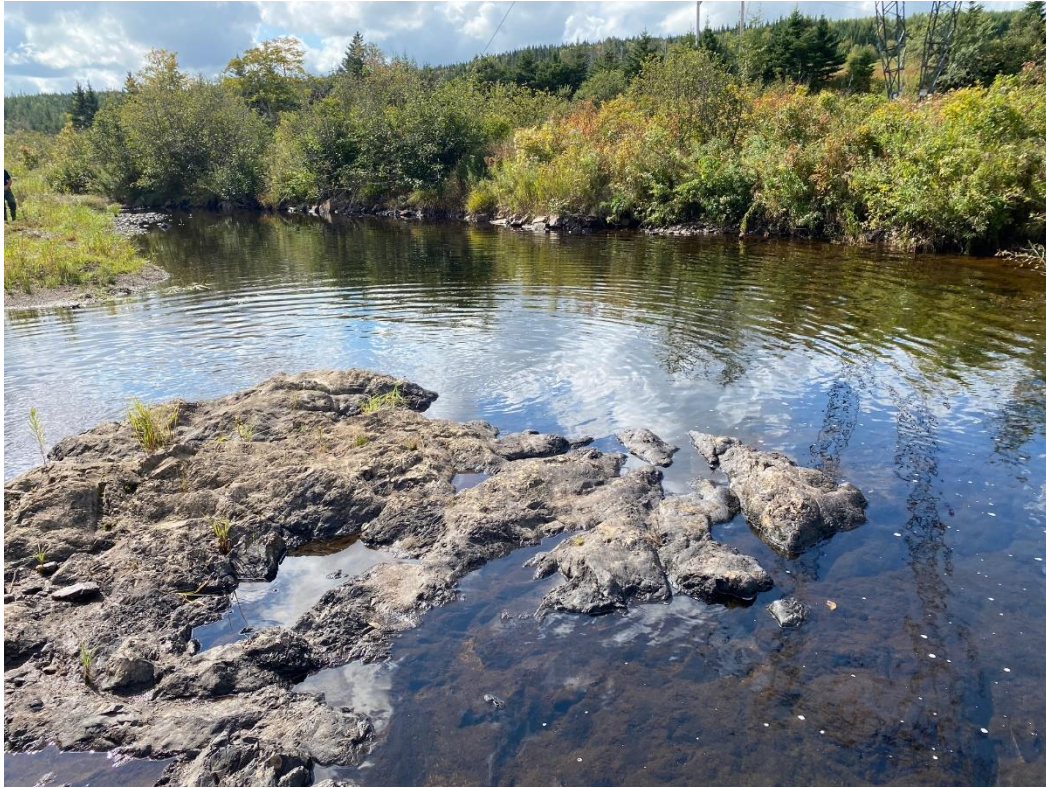
Figure 8: Exposed bedrock indicating significant down-cutting of stream bed during past century.

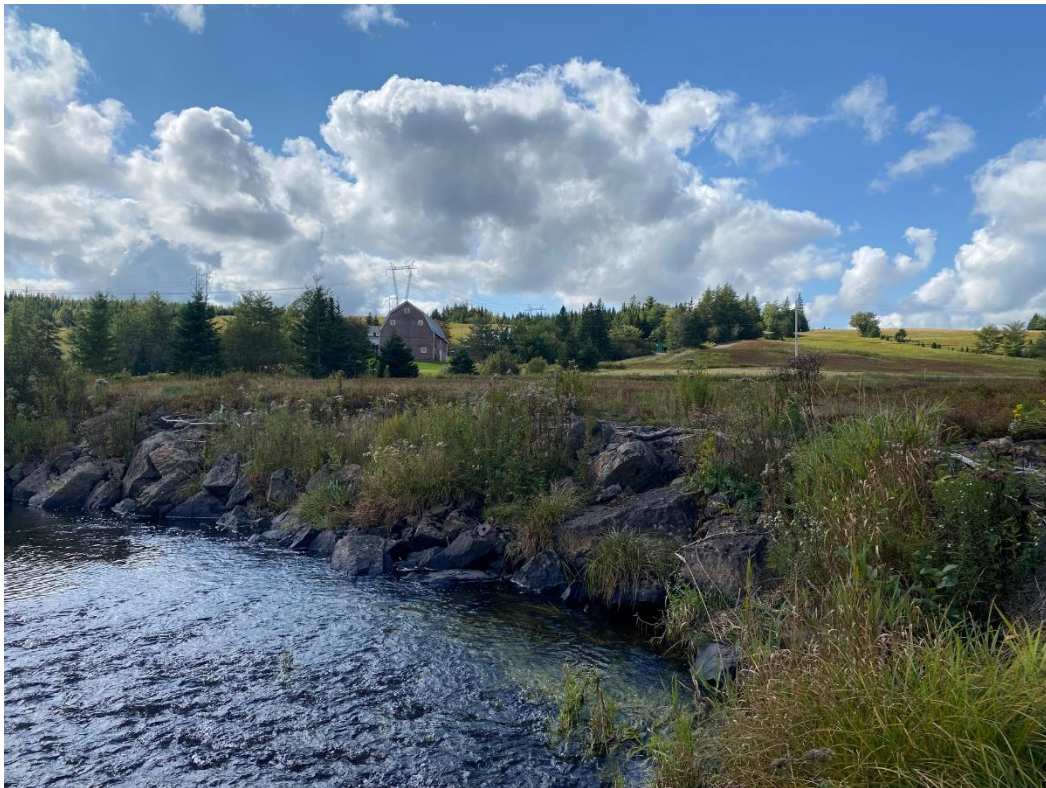
Figure 9: Stream bank stabilization work that occurred in the 1980s as part of an agricultural program.

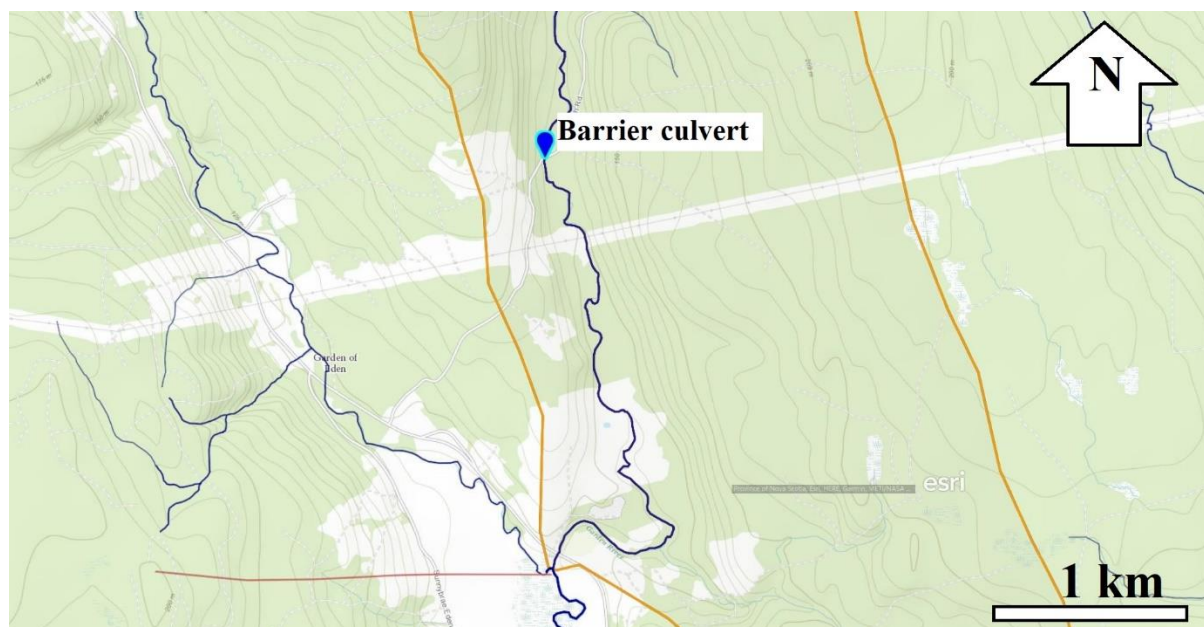
Figure 11: Topographic map with a pin dropped to indicate the location of the barrier culvert relative to Garden River's confluence with the East River. The culvert is creating geomorphic instability and limiting fish passage.

Garden River – Culvert Remediation This project will be focused on restoring fish passage at the Garden River – MacIntosh Road crossing. Currently several undersized and improperly installed culverts are causing habitat degradation and blocking fish migration. The Department of Transportation will need to be engaged.	30,000*	\$100,000
	Total	53,000 sq. m	\$300,000
2023	East River – Site 002 (Newtown / Hwy 347) This project is directly above the East River – Highway 347 crossing and will involve bank stabilization and potentially the installation of an upstream sill to prevent channel migration above the bridge. Presently the channel is causing excessive erosion upstream of the bridge which is causing siltation. This site is not	2,000	\$45,000

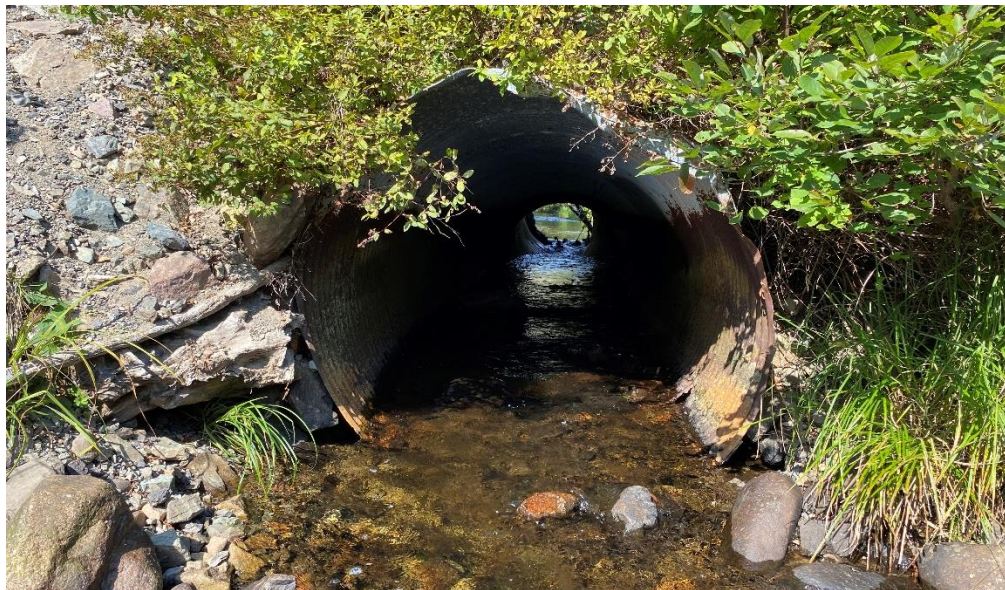
Figure 12: Looking upstream through the main culvert. Partial fish passage was available at this time (Sept 2021).

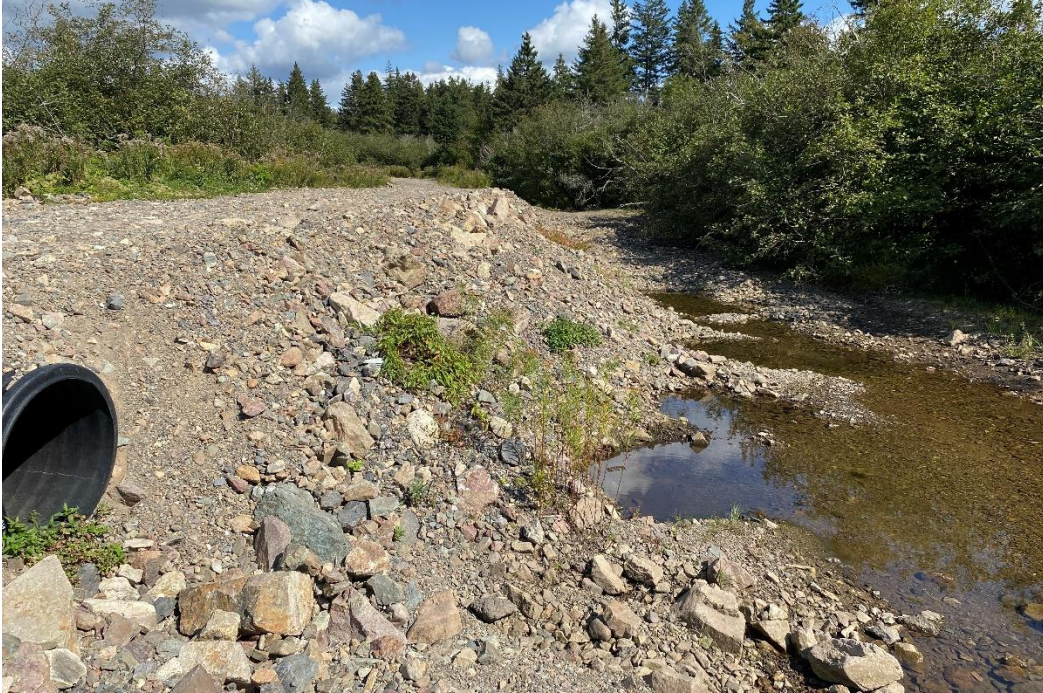
Figure 13: Looking east on the down-stream side of the Garden River – MacIntosh Road Crossing. Pictured on the left is an overflow culvert.

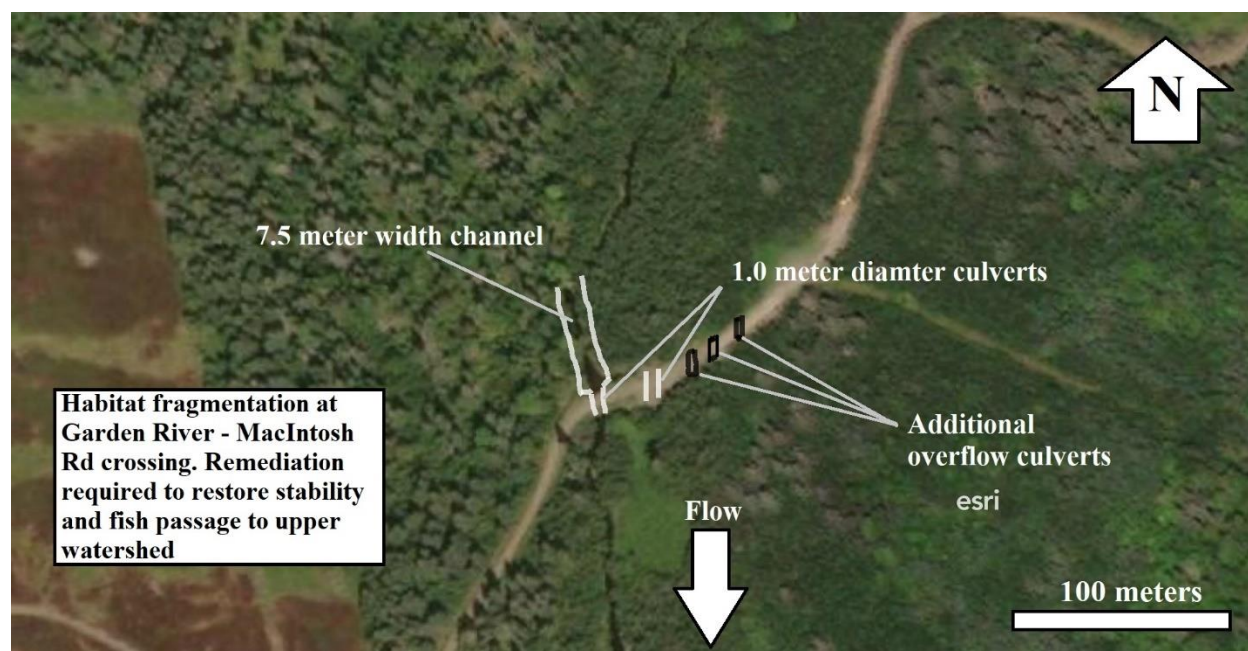
Figure 17: Partial barrier culvert located at -62.30295W, 45.44278N with layout of overflow culverts.

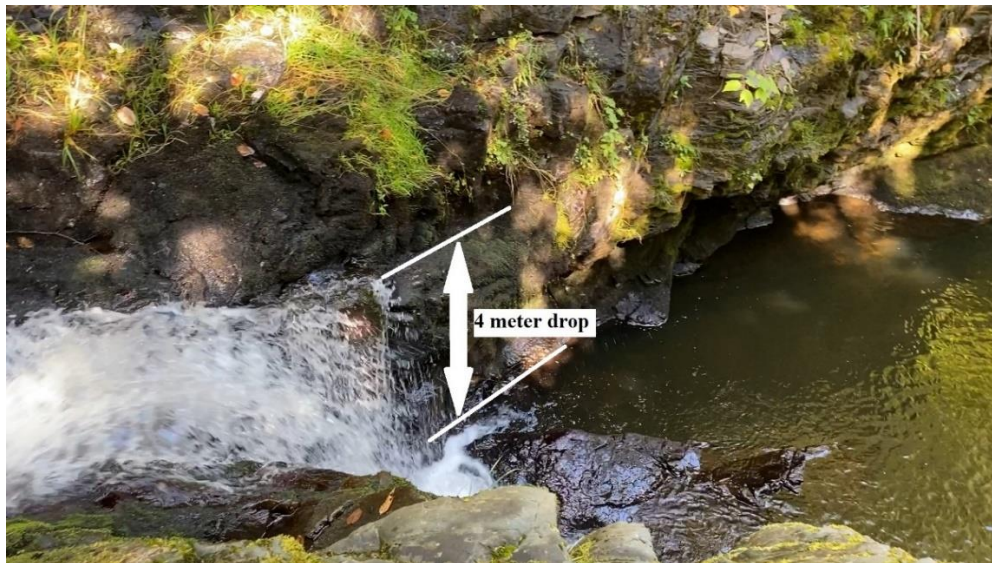
Figure 23: Significant barrier falls below Greens Brook Settlement Rd.

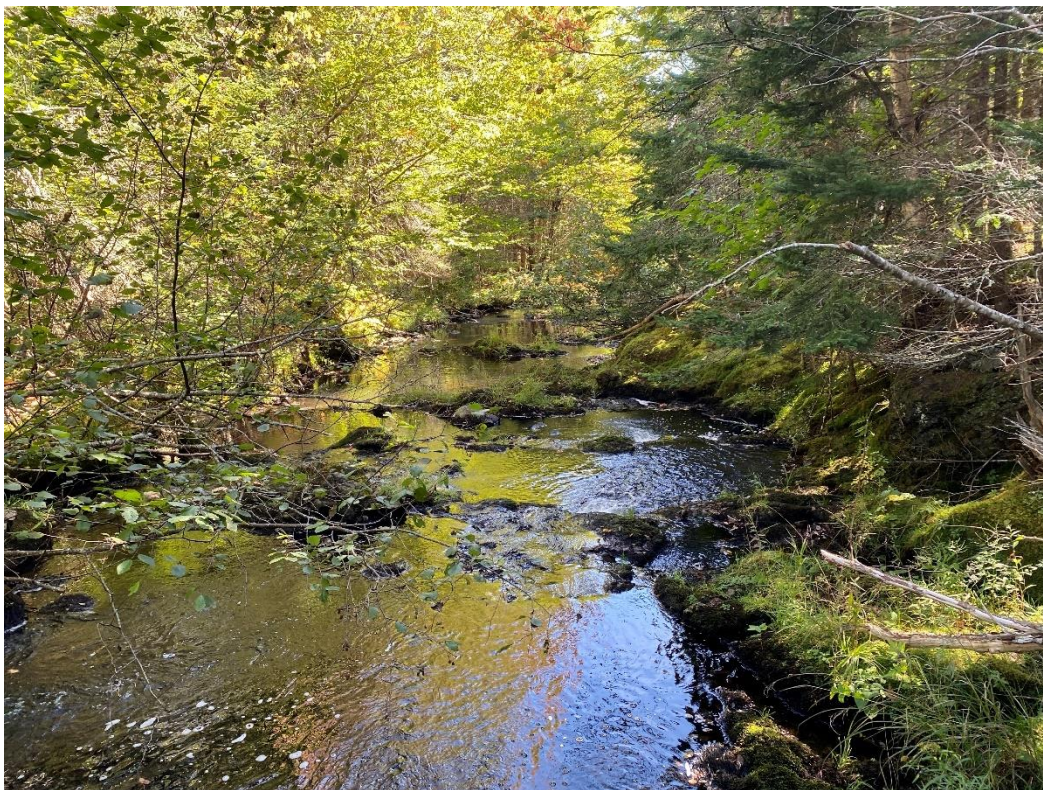
Figure 27: Historical channelization is beginning to recover following floodplain reforestation.

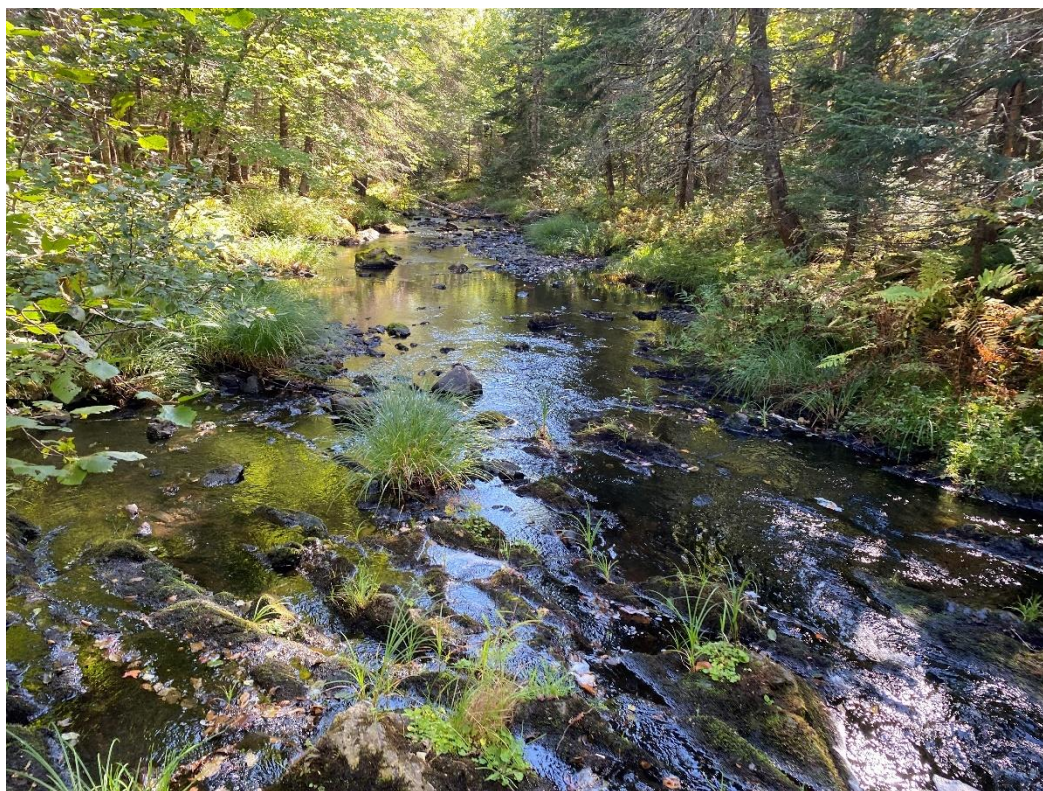
Figure 28: Looking downstream on Greens Brook, substrate has been scoured to bedrock.

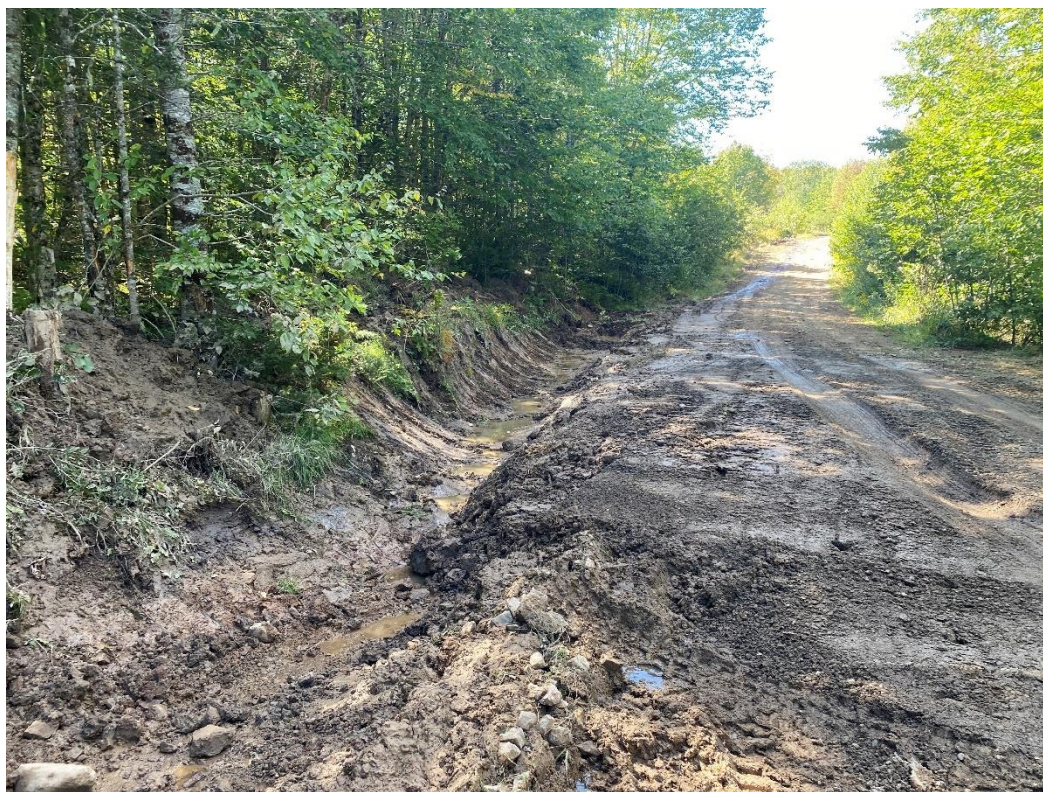
Figure 29: Forestry Road construction creating siltation near the Greens Brook - Black Brook confluence.

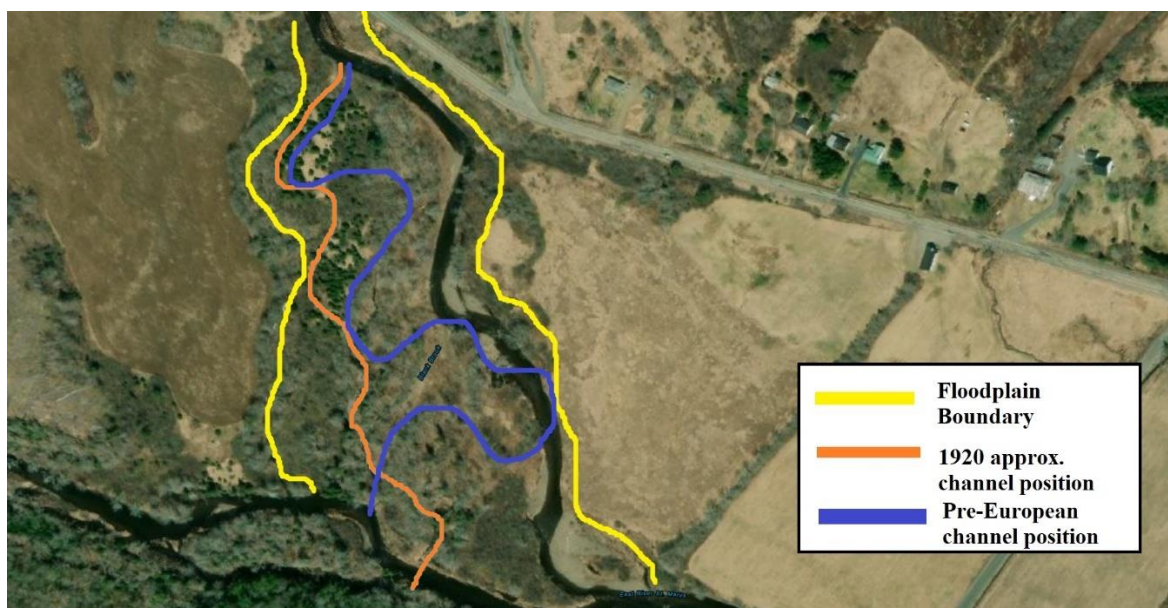
Figure 32: A review of LiDar imaging found that this reach of channel has been highly mobile. Evidence of past channelization work was found below the bridge and along the farm land.

The design of bank stabilization work on this project should be completed within the context that the potential for significant lateral channel migration at this erosion site is limited. The bank height along the erosion site is quite high and the chances of the channel cutting a new path into the field is unlikely. The channel in this site also runs along the easternly terrace of the floodplain (see figure 32) therefore it is likely that extensive lateral channel migration is unlikely to exceed 0.5 meters annually and will likely begin to stabilize before another 2 meters of bank is lost. An emphasize on establishing a 5 to 10 meter buffer zone through tree planting is required.

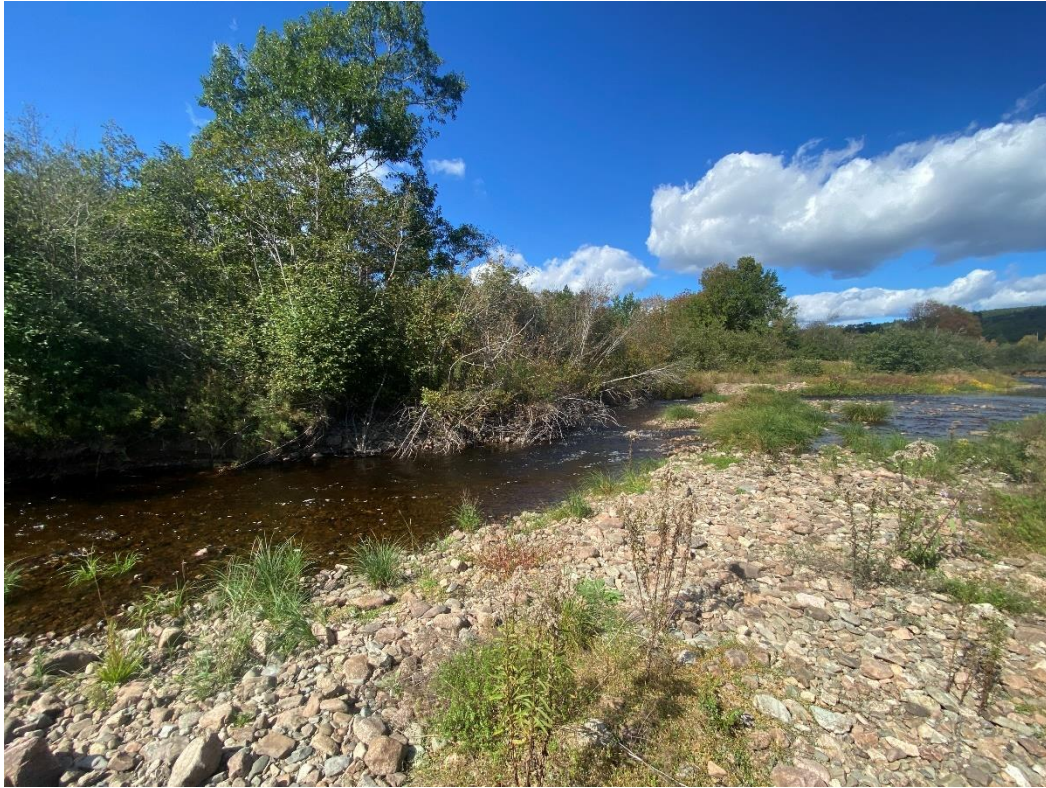
Figure 33: Wide diagonal bars like the one shown above indicate channel instability.

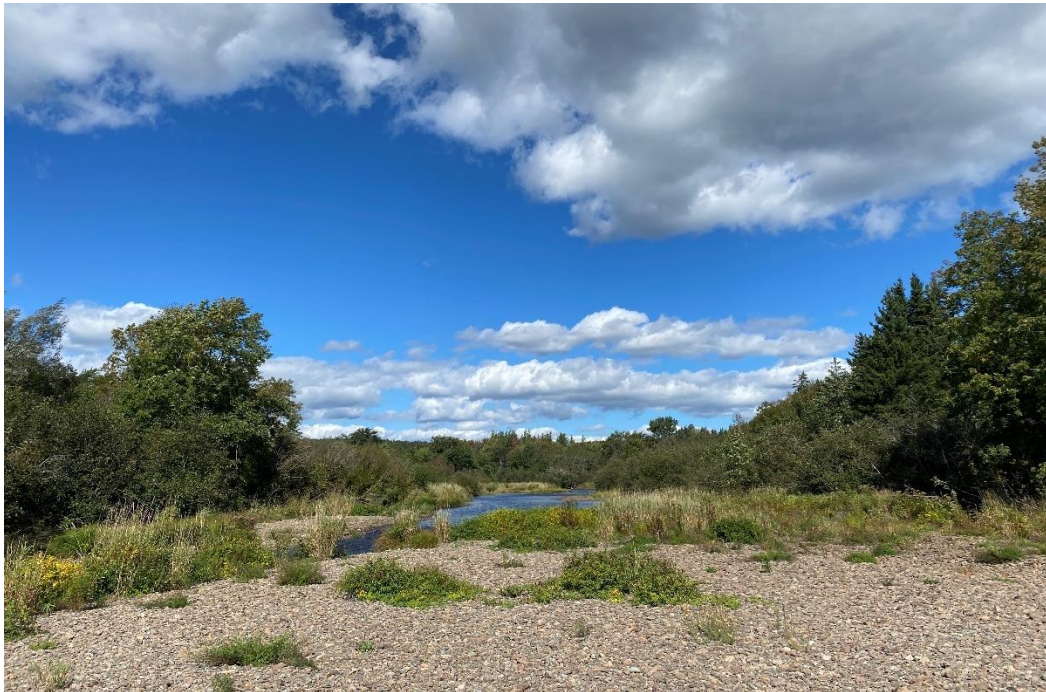
Figure 34: Looking upstream above the bank erosion site. Black Brook has been transporting significant sediment loads in recent years.

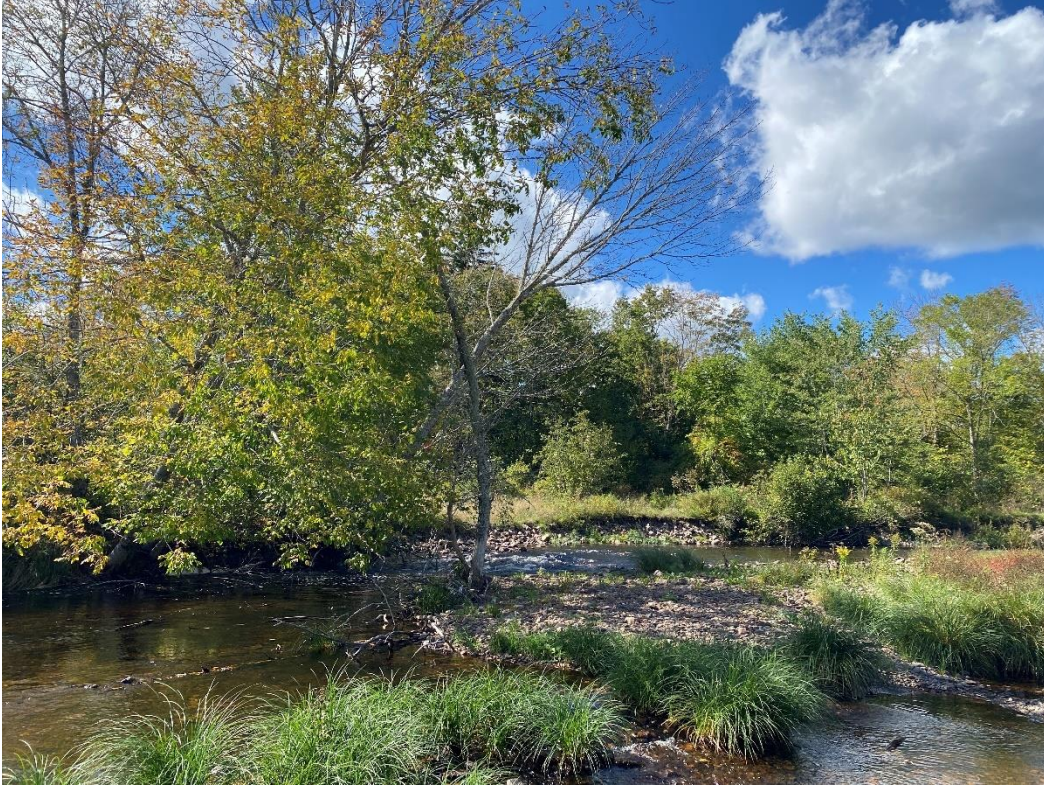
Figure 35: Above the erosion site, bank erosion and accumulation of large woody debris.

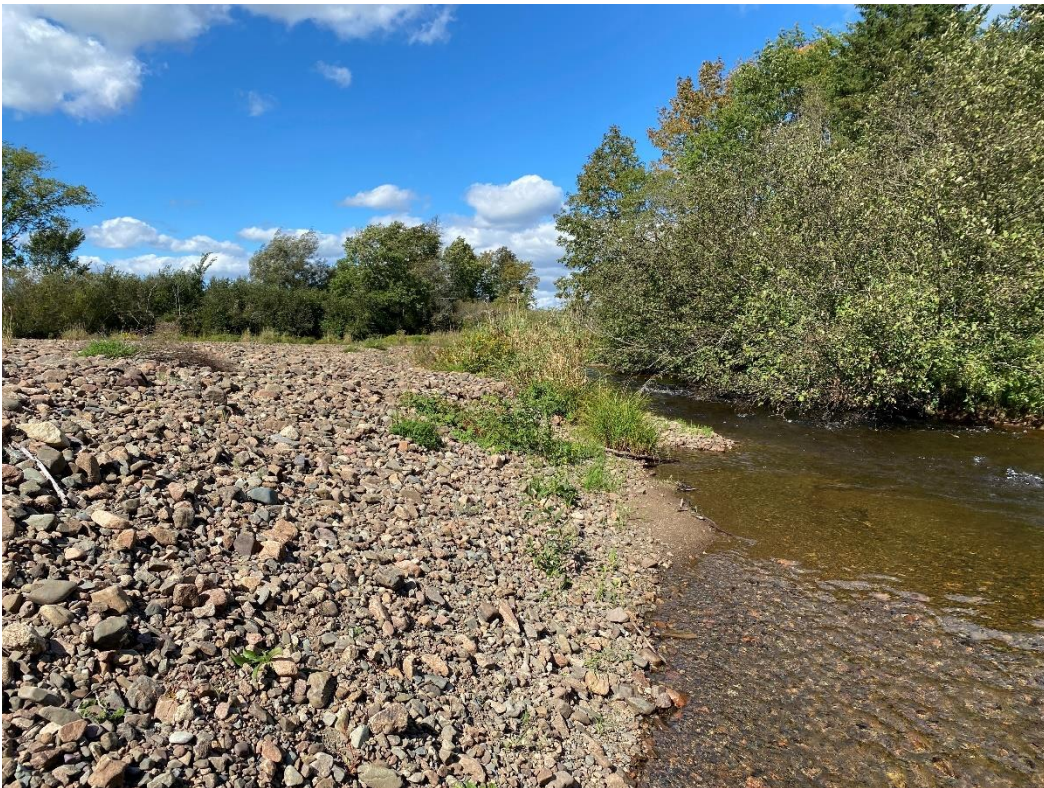
Figure 36: Large gravel bar accumulating 40 meters above the Black Brook – East River confluence.

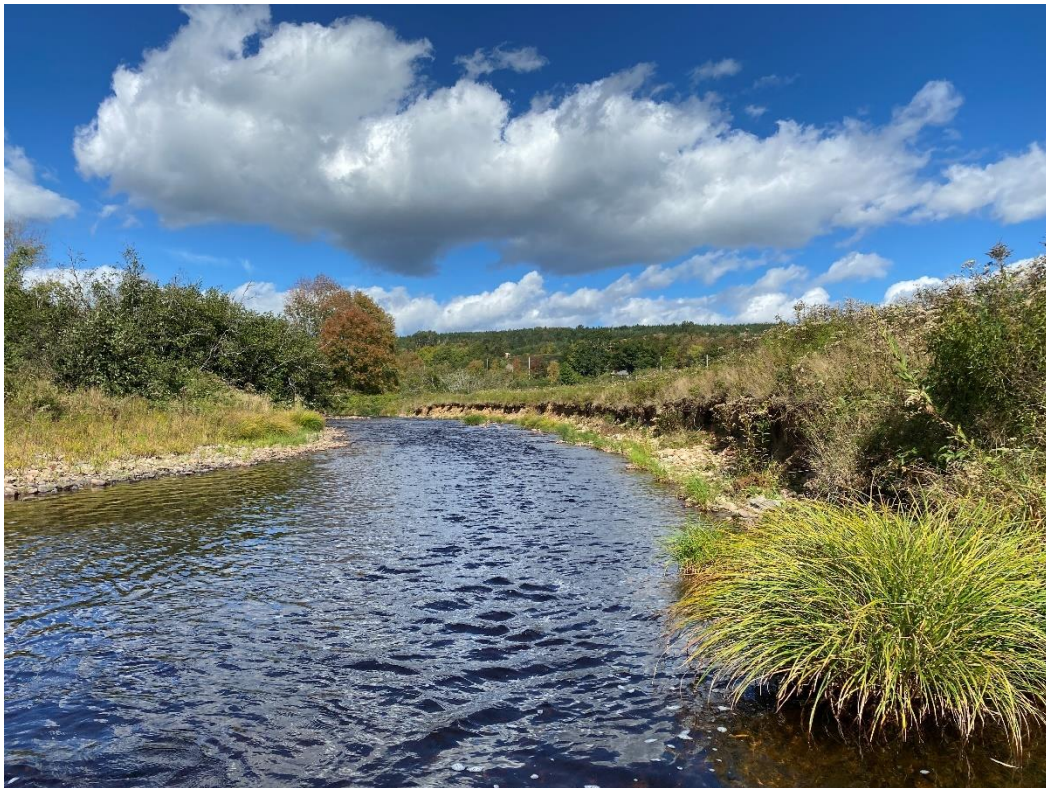
Figure 38: Looking upstream at severe bank erosion.

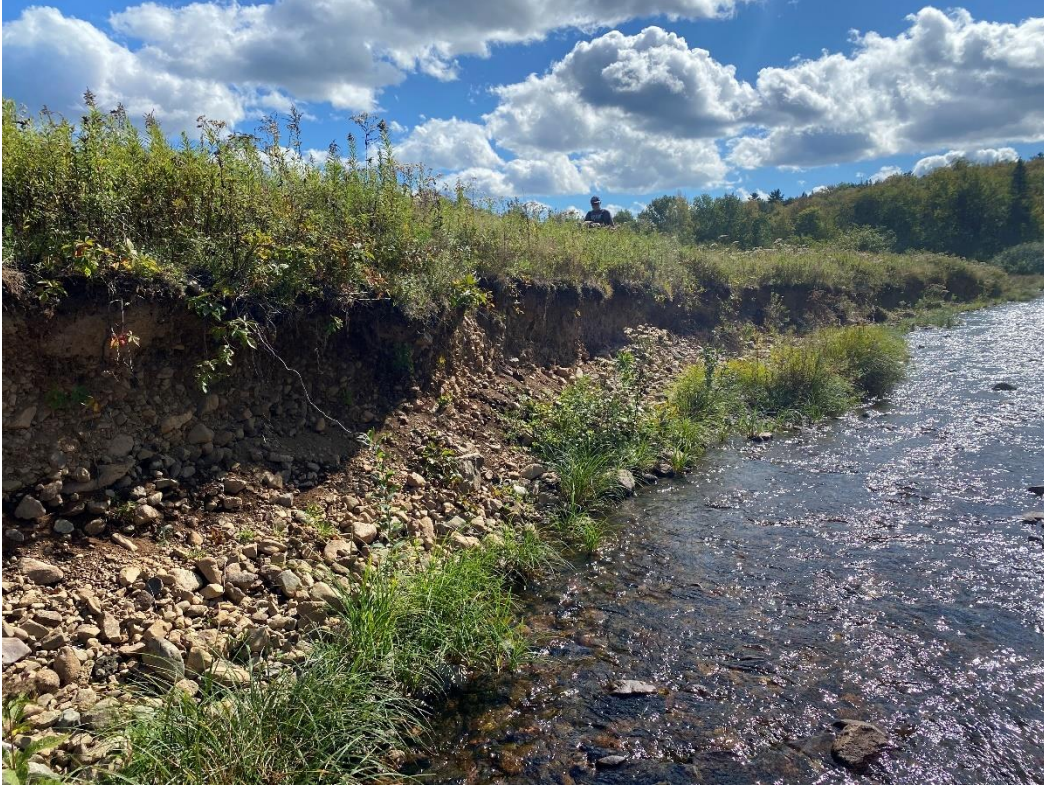
Figure 39: Close up look at eroding bank on Black Brook. Average bank height was 2 meters.

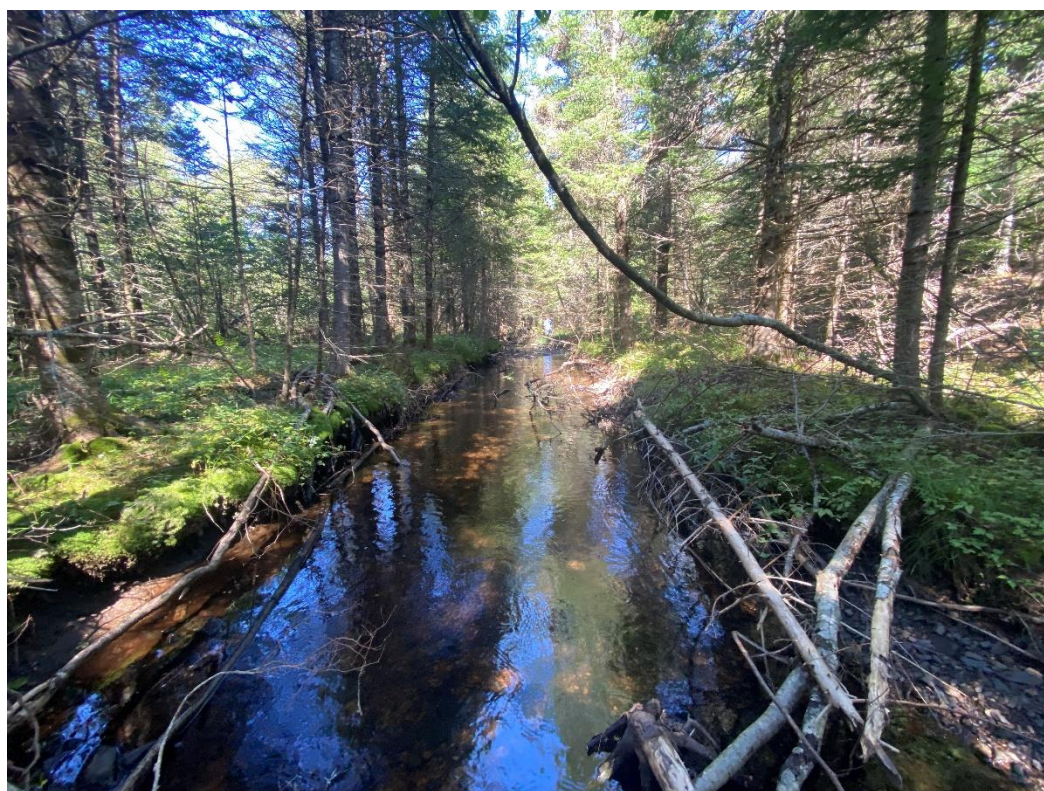
Figure 44: Signs of past channelization. Looking upstream on Frasers Brook.

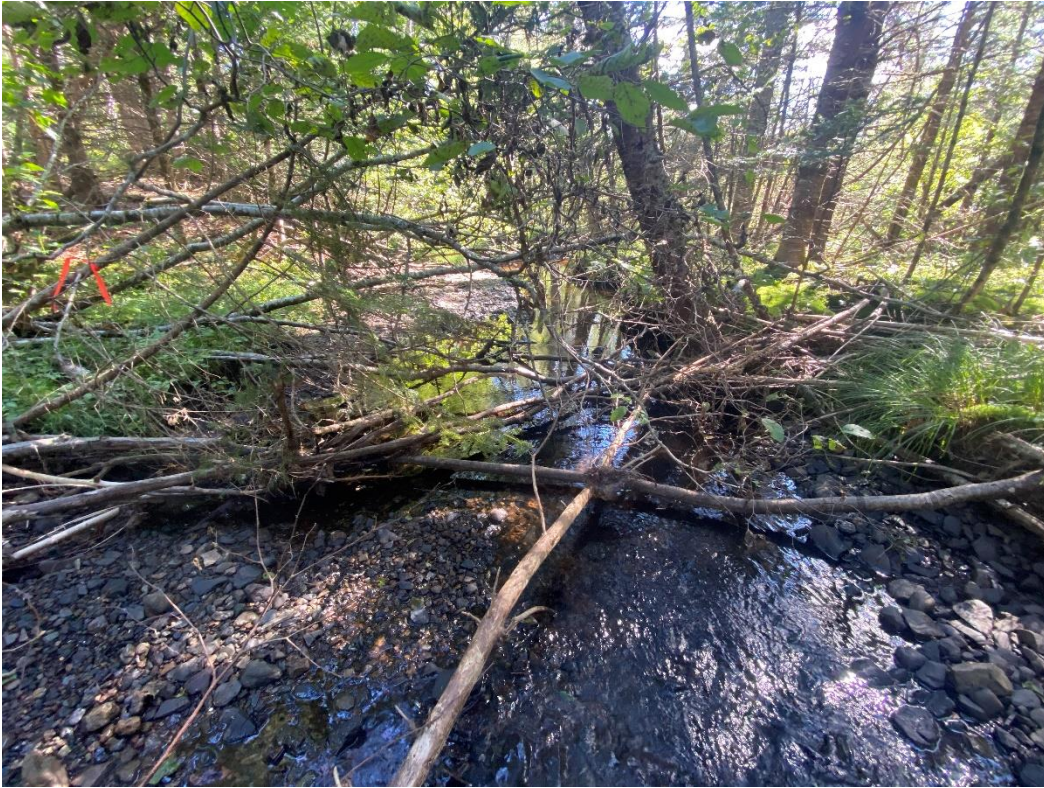
Figure 45: Debris accumulation below forestry harvest.

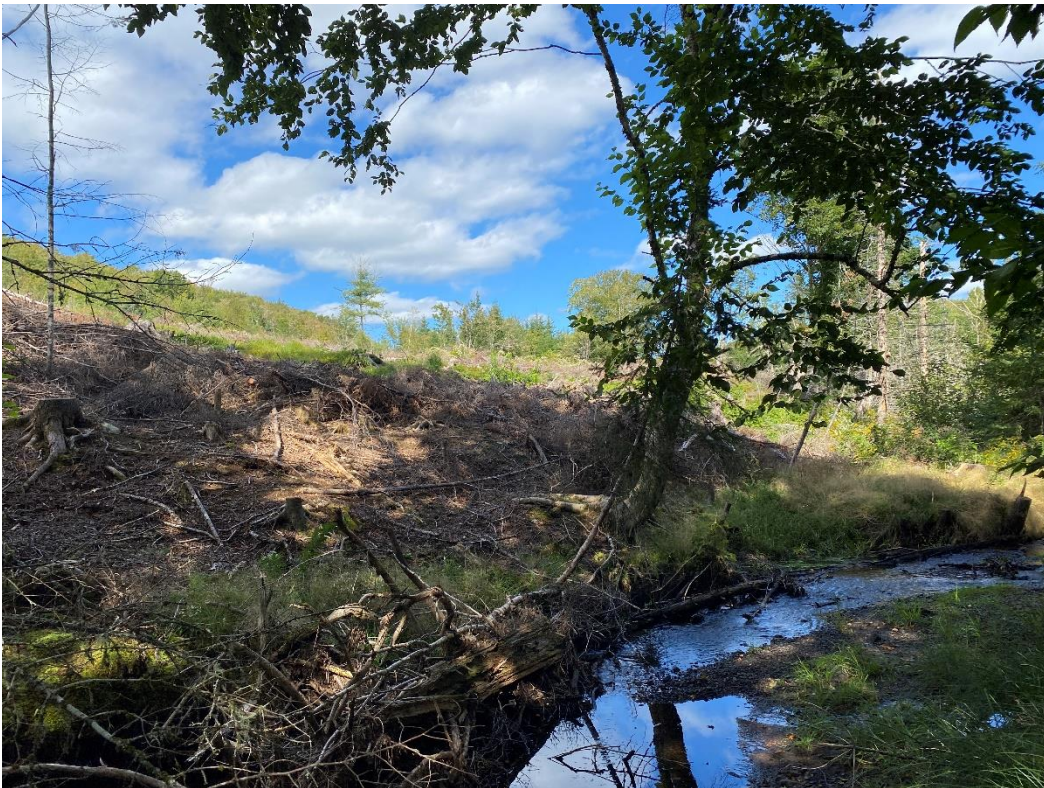
Figure 46: Looking upstream along Frasers Brook. Forest harvesting occurred with the protected buffer zone.
