West Branch of the St. Mary's River Restoration Project 2017 Post Construction Report

Department of Fisheries and Oceans
Small Craft Harbours Branch
August, 2017

Charles MacInnis, B.Sc.
MacInnis Natural Resource Services

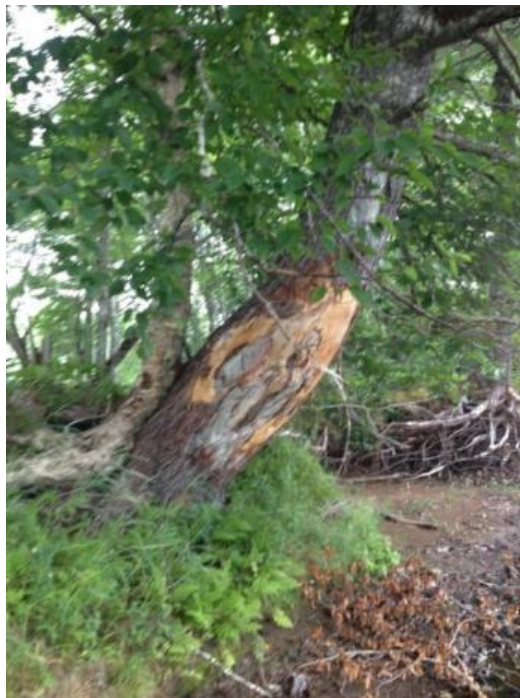
In 2013, the SMRA developed a Salmon Recovery Strategy that identified the need to address the deteriorating habitat resulting from past human activity, acidic precipitation, peak ice conditions, flood events, etc. The Association used this Recovery Strategy as a blueprint to address the habitat issues and create conditions so that all flora and fauna can survive and thrive. This Strategy concluded that there has been significant habitat degradation on the St. Mary's River that has had a negative impact on its salmon habitat. While low readings on the pH scale is a concern on some tributaries, the effects of peak rain and ice events has caused widespread damage along much of the West Branch and various locations on the East and Main Branches of the River (Figure 2).

Figure 2: Ice scour on a tree in the Upper West Branch, St. Mary's River

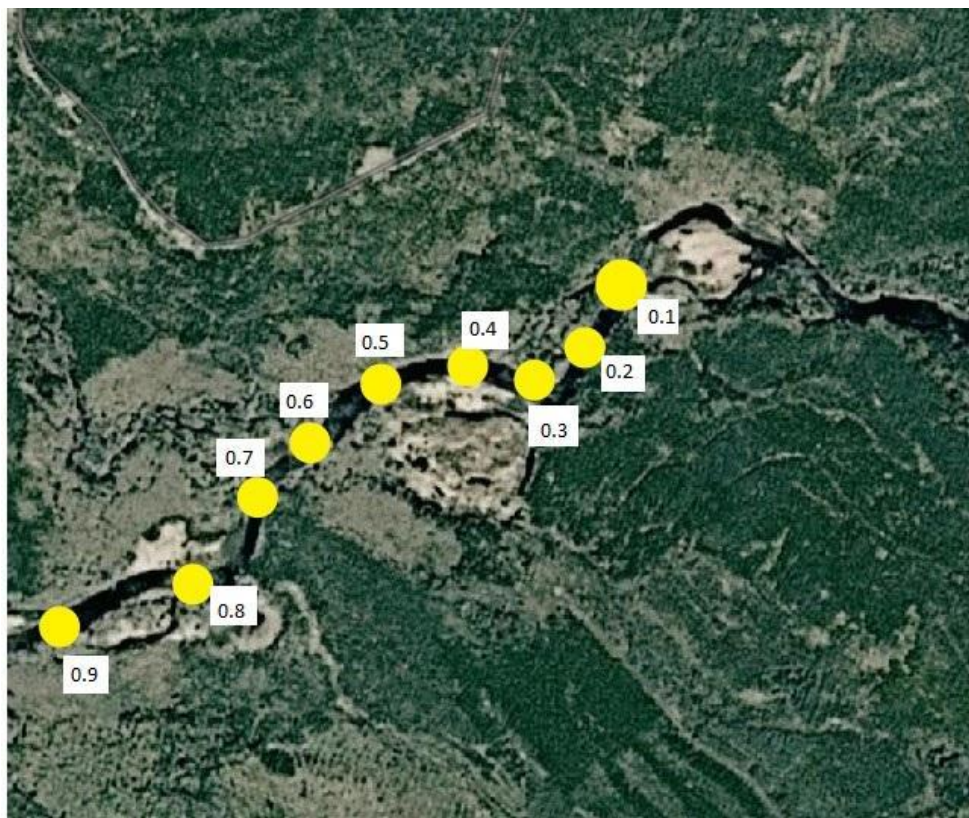
Figure 6: Site 0 with structures labeled

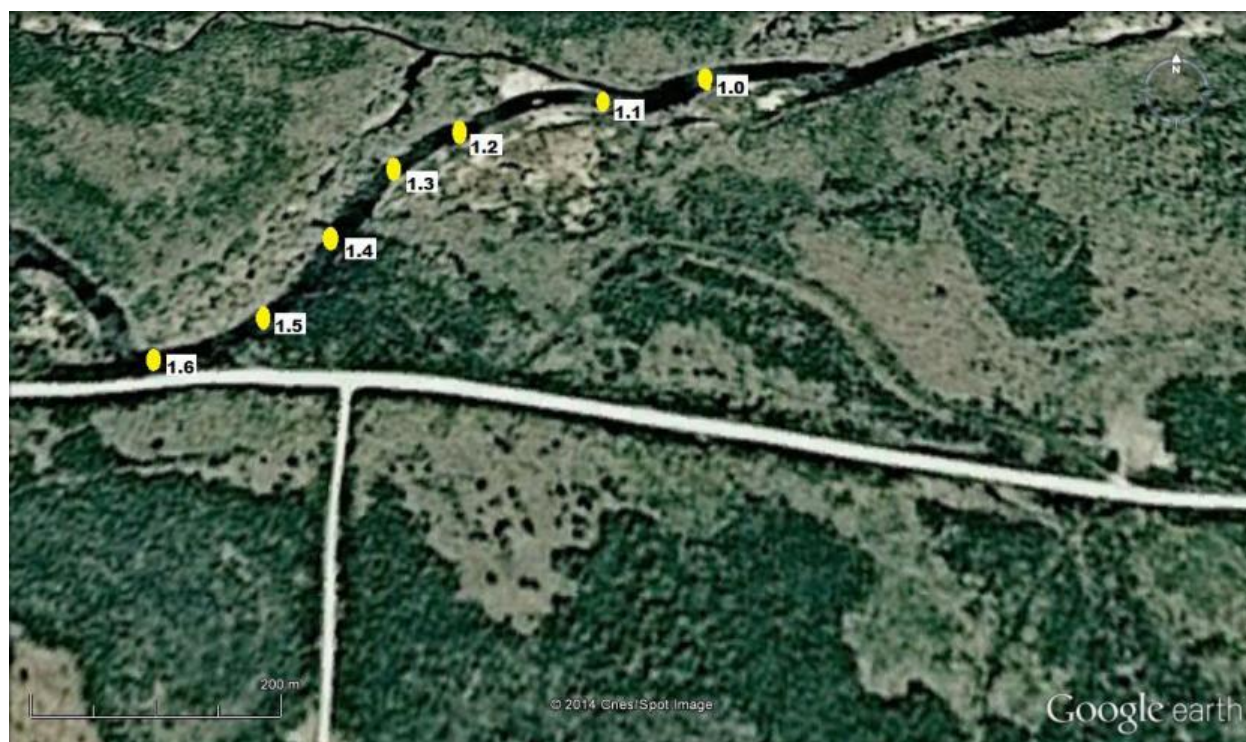
Figure 7: Site 1 with structures labeled

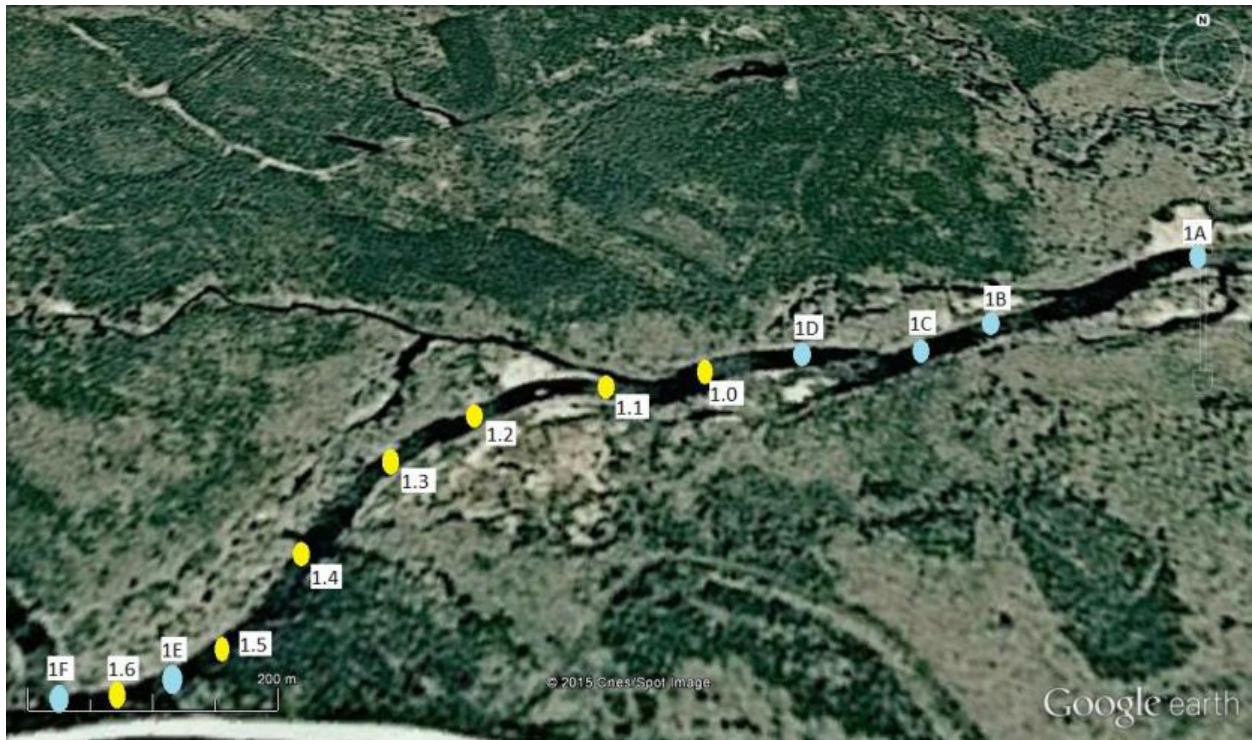
Figure 8: Updated Site 1 plan (all labelled structures are complete). Yellow dots were in the original plan and blue dots are the new structures.

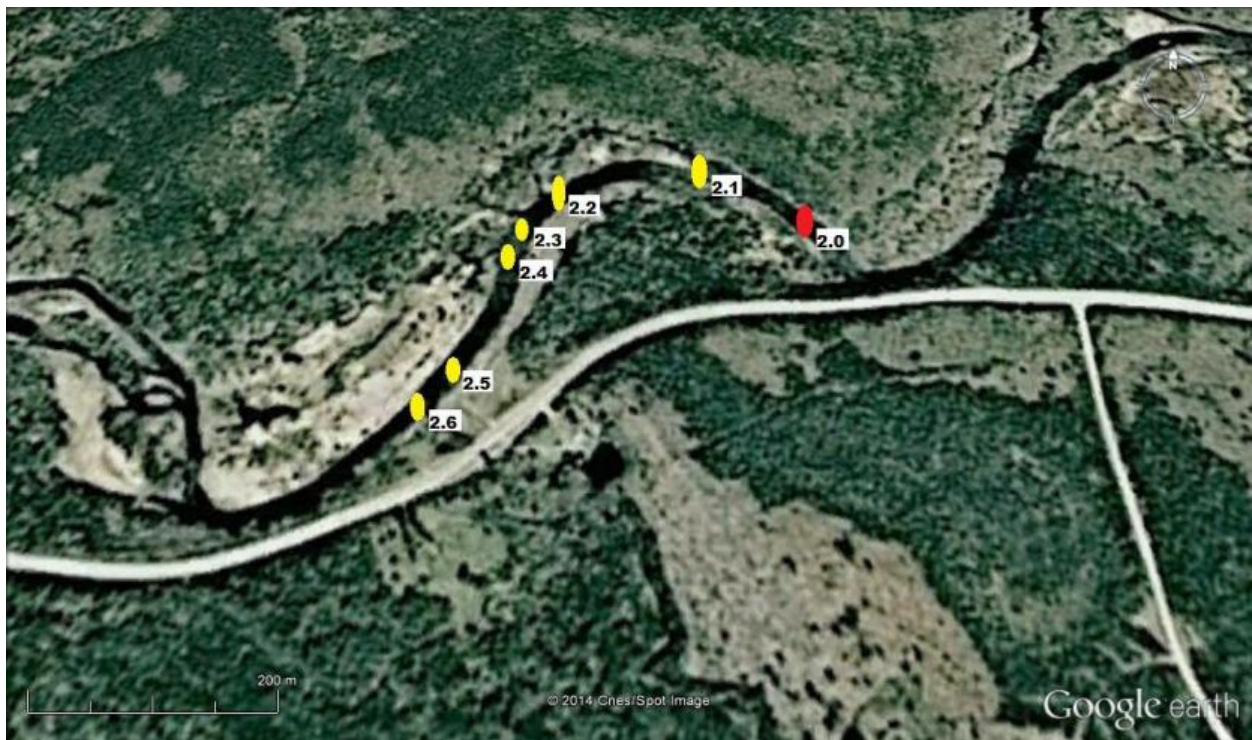
Figure 9: Site 2 with completed (yellow) and planned (red) structures labeled.

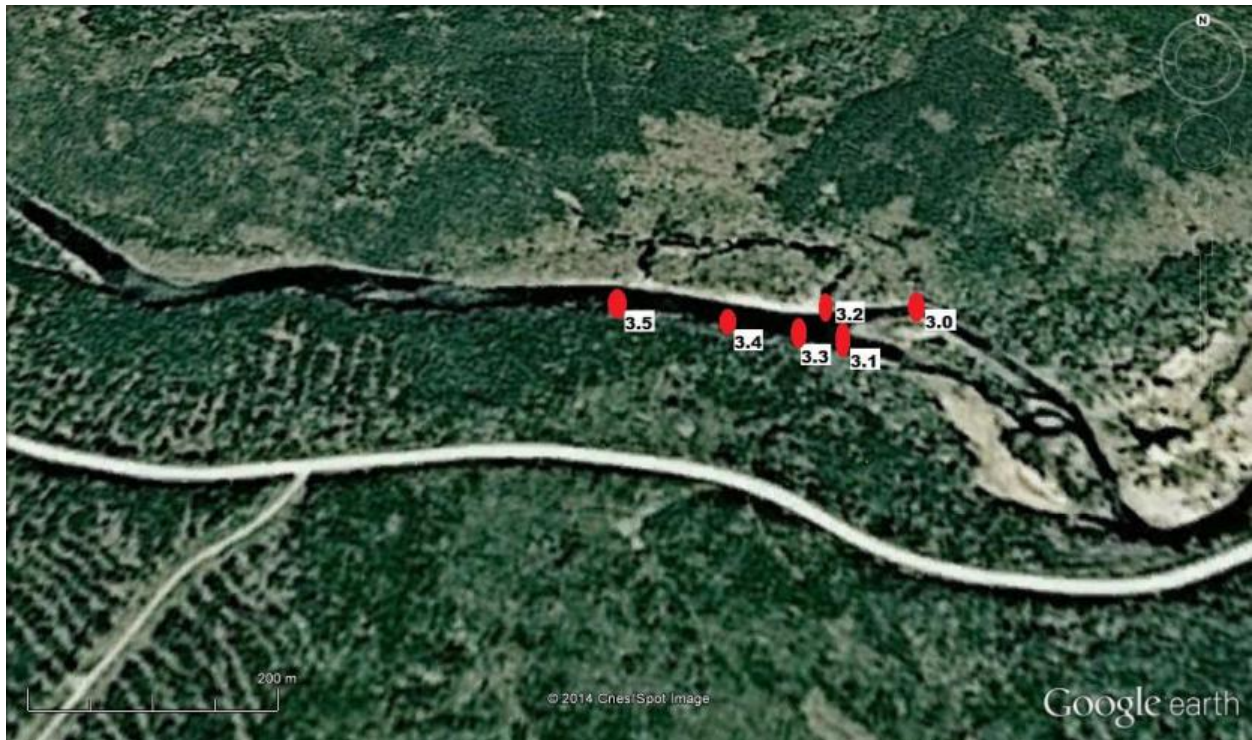
Figure 10: Site 3 with planned structures labeled. Completed in September 2016.

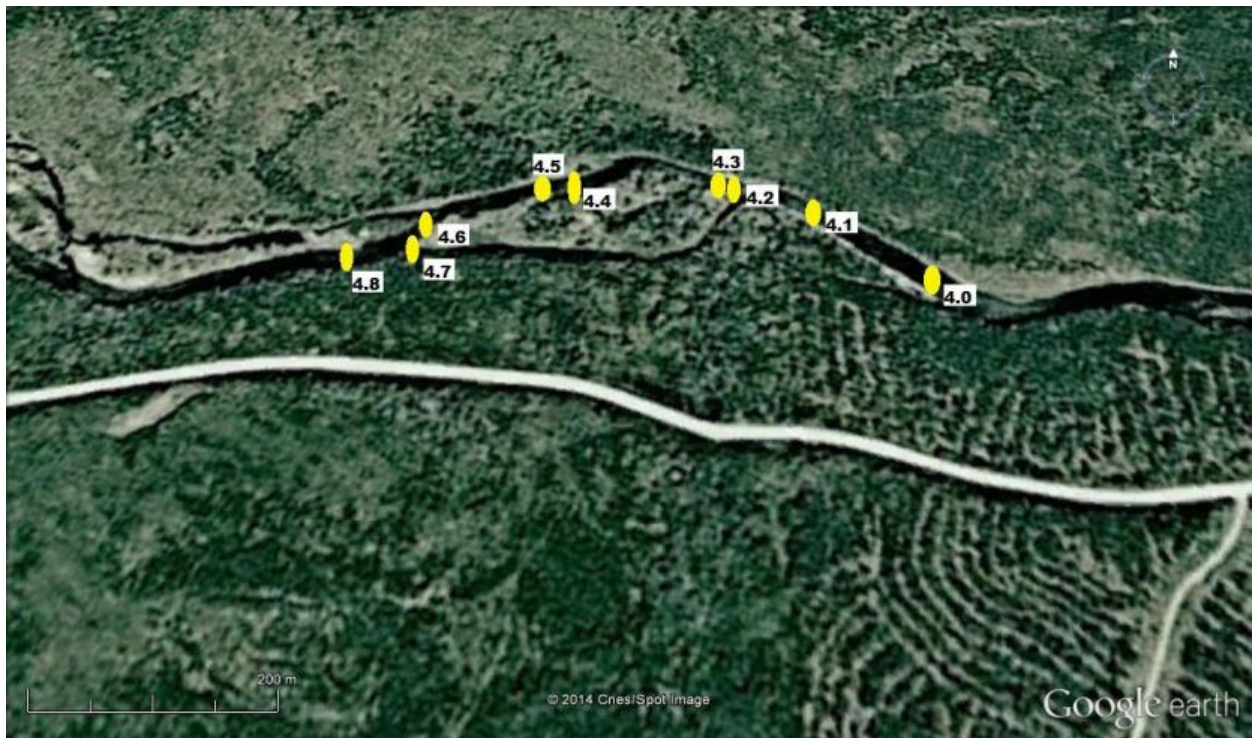
Figure 11: Site 4 with structures labeled.

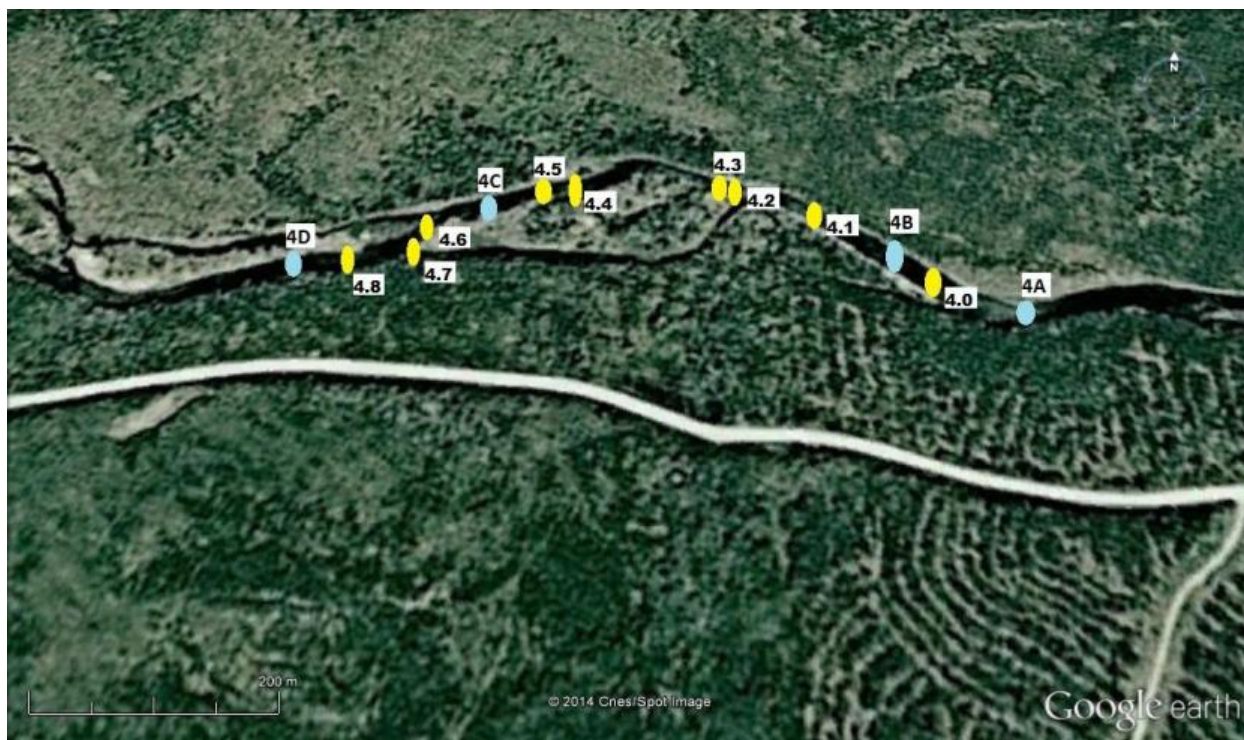
Figure 12: Updated Site 4 plan (all labelled structures are complete). Yellow dots were in the original plan and blue dots are the new structures built in 2015.

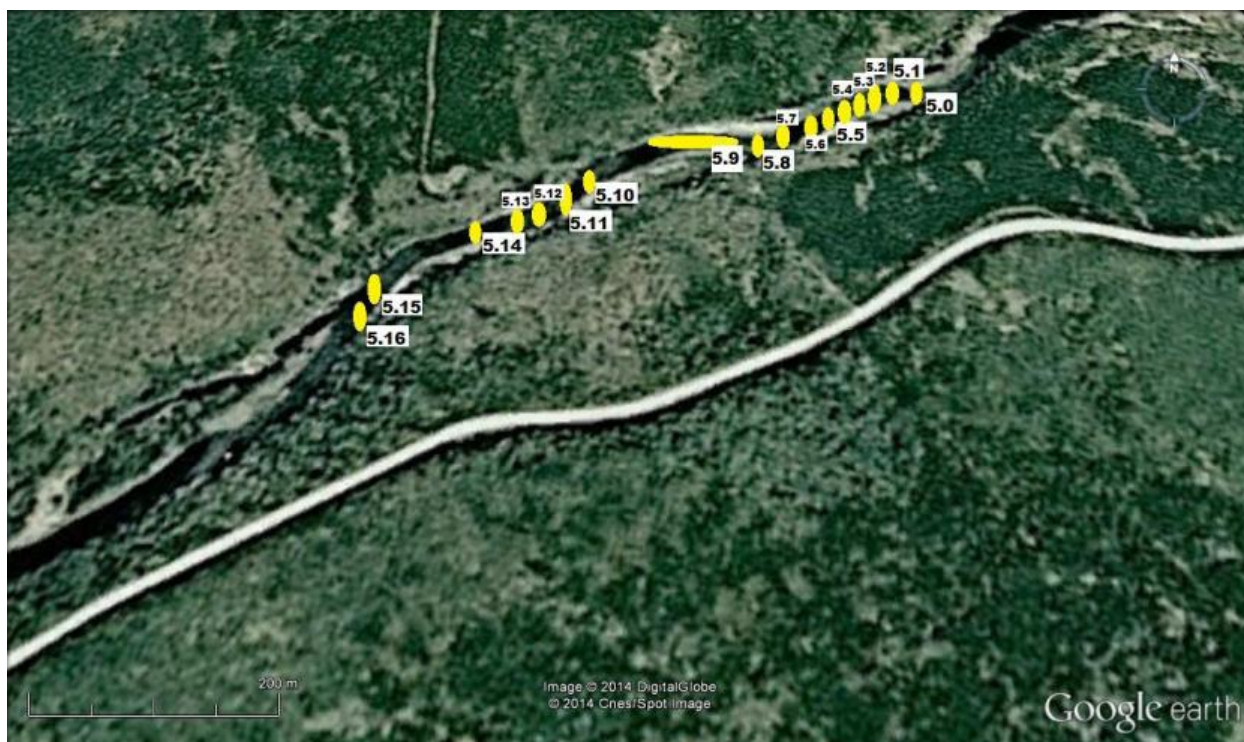
Figure 13: Site 5 with structures labeled.

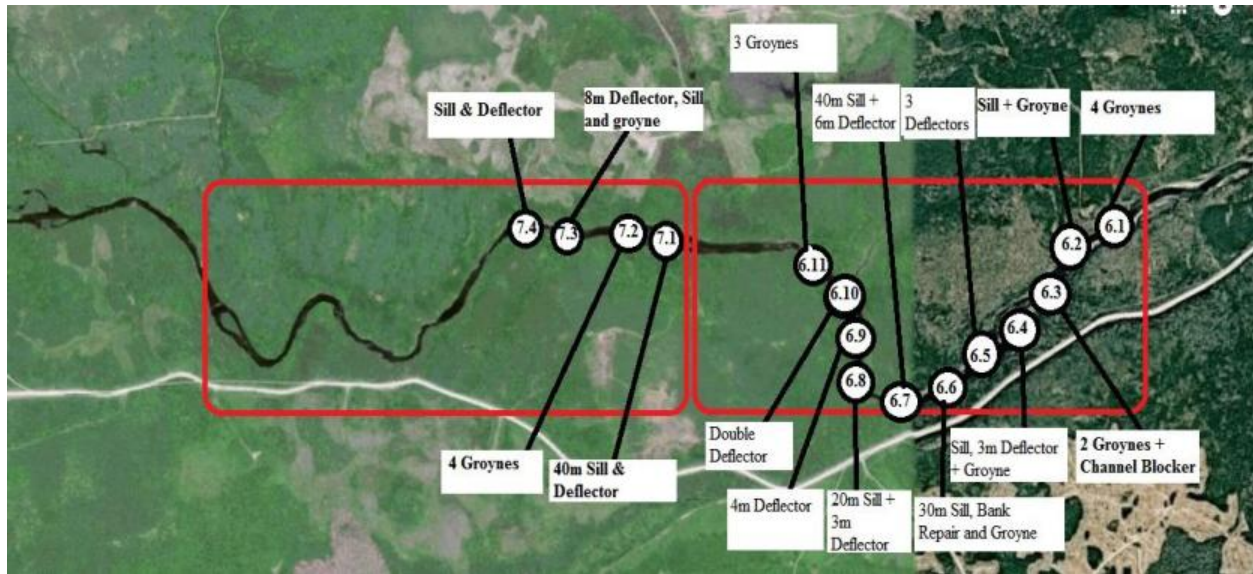
Figure 14: Site 7 and Site 6 with labeled structures.

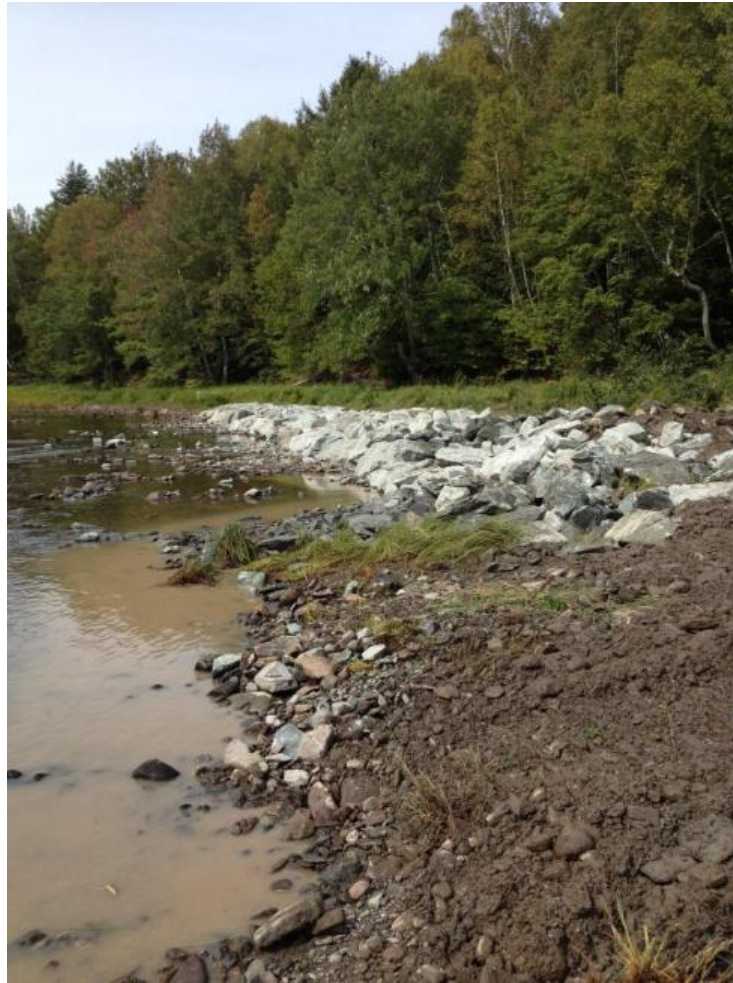
Figure 17: Bank protection installed at Site 5.

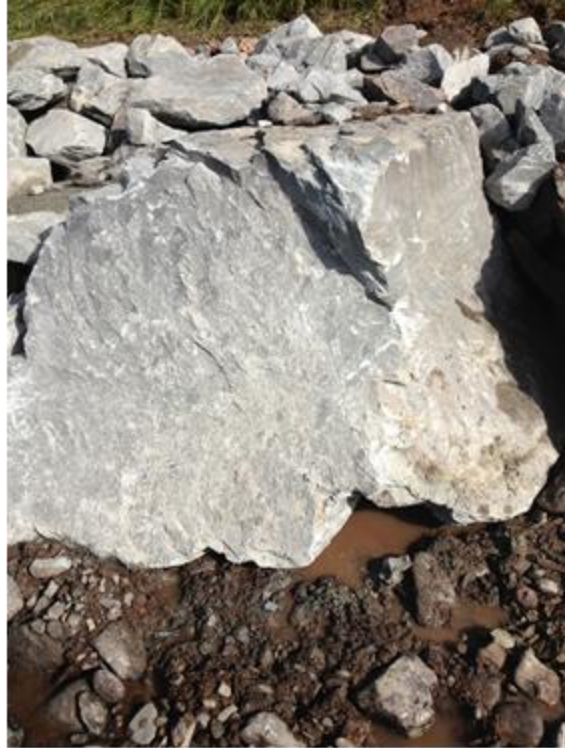
Figure 18: Example of two tonne rock used at Site 4 for bank protection.

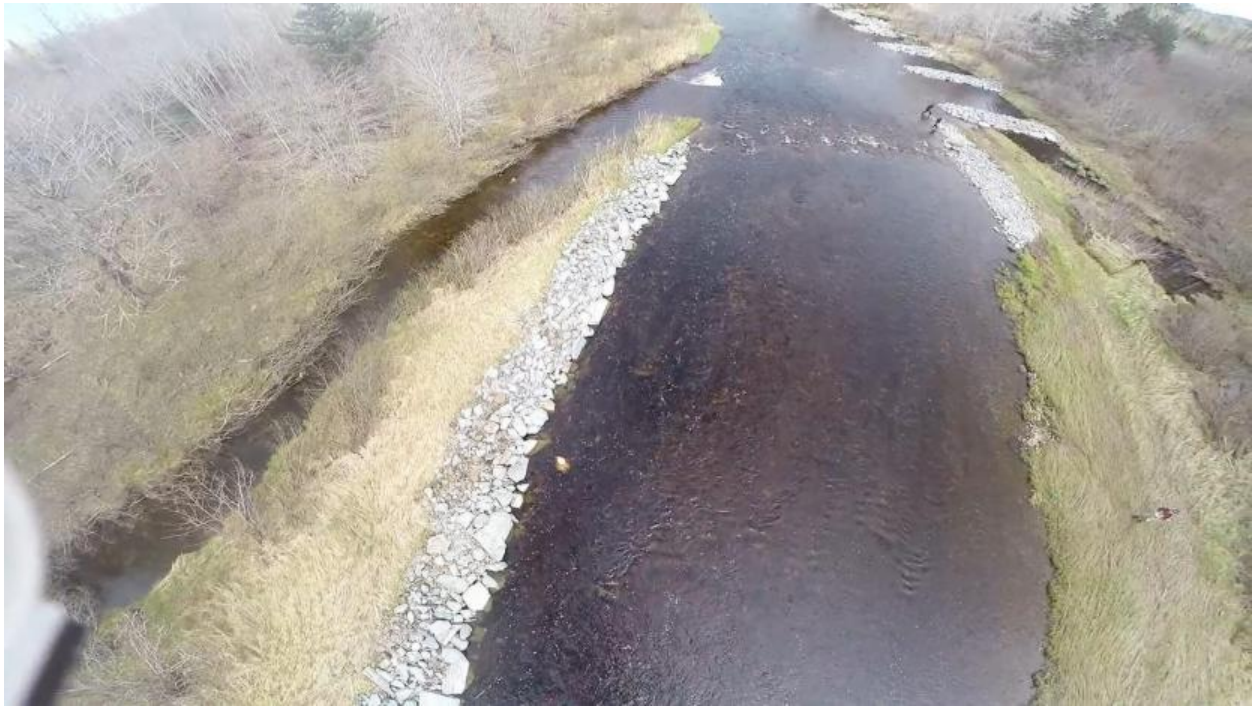
Figure 19: Aerial photograph of armour rock bank.

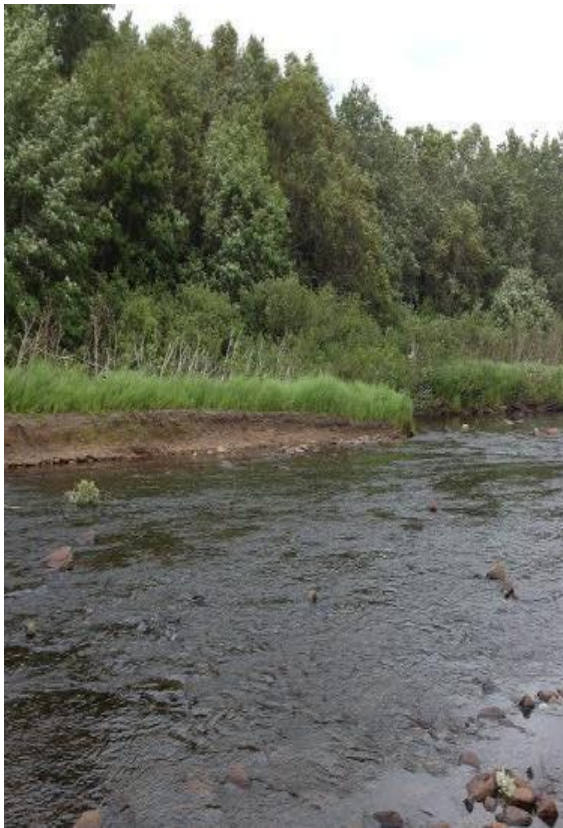
Figure 21: Before photo at Site 1. Bryden Brook entrance.

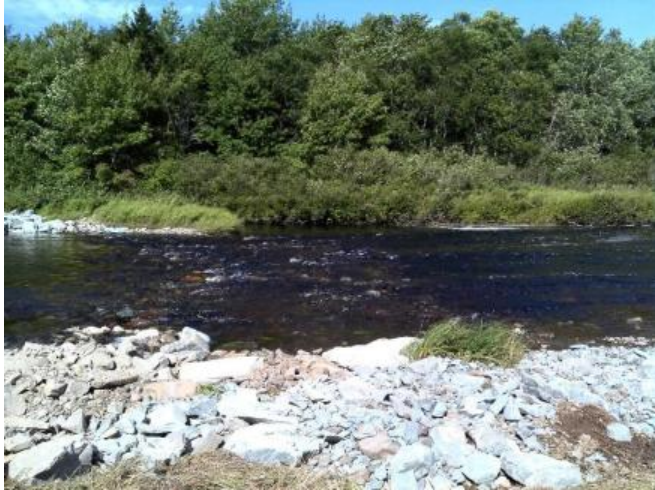
Figure 22: After picture, Site 1. Bryden Brook entrance.

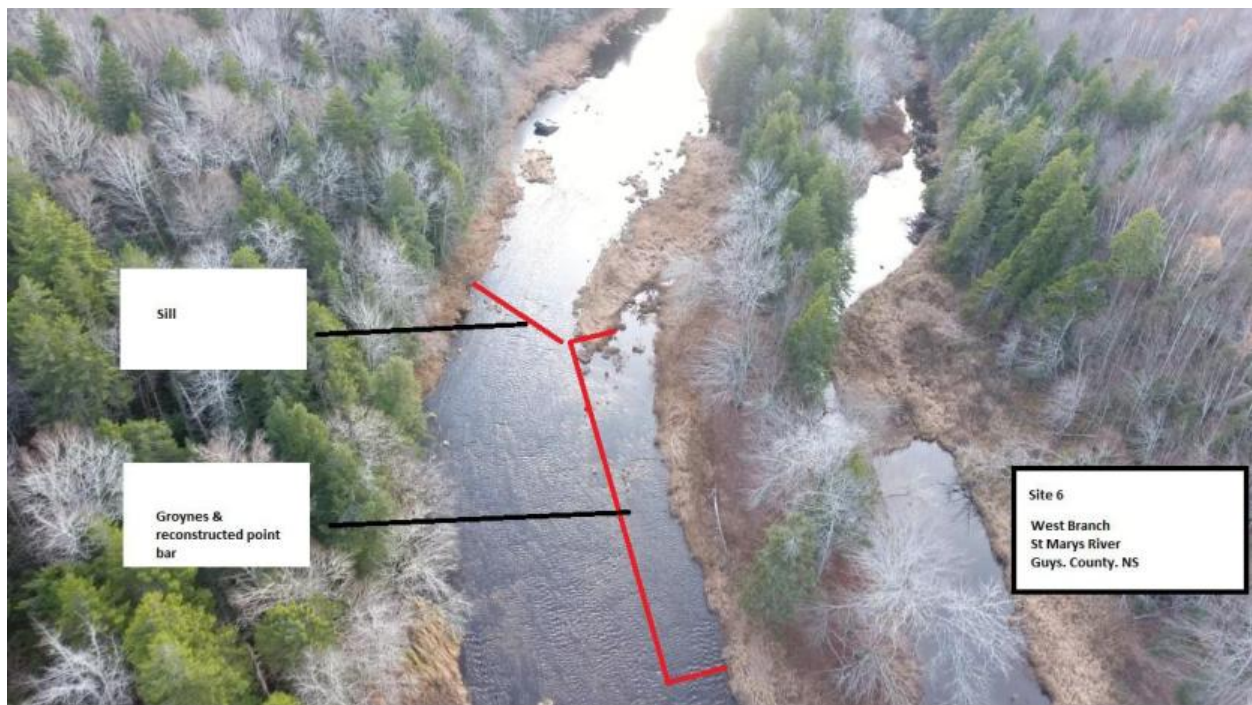
Figure 23: Conceptual design of restoration work on Site 6.

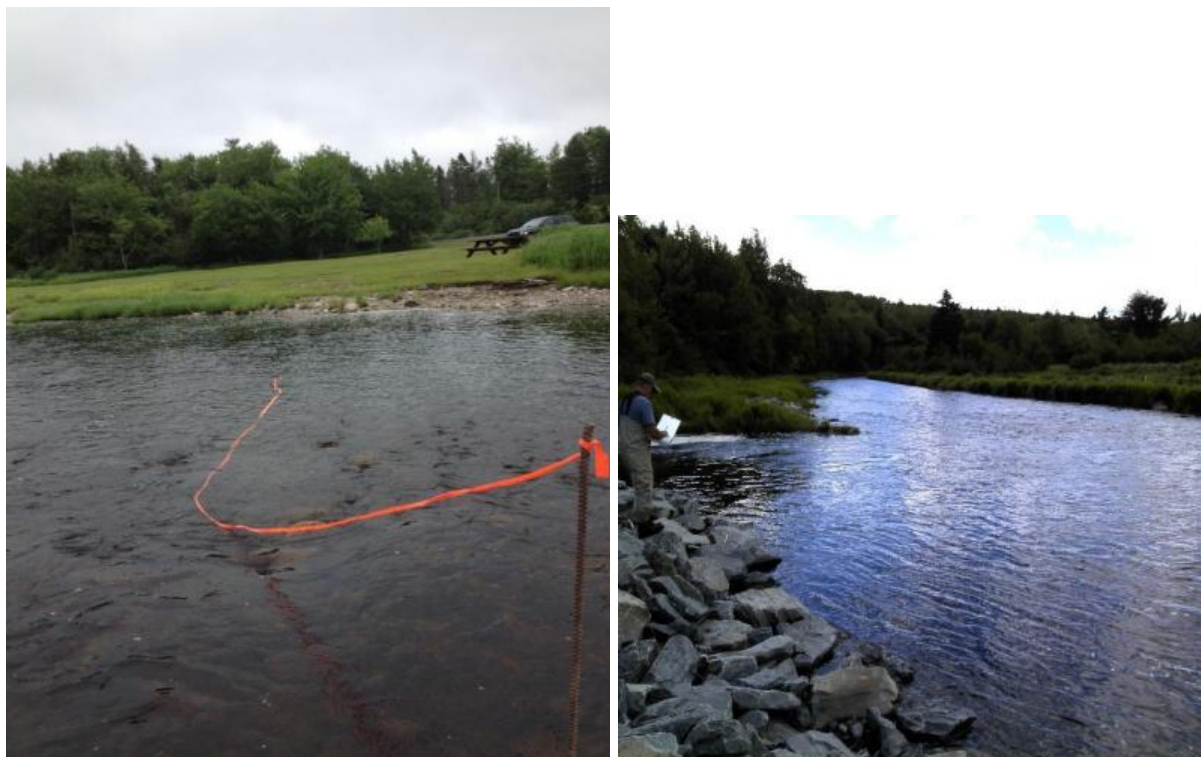
Figure 24. A) Before photo where sill is to be constructed and bank protection is needed (looking at the right bank, facing downstream). B) After photo looking upstream at sill and bank protection.

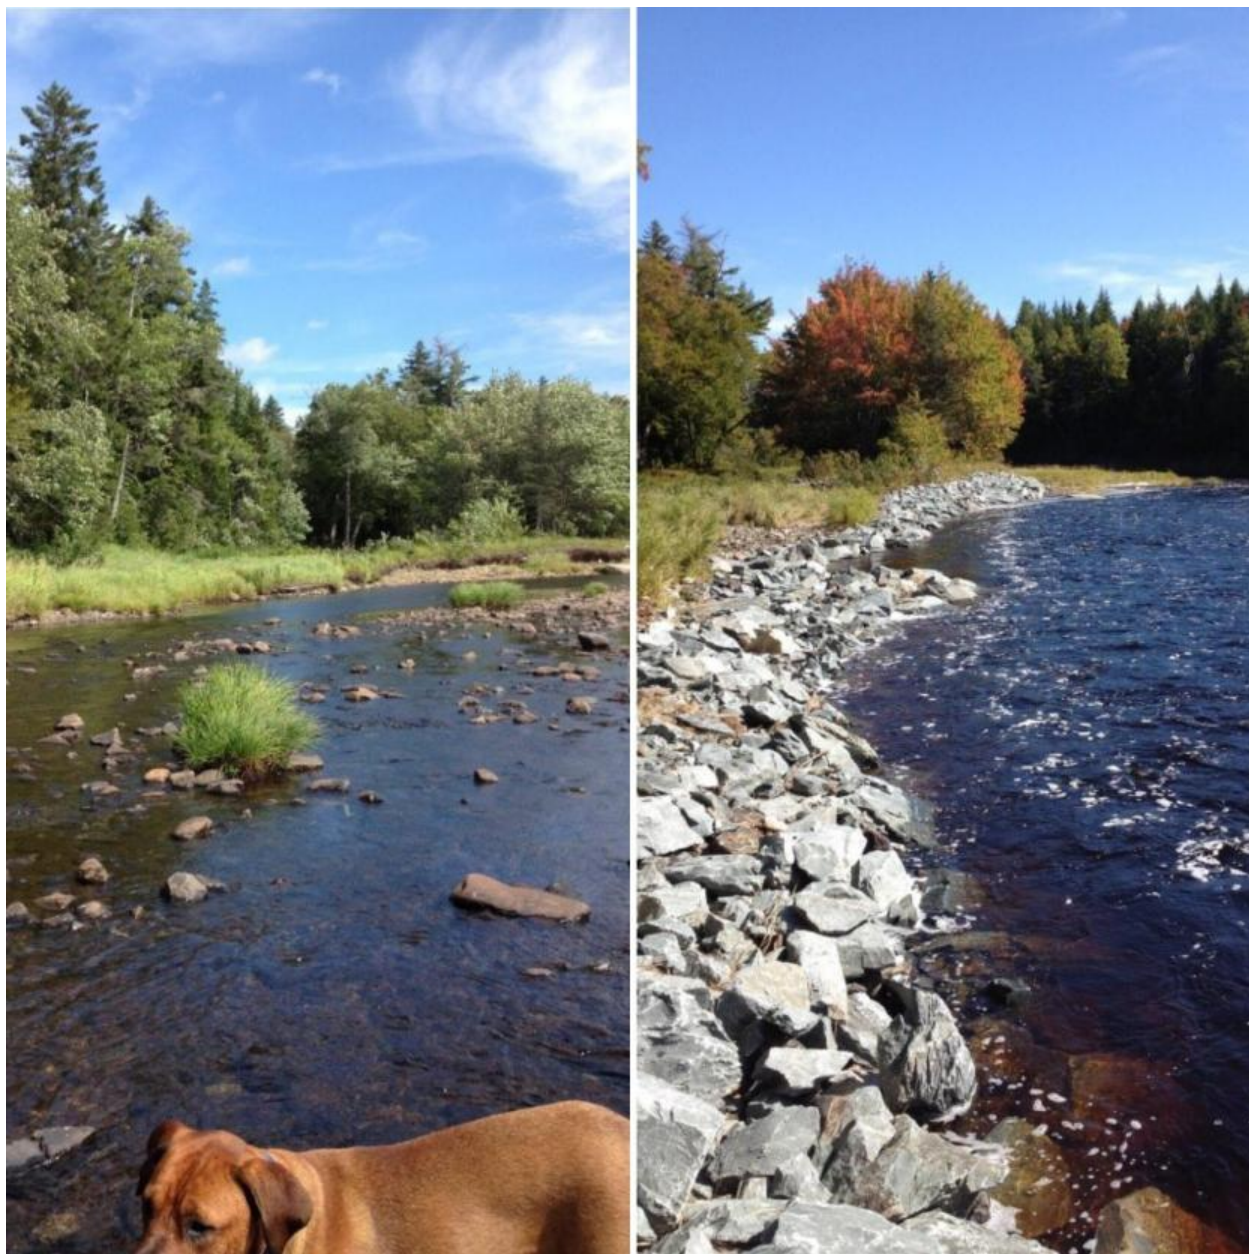
Figure 25: Before and After, armour rock Site 5.

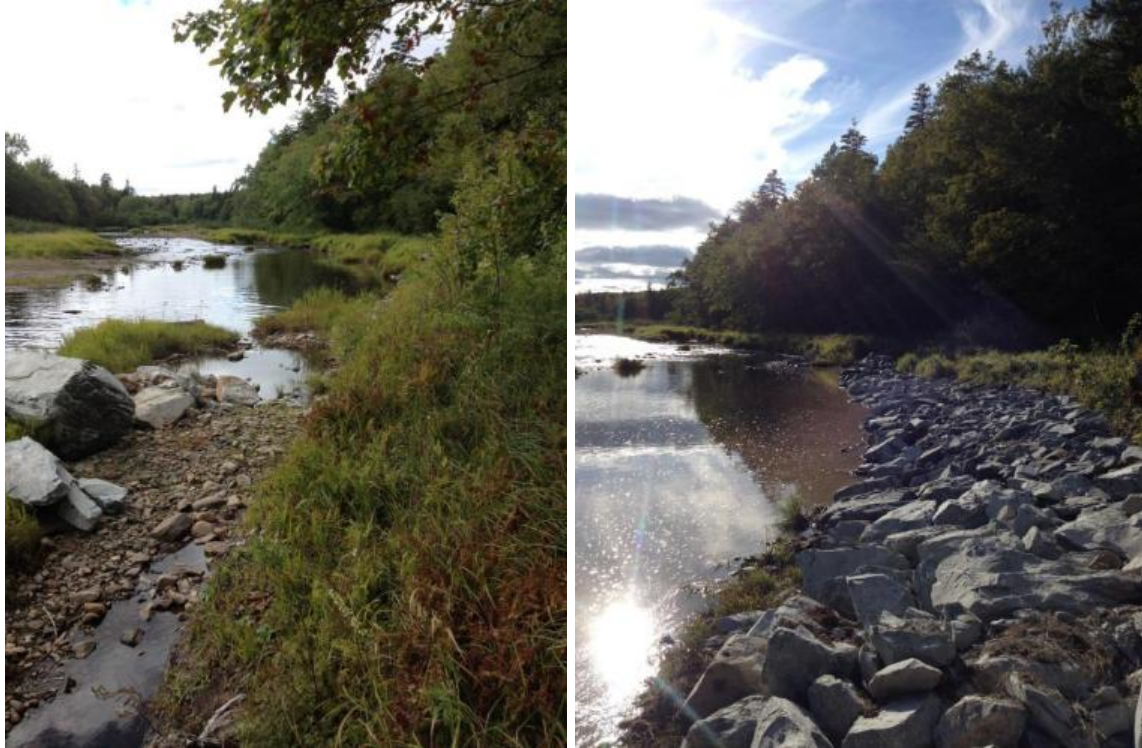
Figure 26: A) Before shot of the pool below sill 2 at Site 5 (structure 5.5). B) This is the bank work below sill two (structures 5.5 to 5.7). Note the 4:1 slope on the bank instead of the normal 2:1 slope. This will assist in the planting of native trees and grasses later.

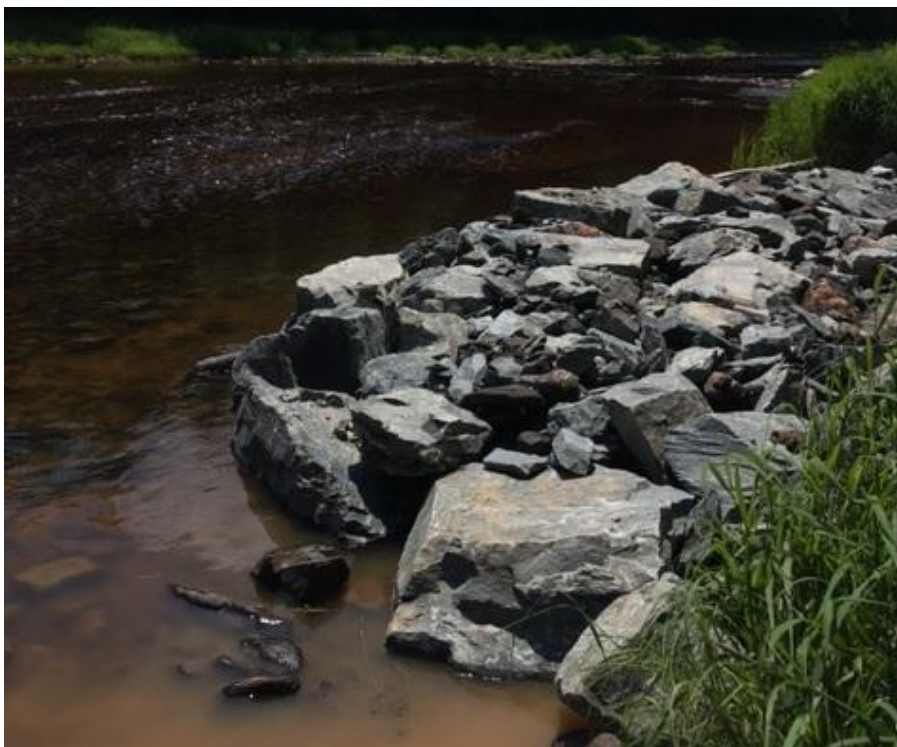
Figure 32: Site 6, Structure 13. Rock deflector

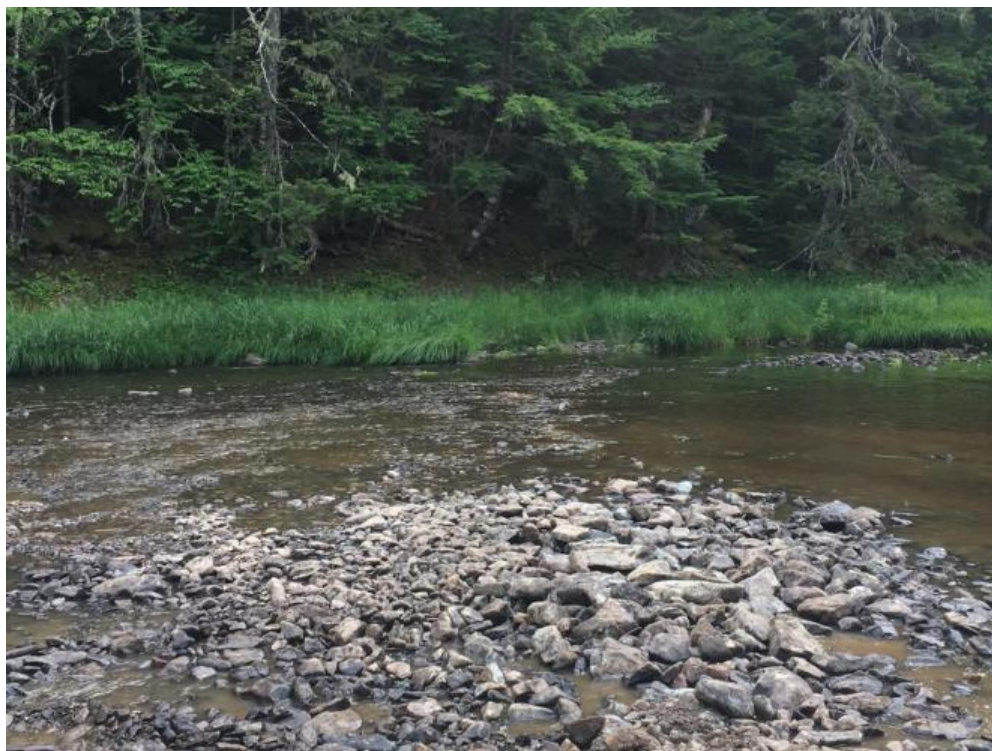
Figure 33: Site 7, structure 2 - rock sill

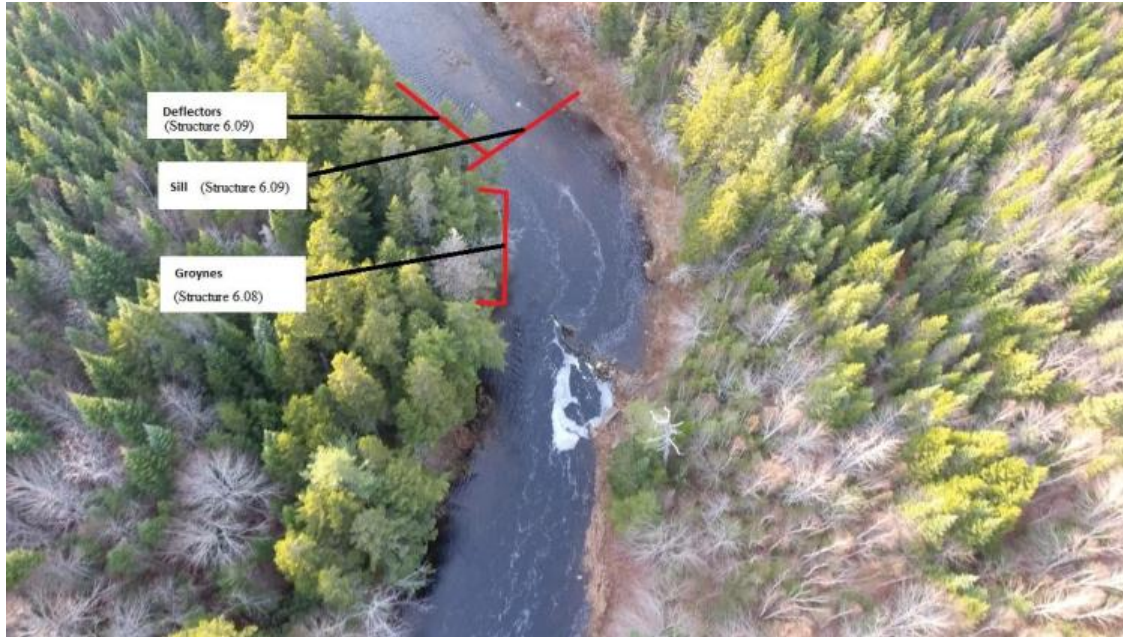
Figure 27: Site 6 (See reference point 6.4 from Figure 14).

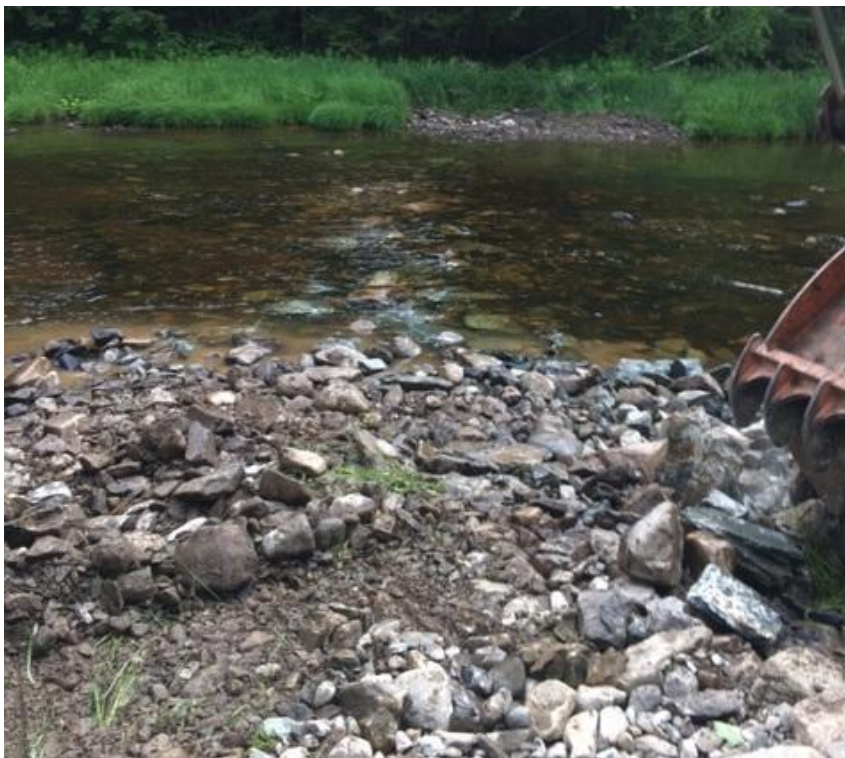
6.07	00551635 E 05002089 N	Over widened channel	Groyne
6.08	00551628 E 05002078 N	Over widened channel	Groyne
6.09	00551628 E 05002045 N	Lack of pools, straight and over widened channel	Sill and 3 m deflector

Figure 28: Site 6, structure 6.09 during construction.

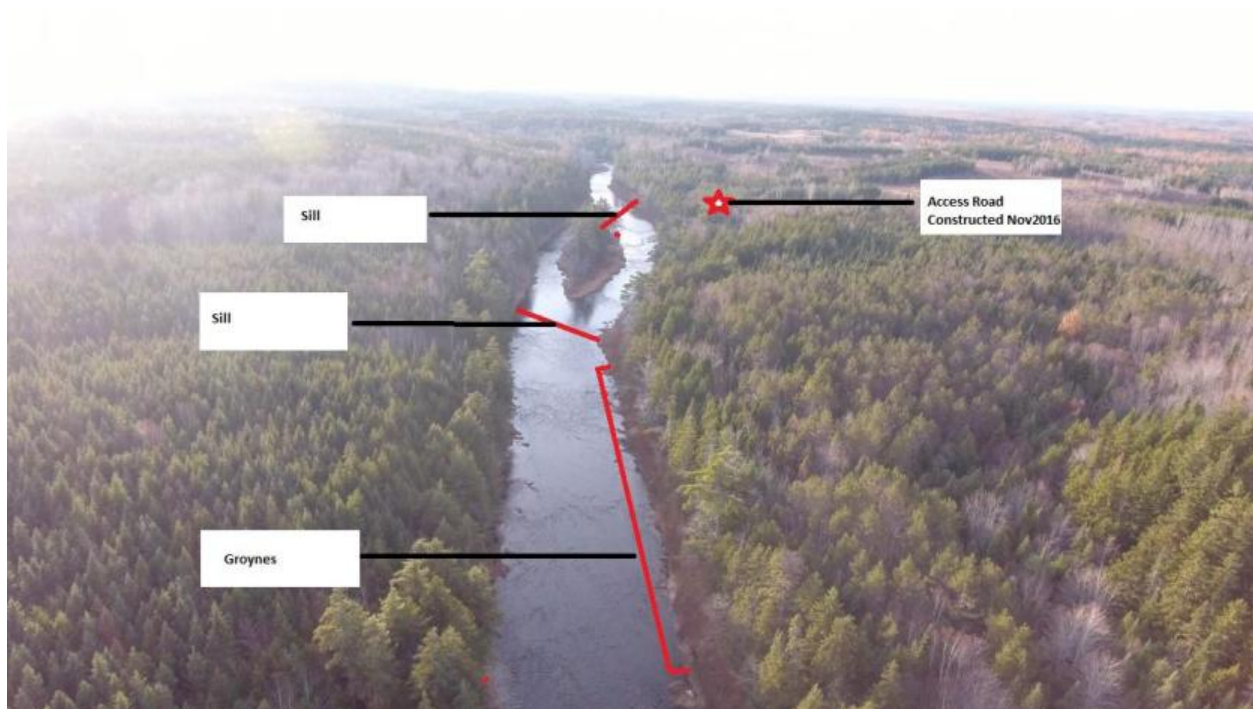
Figure 29: Upper section of Site 6.

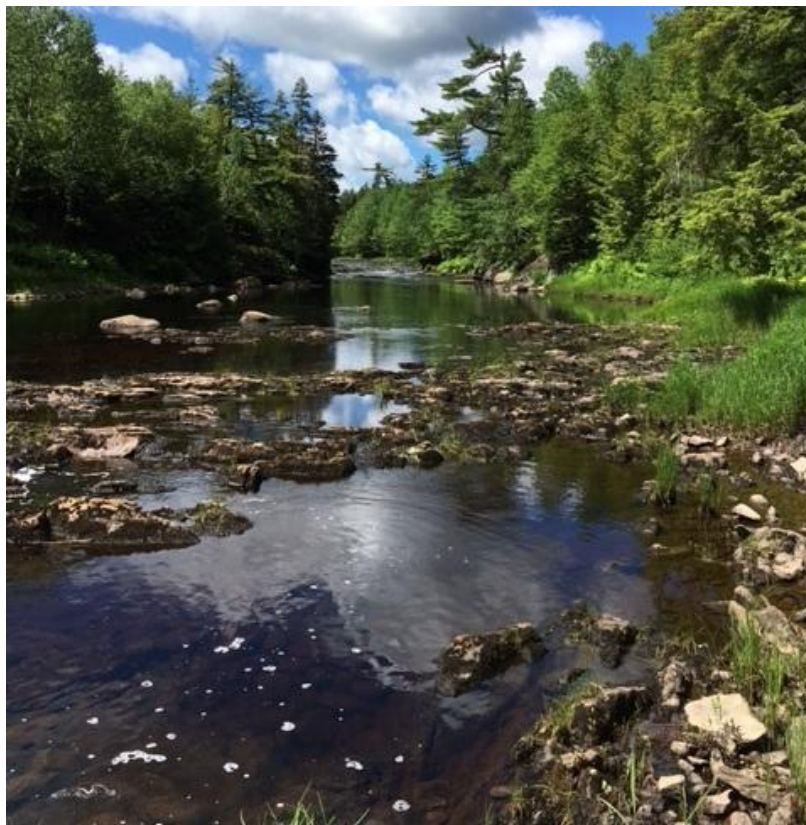
Figure 30: An example of degraded habitat from Site 7. Stream bed comprised exclusively of bedrock.

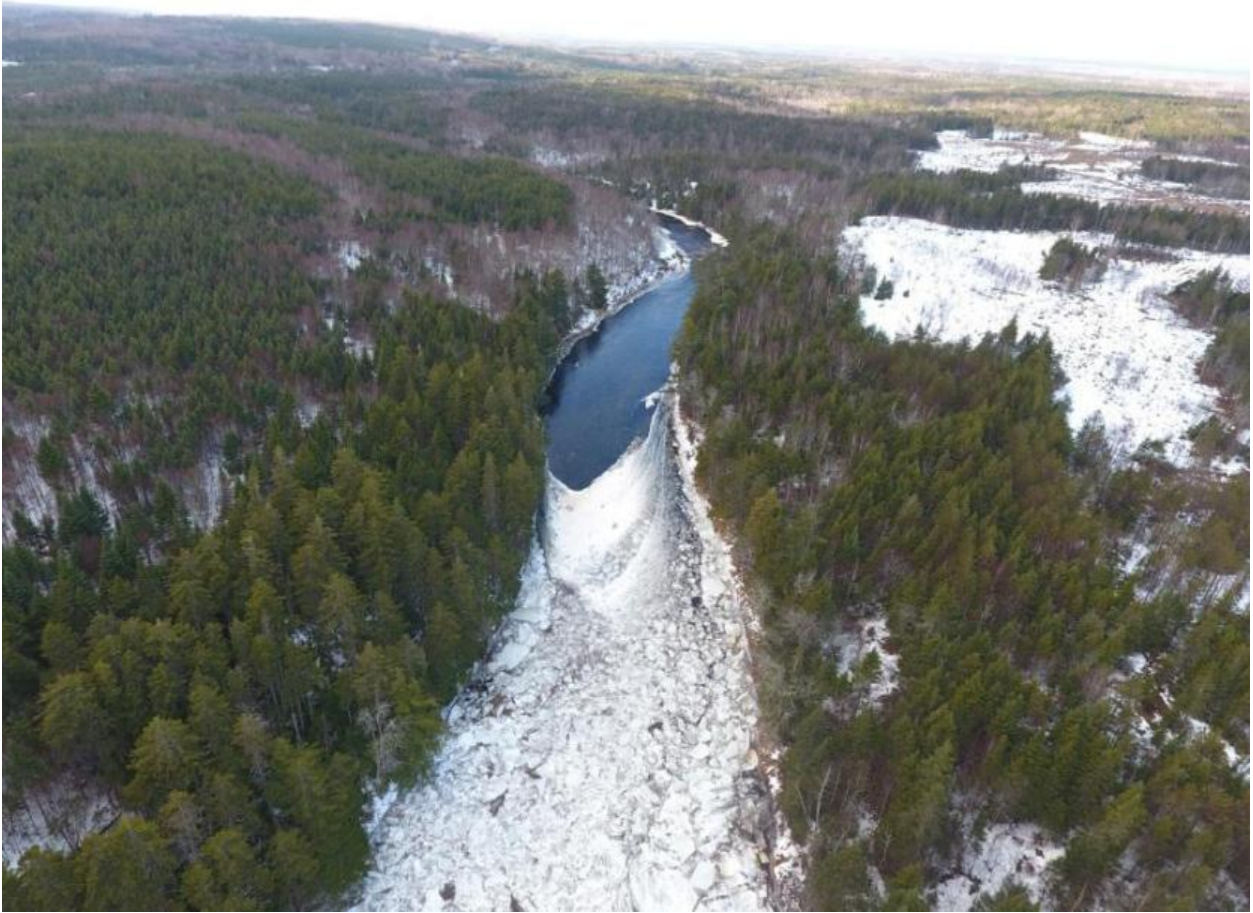
Figure 31: Ice Production Site 7, caused by an over widened channel.

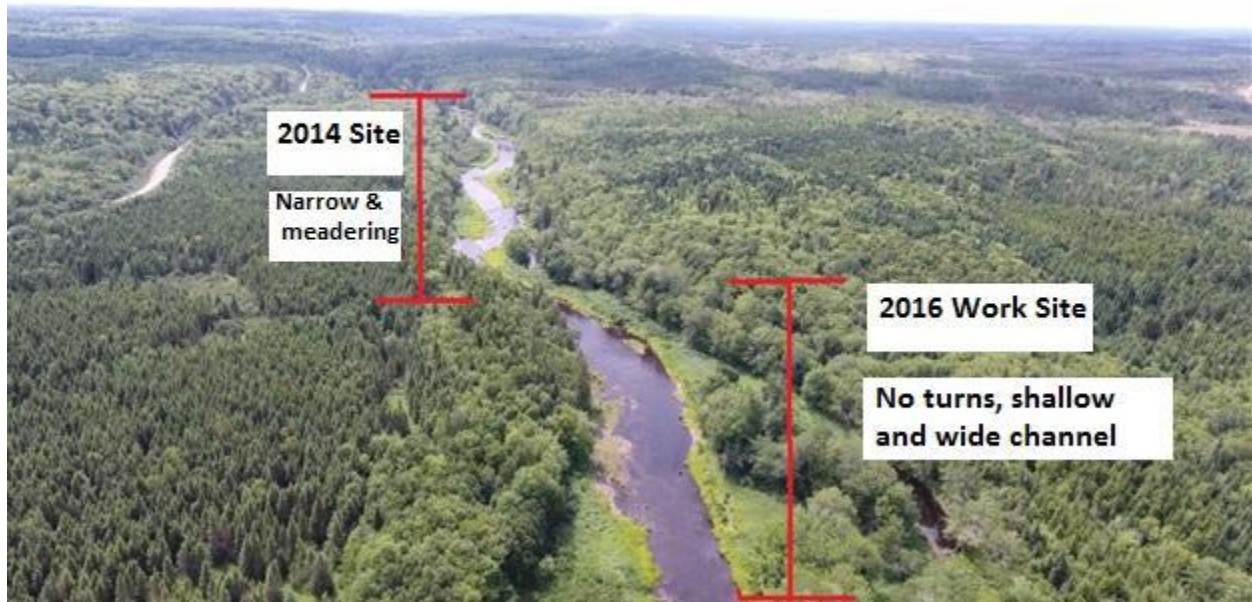
Figure 31: Aerial photo, taken prior to 2016 work. Site 5 is at top of picture. Site 4b is below.
