AN ANALYSIS FROM AIR PHOTOGRAPHS OF HISTORICAL CHANNEL CHANGES  
OF THE WEST BRANCH, ST. MARY'S RIVER, GUYSBOROUGH COUNTY,  
NOVA SCOTIA.

Sean C. Mitchell, and Megan L. Myers

February, 2010

St. Mary's River Association Technical Report #007

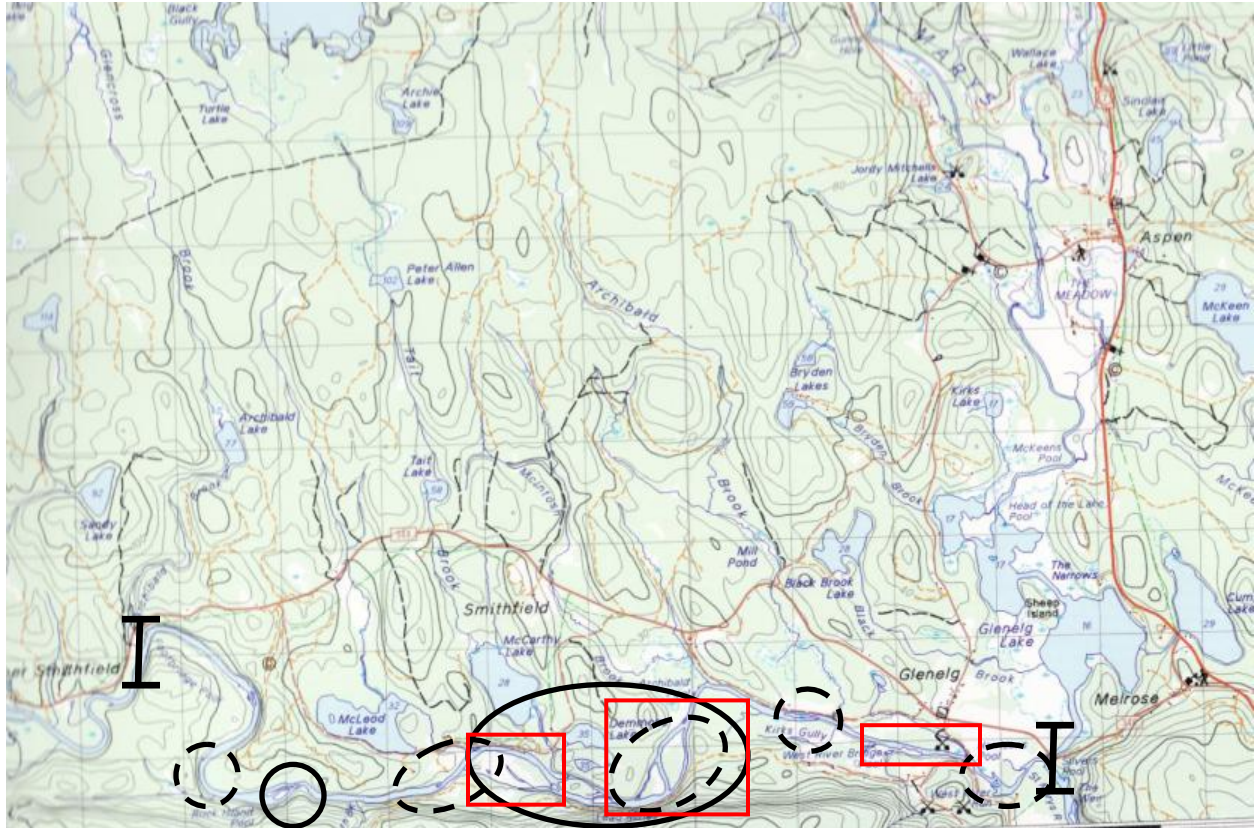
Within this section there is significant lateral bar and island development (Figure 3). The aggradation is extensive throughout the section. Points of most extreme lateral bar formation are (1) on the bend upstream of McLeod Lake, (2) between McLeod and McCarthy lakes, (3) on bend downstream of Pommen Lake, (4) upstream of McInnis and Archibald's brooks, and (5) in the area from upstream of Glenelg Bridge to Silver's Pool. Aggradation to such a degree as to cause anastomosing channels (braiding) occurs at a point upstream of the Churn Brook confluence and also from the McLeod Lake outflow to McIntosh Brook confluence. The gravel accumulation appears to become greater as one moves down the section from Glencross Brook to Silver's Pool. There are 9 islands within this section of the river (islands defined as being surrounded by water and vegetated indicating they are stable overtime).

Historical lateral channel movement is evident at three locations. First, on the south side of the river across from McCarthy Lake are old channels and a "young" forest naturally revegetating on the floodplain indicative of relatively recent continual exposure from water. The second area is a large island on the bend downstream of Pommen Lake which splits the channel in two. The water appears to be seeking different routes. This channel could change the direction of the main channel flow from flowing north of the island to flowing along the south of the island. Lastly, for a distance extending ~1.5 km upstream of the Glenelg bridge, along the south bank, are old channels, some still with water in them, and vegetation growing in the typically meandering pattern indicating a historical channel.

Aggradation from a point upstream of McLeod Lake to the Glenelg bridge appears to be reduced in 1998 relative to 1980 (dates of photographs August 23 & October 11, 1980, and June 11 & 12, 1998). This inference is based upon reductions of island areas, reduction of bare bar material, and increased vegetation cover. This may be a suggestion of channel recovery (reduction in sediment input from upstream?) relative to historical conditions. However, this apparent reduction in bar size could be a function of higher streamflows ( $19.6$  and  $22.7 \text{ m}^3/\text{s}$ ) in 1998 compared with 1980 ( $2.46 \text{ m}^3/\text{s}$ ; small number of photos in this series taken on October 11 at  $30.5 \text{ m}^3/\text{s}$ ). Between Glenelg Bridge and Silver's Pool, however, aggradation is problematic. There is significant movement of bars between periods of photography and bars change in size and shape (Plate 1). Gravel accumulating along both sides of the stream is changing shape. In 1980, gravel accumulation formed a mid channel bar. By 1998, more sediment had accumulated, so the mid channel bar became part of the bank. These bars do show significant vegetation growth between periods, but the obvious changes in shape and size indicate considerable redistribution of non-vegetated material.

Figure 3: Section I, illustrating locations of described channel morphometric features. Lateral bar formation and island development shown in dotted ellipses, braiding (anastomosing channels) in solid ellipses, and historical lateral channel movement in red boxes.

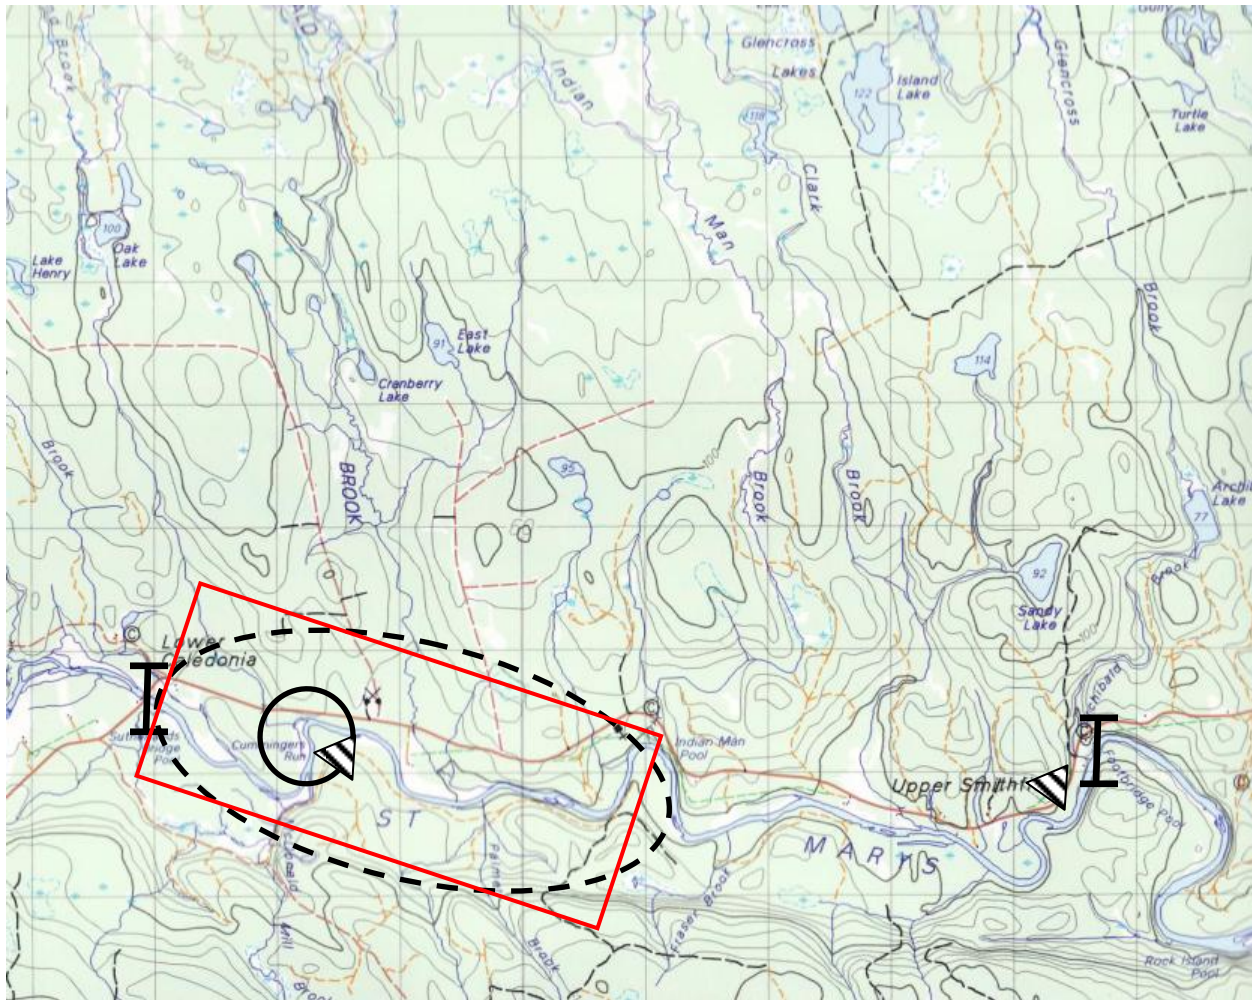
Between Glencross Brook and Indian Man Brook the meander which occurs in more upstream sections (IV & V, see below) is noticeably lost, though the sinuosity here is greater than Section I. There is an island upstream of the Indian Man Brook confluence and a further two islands upstream of the Clark's Brook confluence (Figure 4). Significant lateral channel movement in the form of old channels appears to have historically taken place between Lower Caledonia and Indian Man Brook. Lateral movement is particularly apparent at Sutherland's Brook confluence with braiding of the channel (Plate 2).

All of the islands appear to have increased in size over the period of photography (dates of photography October 11, 1980 and June 11, 1998). There is also apparent aggradation along the island near Indian Man Brook which is adding to its size. In 1980 the island was about 30 m wide by 180 m long. In 1997 the island was about 55 m wide by 210 m long. Between Lower Caledonia and Indian Man Brook are areas of large bar development, particularly upstream and downstream of the Sutherland's Brook confluence. There is also significant increase in size of bars downstream of the Lower Caledonia bridge, but river discharge was two thirds in 1998 what it was in 1980. Therefore, water level was lower and so at least some of the apparent increase in bar size may be due to variation in flow between dates of photography.

Figure 4: Section II, illustrating locations of described channel morphometric features. Lateral bar formation and island development shown in dotted ellipses, braiding (anastomosing channels) in solid ellipses, and historical lateral channel movement in red boxes. Also shown are the eroding banks (hatched triangles) from the survey of McGowan (1993).

McGowan (1993) identified two large eroding banks in this section. Immediately downstream of McDonald Mill Brook (Cumming's Run), on the east side of the river, he identified an eroding bank ~30 m long by 10 m high with an approximate 80° slope. The top of the slope is cleared of trees and has a cabin situated on it. The second site was immediately upstream of Glencross Brook on the south side of the river. This bank is also ~30 m long (height not provided) and at 70° slope. Trees along the top have been removed and cottages built to the edge of the bank. McGowan (1993) considered this slope unstable.

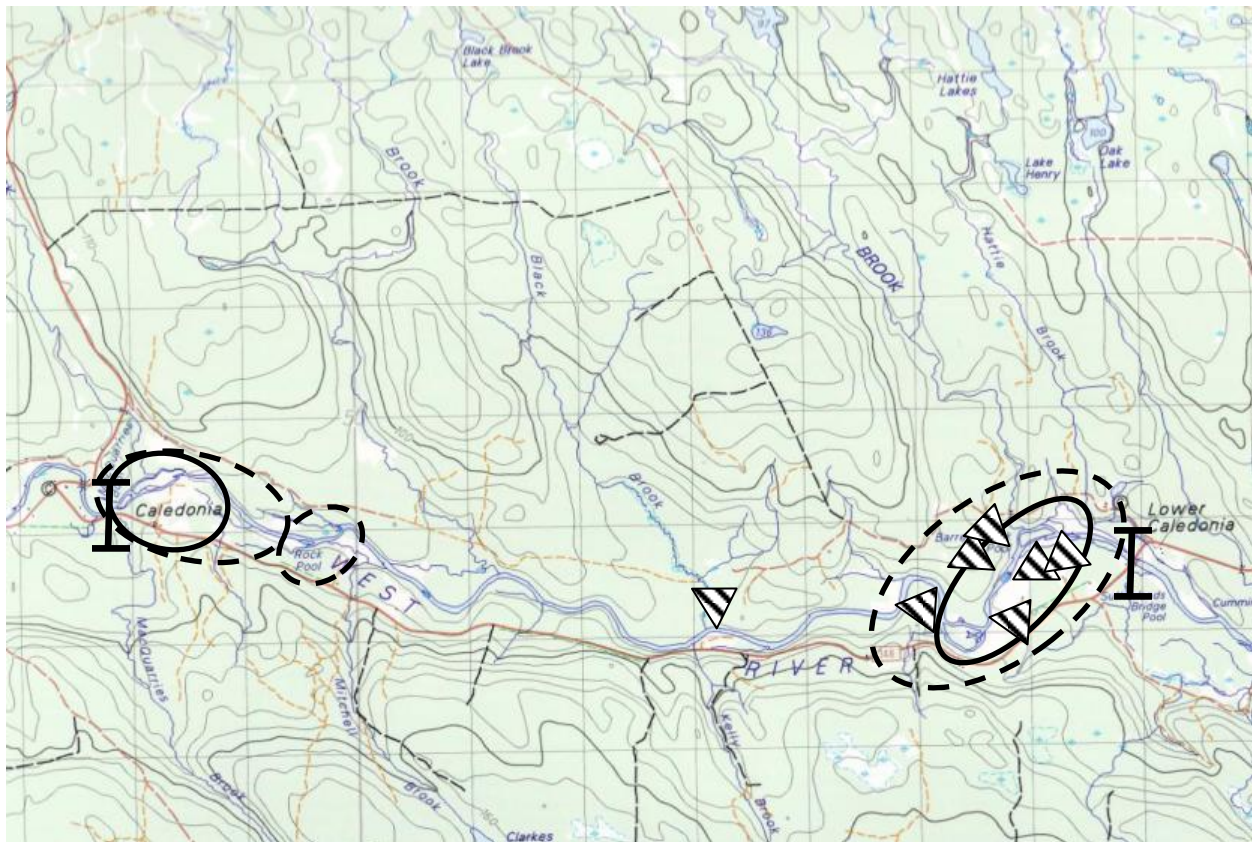
Within Section III there is evidence of aggradation in the form of large point and mid-channel bars, islands and braiding channels. This aggradation is particularly prominent near Caledonia (leading to braiding channels; Plate 3), near the Mitchell Brook confluence, and upstream of Lower Caledonia (Figure 5; Plate 4). Between Mitchell Brook and approximately 1 km upstream of Barren Brook there is little evidence of significant channel change; the channel remains a discrete channel, small isolated lateral bars are present, and the banks appear solid; there is little to no sign of aggradation or negative impact. There are four islands within this section of river.

There is little evidence of significant change in these areas over the 18 year period. Cross Brook appears to be a significant sediment source as there is an increase in bare sediment exposed as bar between the two periods of photography (October 11, 1980 and June 11, 1998). As with Section II, river discharge was two thirds in 1998 what it was in 1980. Therefore, water level was lower and so at least some of the apparent increase in bar size may be due to variation in flow between photography dates. Over time, the bars throughout this section appear stable; there is no significant change in size or shape and the amount of vegetative cover appears to be increasing. Further indication of a low rate of aggradation in this section is the small amount of sediment building up along the river downstream of Chisholm Brook. There are minor sediment accumulations occurring in several spots for approximately 1200 meters of the river downstream of Chisholm Brook. The most significant accumulation is seen at the tip of a mid-channel bar where approximately 10 meters of gravel is accumulating. Near Barren Brook there is some evidence of channel change (Plate 3). In 1980 the main channel ran along the south of the

Figure 5: Section III, illustrating locations of described channel morphometric features. Lateral bar formation and island development shown in dotted ellipses, and braiding (anastomosing channels) in solid ellipses. Also shown are the eroding banks (hatched triangles) from the survey of McGowan (1993).

McGowan (1993) identified seven large eroding banks between Kelly Brook and Barren Brook. The length of eroding bank ranged from ~25m to over 100 m, but were generally on the order of 60 m and 8-10 m high. One was located on the north side of the river ~100 km downstream of Kelly Brook, the second approximately halfway between Kelly Brook and Barren Brook and numbers 3 to 7 on a stretch extending from ~1 km upstream of Barren Brook to 500 m downstream.

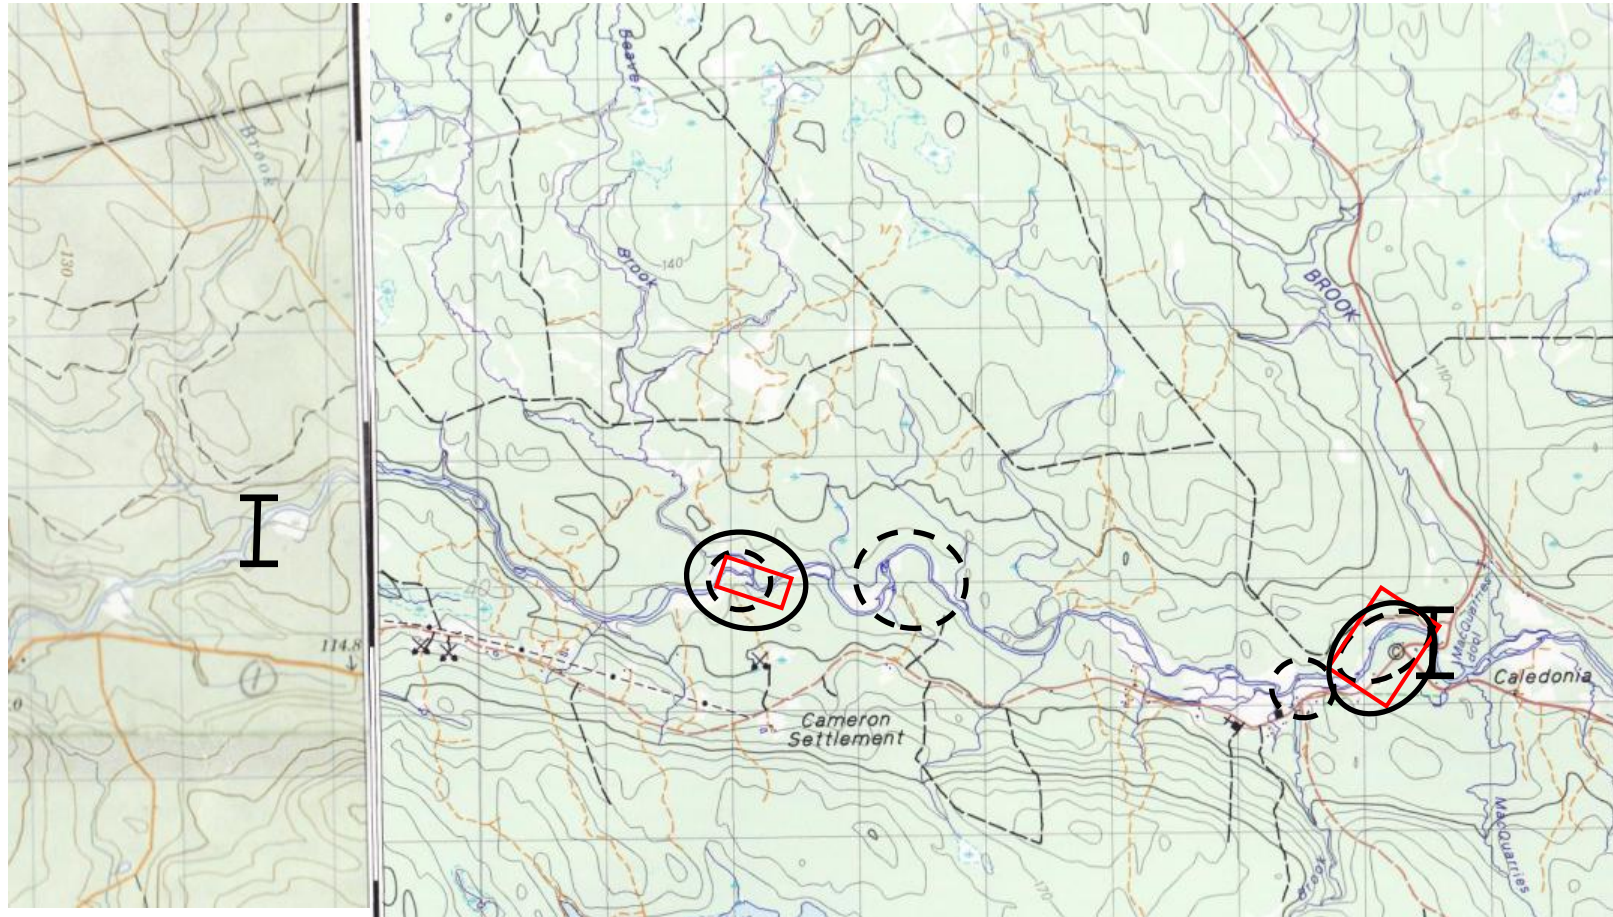
There is moderate bar development within this section of the river, particularly noticeable at the Beaver Brook and Chisholm Brook confluences. Bar development is particularly pronounced upstream of Caledonia (Figure 6). There is significant evidence of historical lateral channel movement in this section, suggesting that this is an active area of channel (Plate 5). This is particularly so at the Beaver Brook confluence and upstream of Caledonia where limited anastomosing (braiding) has developed; there is little evidence of significant lateral channel movement within the section apart from these two areas. Chisholm Brook may have been a historically significant sediment source based on the 1980 air photos which show bar development in the brook and also gravel accumulation in the West Branch downstream of the Chisholm Brook confluence. This site was visited on June 29, 2009 and the mid channel bar was measured. The length was 30 meters and the width was 10.2 meters. The bar is covered in vegetation and the substrate is primarily large gravel and small cobble.

Near Beaver Brook three bars appear to be stable and increasing in vegetation cover over time. The amount of bare ground is diminishing between the two periods of photography. The river in the Cameron Settlement area also appears stable with bars remaining approximately the same size over 17 years. Many bars are well vegetated, including the extensive bar development upstream of Caledonia.

Gravel accumulation is occurring along the south side of the island downstream of East Bryden Brook and is contributing to the narrowing of the stream. In the 1980 photo, the river was approximately 10 meters wide and in the 1998 photo only 5 meters. At the confluence of Beaver Brook the 1980 photo shows a gravel bar along the stream bank after a meander in the river. The 1998 photos show that the bar appears stable in that it is almost completely covered in vegetation whereas there was little vegetation on the bar in 1980. This site was visited on June 26, 2009 where the bar length was measured at 92 meters and the width up to the tree line 13.8 meters.

Figure 6: Section IV, illustrating locations of described channel morphometric features. Note, this section on two map sheets so figure a composite of these two maps. Lateral bar formation and island development shown in dotted ellipses, braiding (anastamosing channels) in solid ellipses, and historical lateral channel movement in red boxes.

Downstream of the Beaver Brook confluence in 1980 and 1998 photos there is evidence of the old main channel. It is more evident in the 1980 photos and there seems to be more water in the old channel (back water). In the 1998 photo it's less obvious and there is little water present. On the turn north of Cameron Settlement in 1980 photos, there is some sediment built up after a large meander in the river. In 1998 photos the build-up is continuing and the mid-channel bar is growing. There is approximately 15 meters of sediment added to the width of the bar between 1980 and 1998. This site was visited on June 4, 2009. There are large gravel bars around every meander in this general area. Not only is the gravel bar here large in terms of length (36.5 meters) and width (33.0 meters), but the height is significant compared to the other sites that were looked at (approximately 0.5-0.75 meters above the river). The substrate of the bar has a large range in size, but the majority is cobble and there is little vegetation growing on it. Finally, on the turn upstream of Chisholm Brook in the 1980 photo there is gravel accumulating after a meander in the river. There's no vegetation occurring on the gravel accumulation. In the 1998 photo there's no change in the size of the gravel accumulation, but there is a width of vegetation along the gravel bar of about 12 m greater in the later photograph than the earlier.

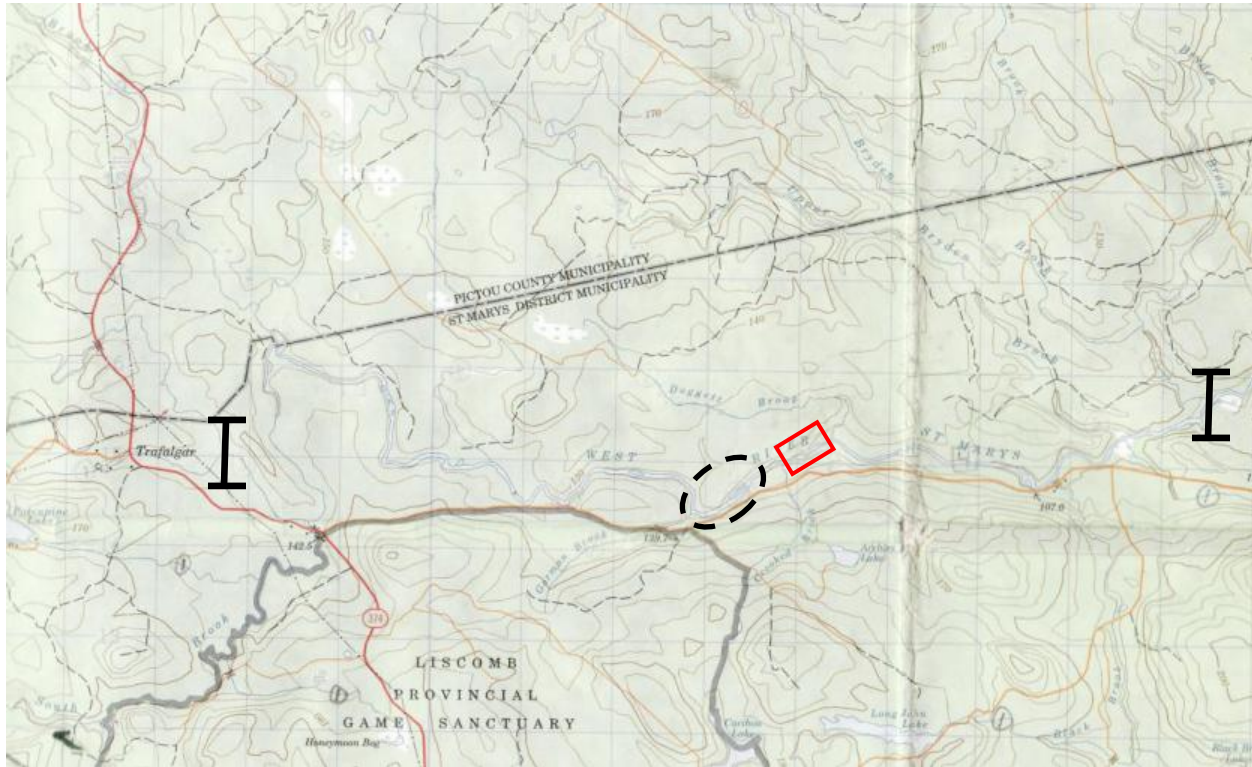
Between Gorman Brook and Crooked Brook, gravel is accumulating downstream of a turn in the river (Figure 7). The gravel is contributing to the widening of the mid-channel bar located after the turn. Between the 1980 photos and the 1997 photos there appears to be approximately 5 m accumulating along the side of the bar. This site was visited on May 4<sup>th</sup>, 2009. The bar was measured to be 62 meters long and 20.6 meters wide. The substrate is large gravel to small

cobble in size, on average, and vegetation is covering the majority of the bar. There is evidence of primary succession.

Upstream of Doggett Brook in the 1980 and 1997 photos there are visible signs of the old channel. In the 1980 photo the old channel is more obvious than in 1997. It appears as though the new channel is creating a wider turn in the stream while the old one cuts straighter across. This site was also visited on May 4, 2009 and it was confirmed that the channel changes are taking place; the old channel has dried up although it is still receiving some backflow.

Figure 7: Section V, illustrating locations of described channel morphometric features. Lateral bar formation and island development shown in dotted ellipses and historical lateral channel movement in red boxes.

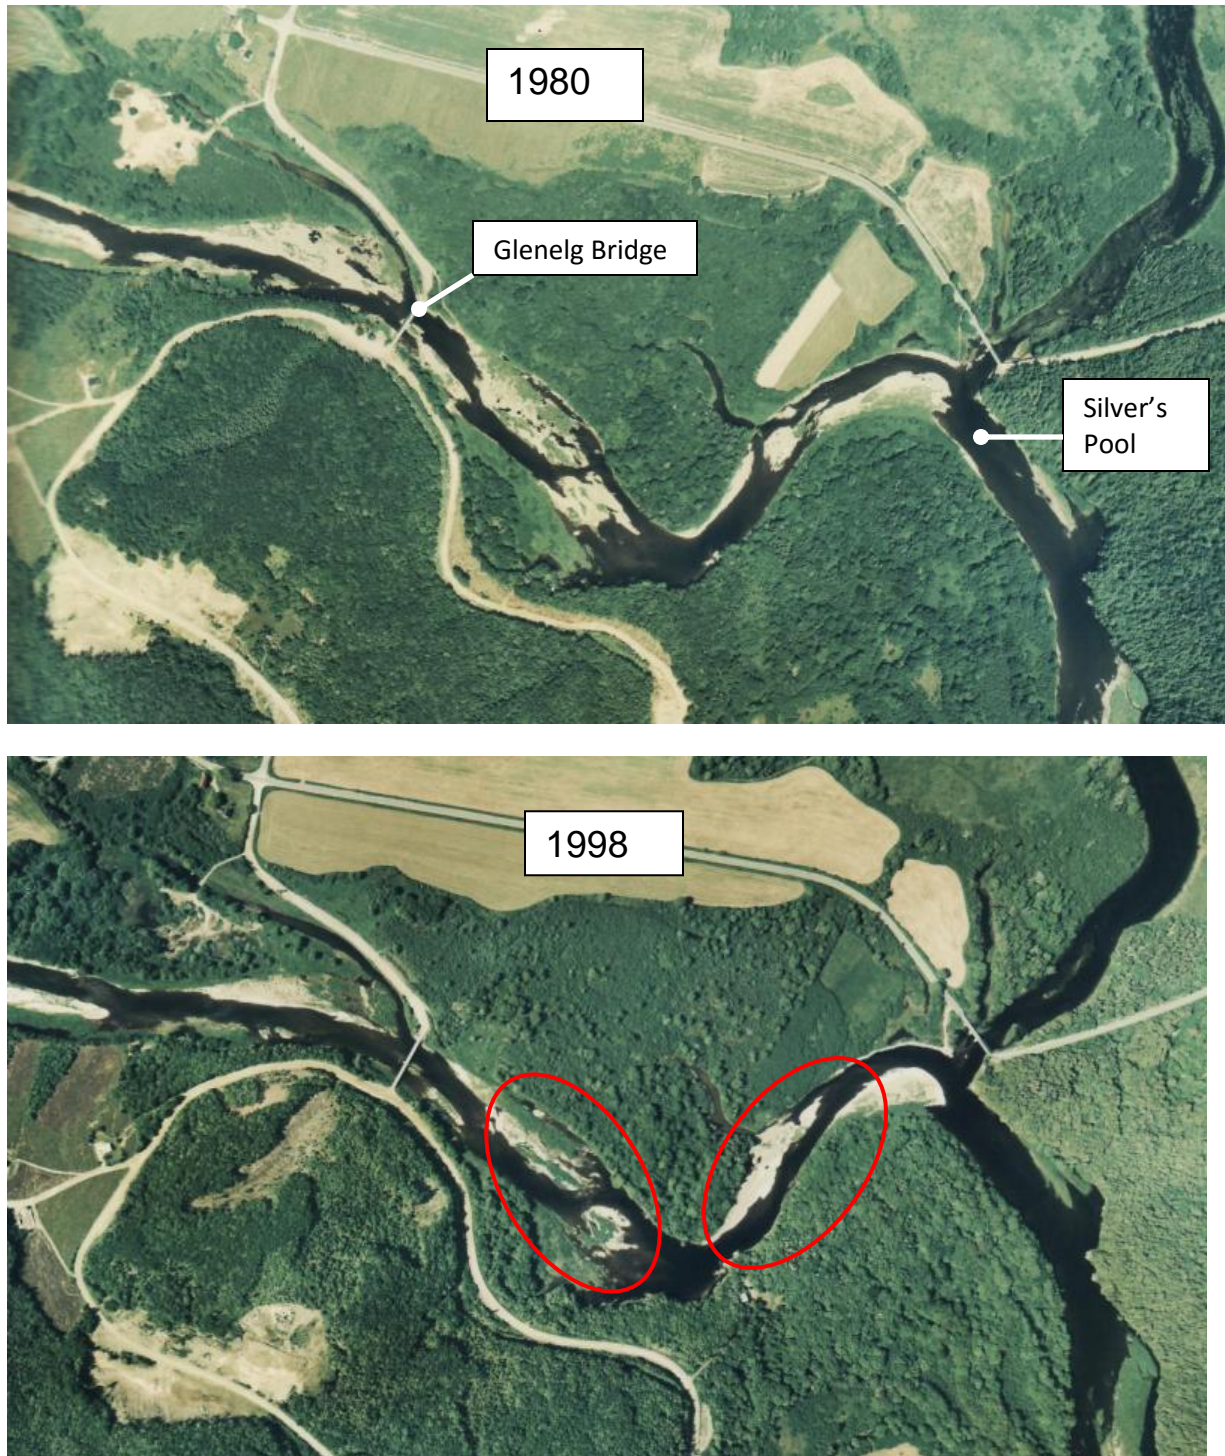
Plate 1: Air photographs of lower Section 1 from Glenelg Bridge to Silver's Pool. Note changing shapes and distributions of sediment and lateral river flow paths (highlighted in ellipses). River discharge in 1980 was very low and so this must be taken into account when comparing between these photographs.

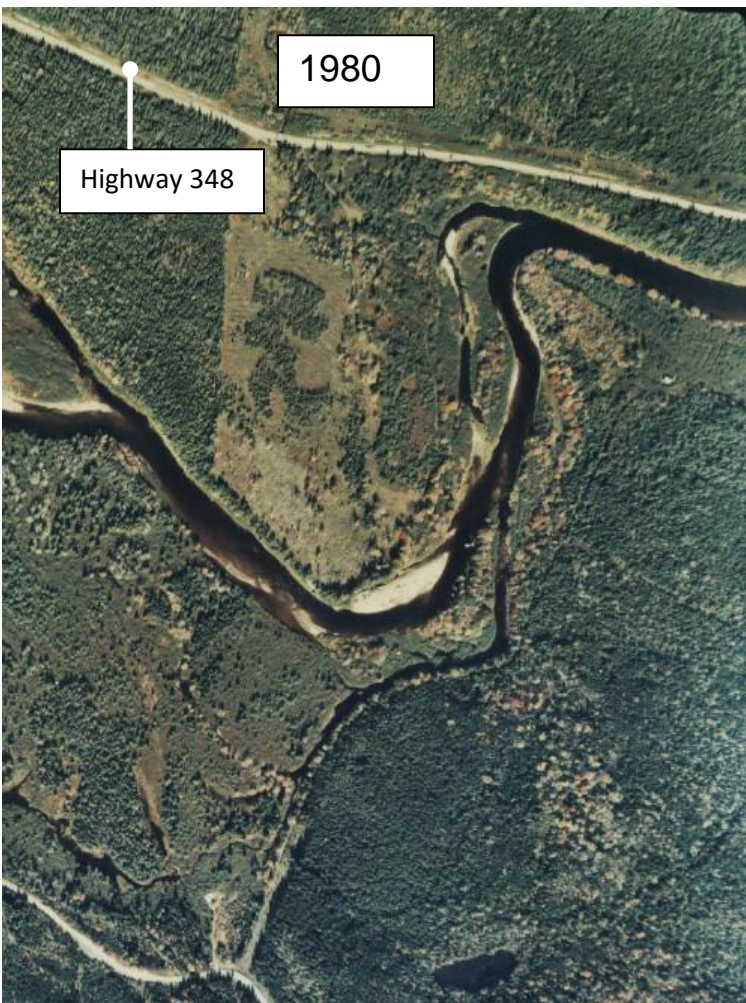
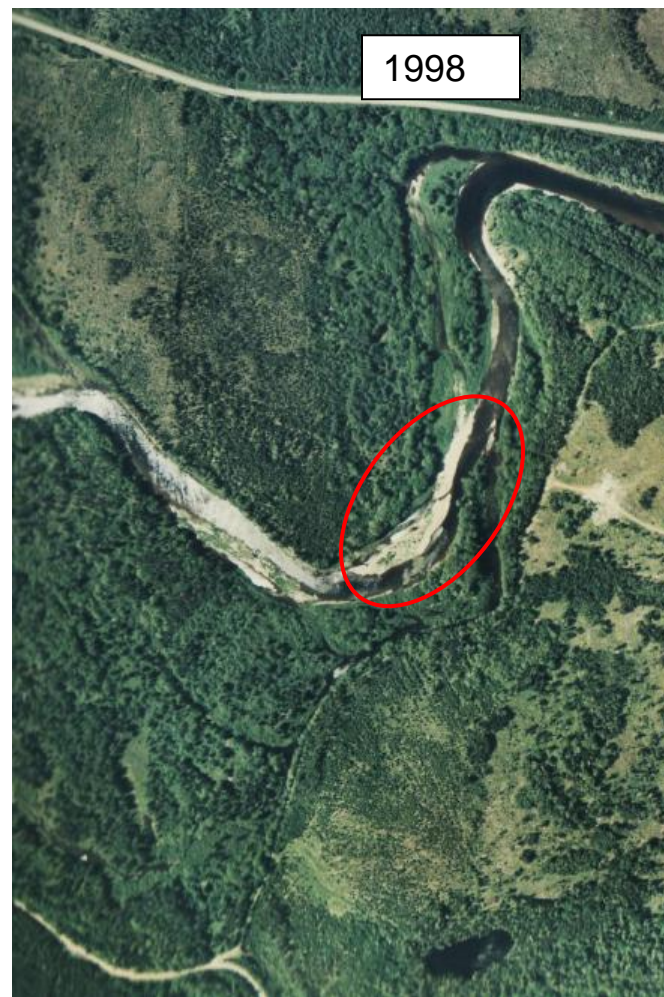
Plate 2: Air photographs of Section II at Sutherland's Brook confluence. Note lateral channel movement and braiding, as well as increased lateral bar formation (red ellipse).

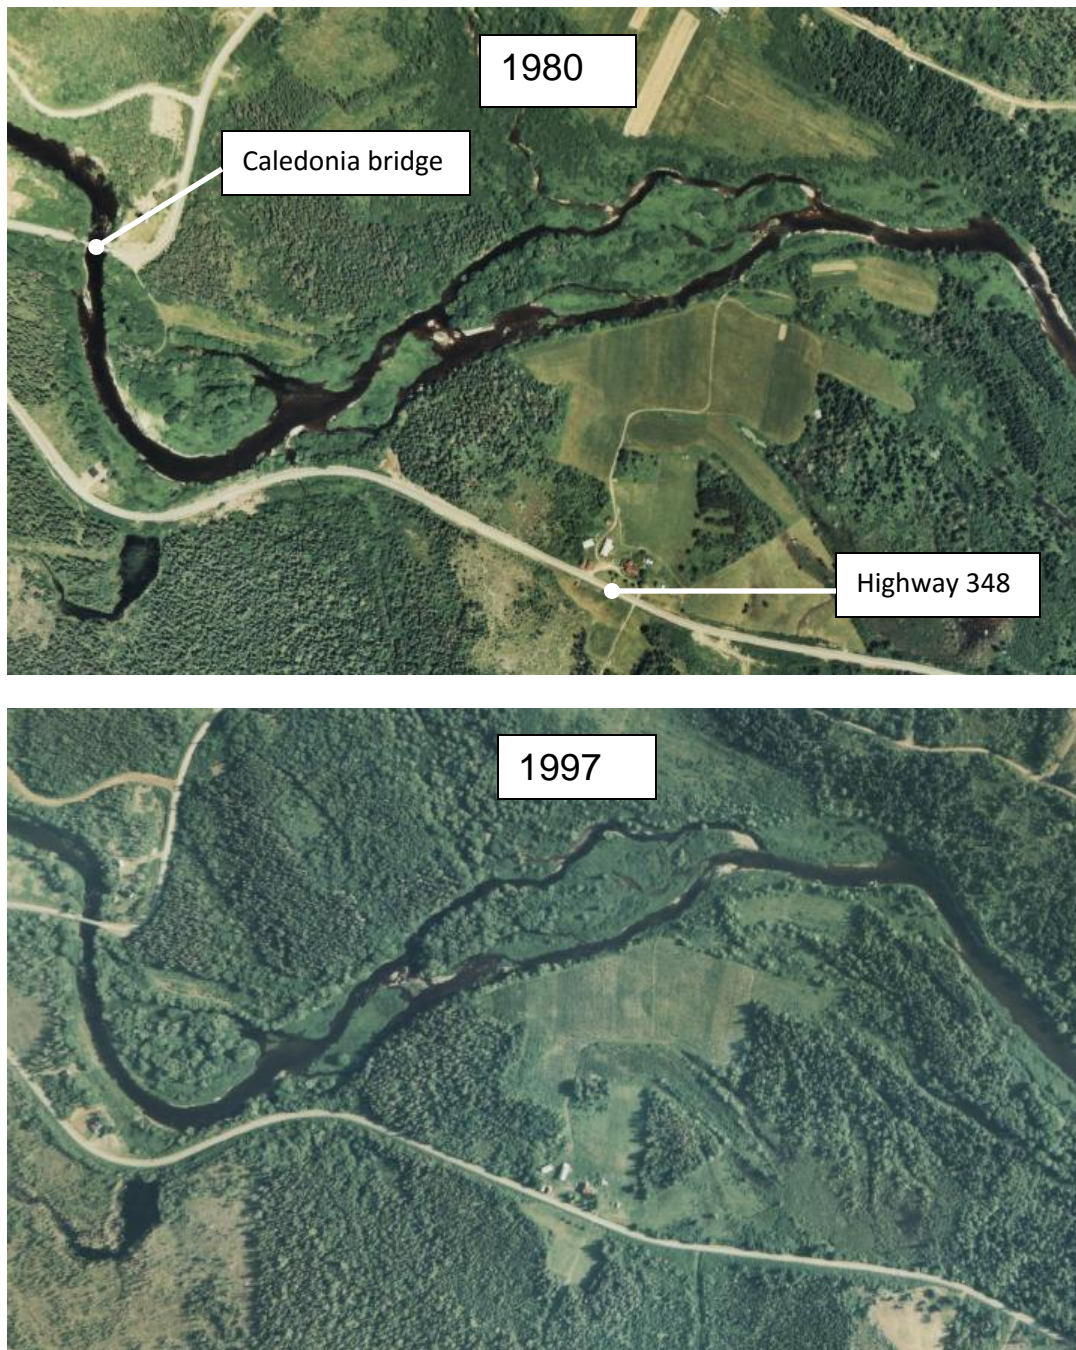
Plate 3: Air photographs of Section III downstream of Caledonia bridge. Note anastamosing channel (braiding). This appears stable over this 17 year period of record.

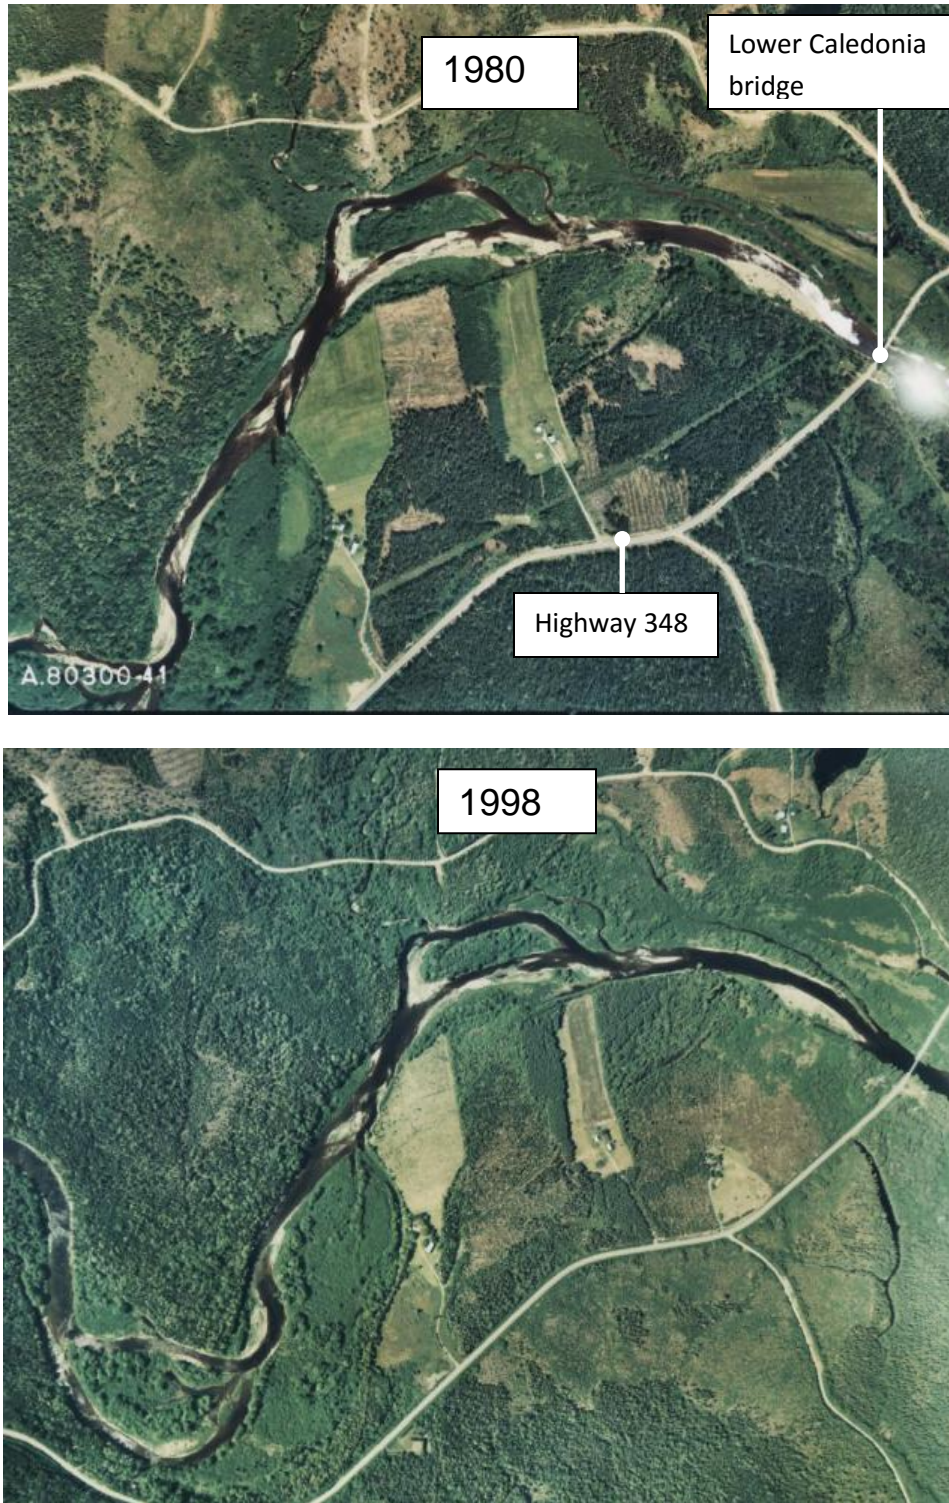
Plate 4: Air photographs of Section III upstream of Lower Caledonia bridge showing Barren Brook area. Note lateral bar presence and large island splitting river flow. Lower photograph also includes anastomosing channel upstream of Barren Brook. These features appear stable over this 17 year period of record.

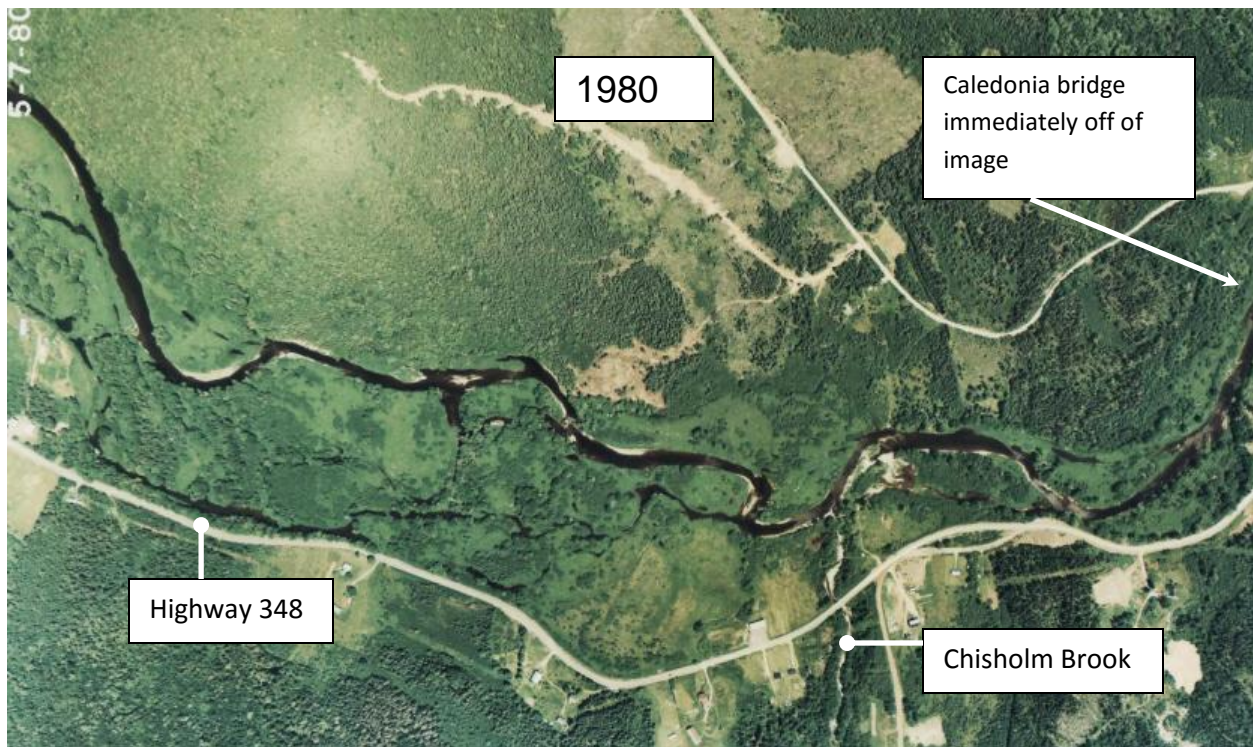
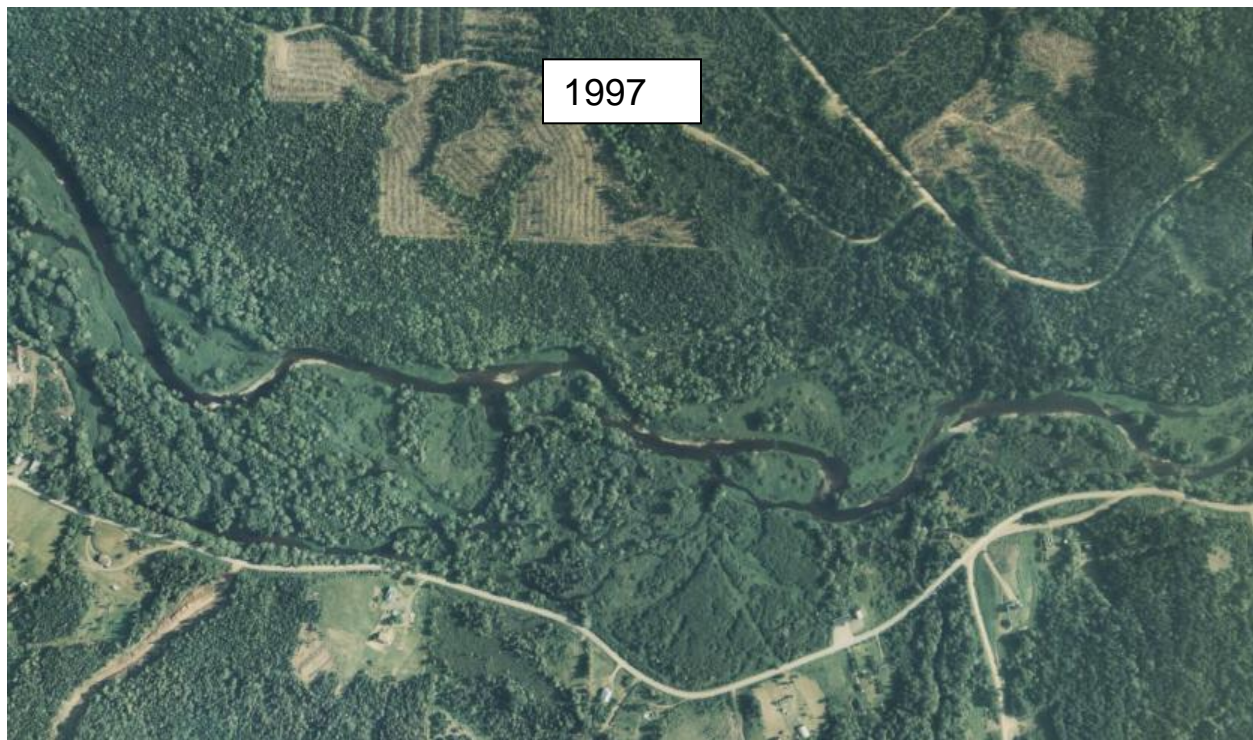
Plate 5: Air photographs of Section IV upstream of Caledonia bridge. Note evidence of historical channels.
