ST. MARY'S RIVER TRIBUTARY STREAM RESTORATION ASSESSMENT AND  
PLANNING FOR 2012.

November 7, 2011

St. Mary's River Association Technical Report #012

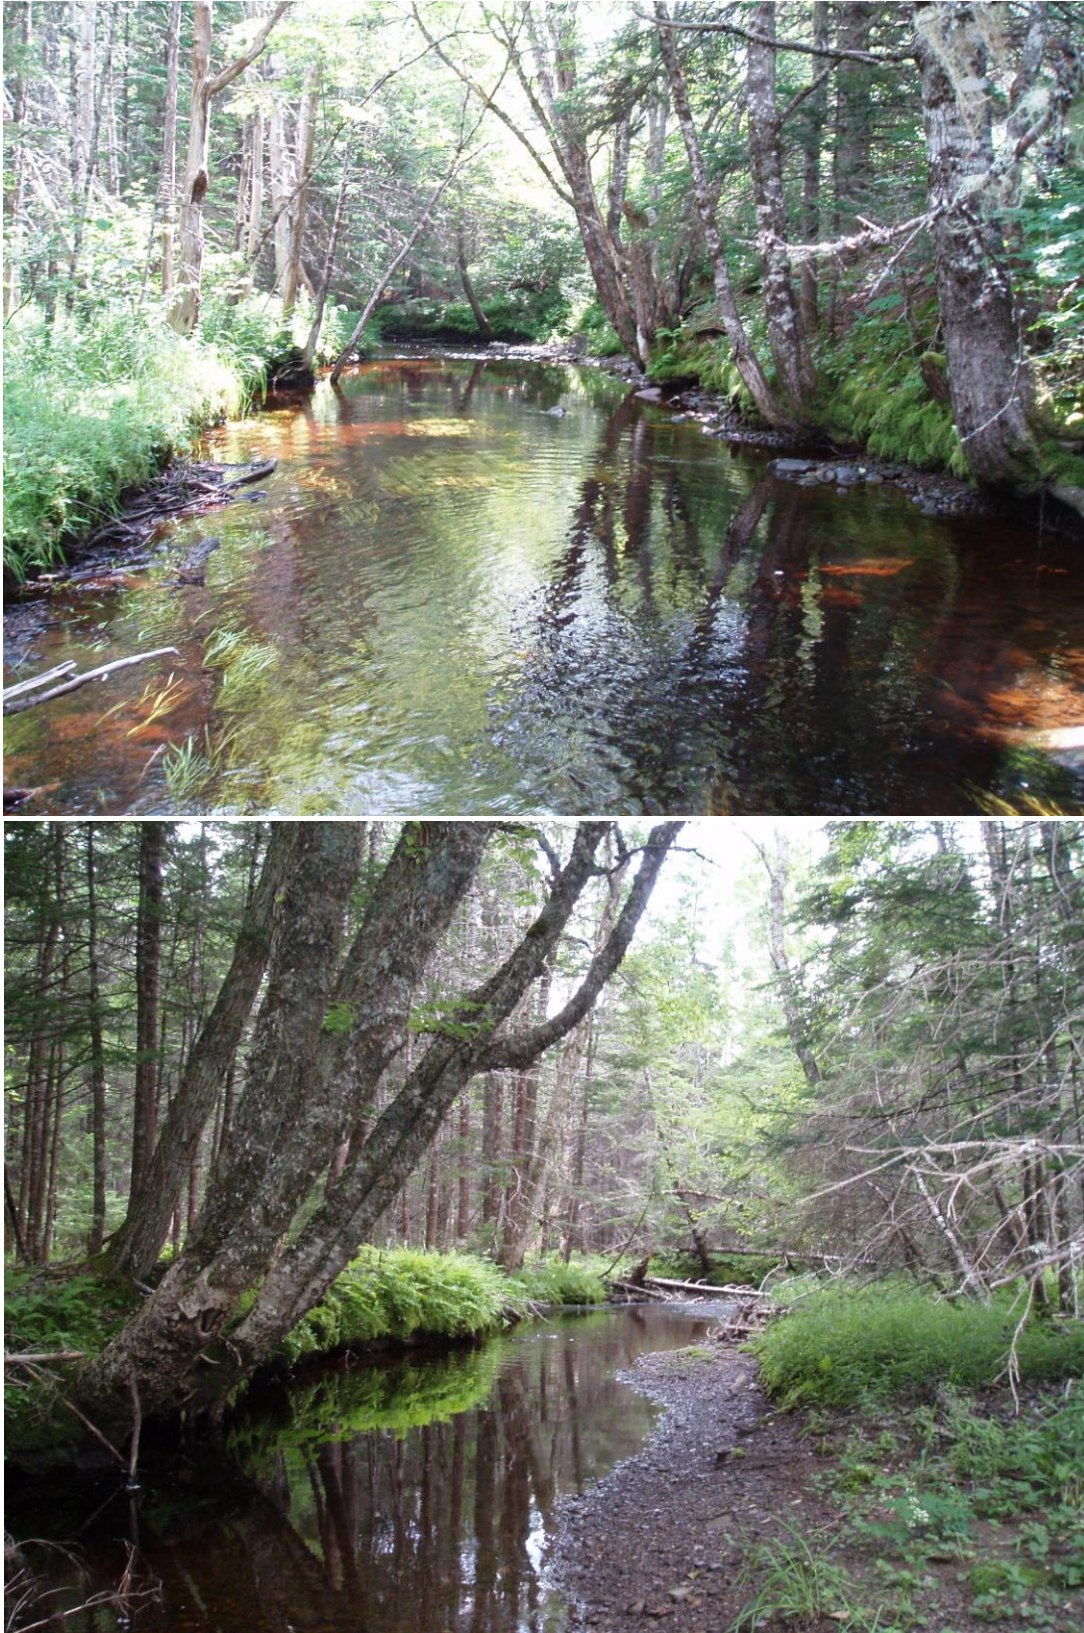
Overall, this stream appears to suffer from little impact and possess very good trout habitat. Salmon habitat is not abundant in this stream.

**Plate 1:** Photographs of typical habitat conditions in Clarke Brook, West Branch St. Mary's River. Photographs taken July 19, 2011.

However, annual maintenance of existing restoration structures is required on an ongoing basis.

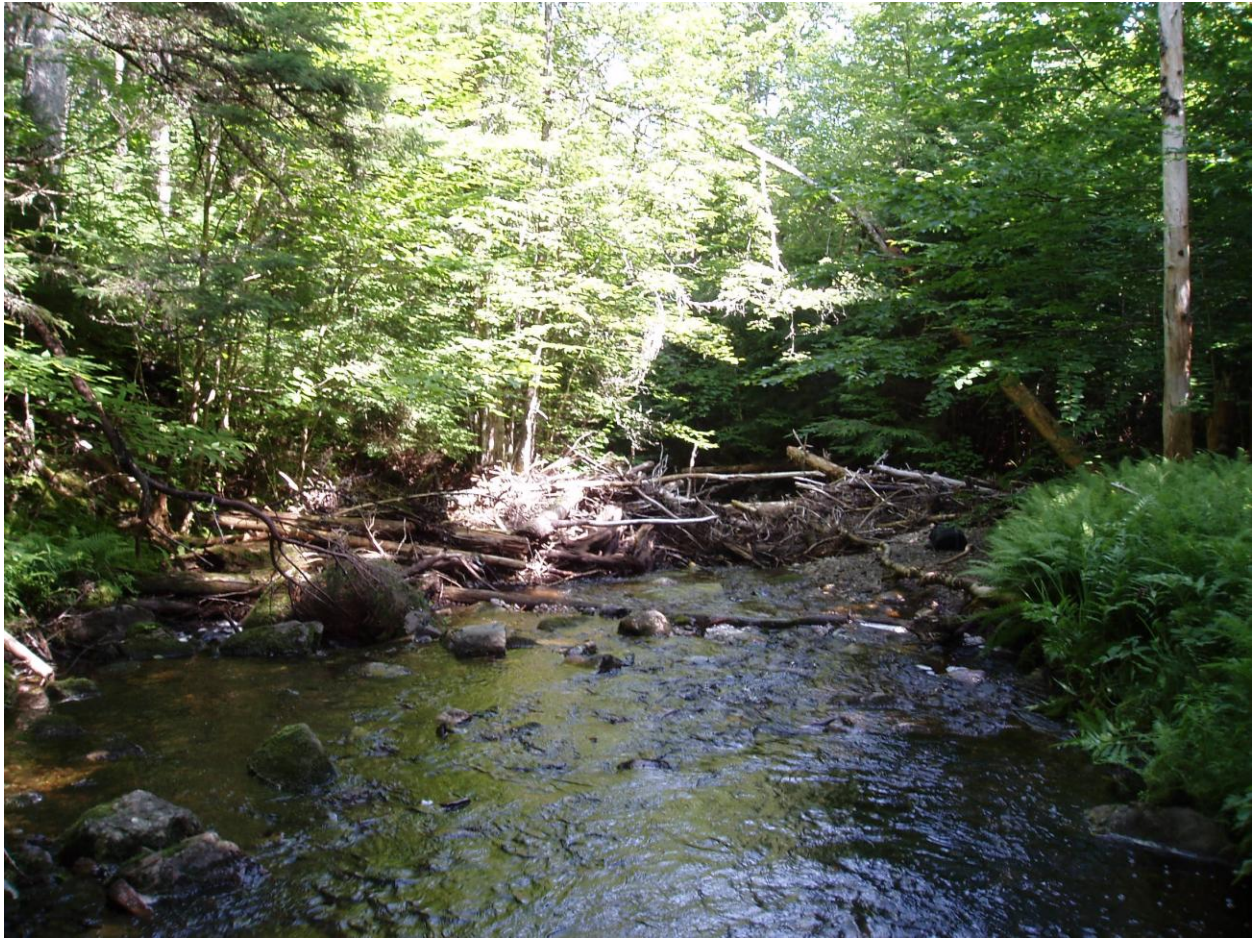
This part of the stream is still bedrock controlled but more alluvial than Reach 1. It is lower gradient, with cobble bars present, and regular riffles rather than cascades. The valley is less confined, with the beginnings of a true floodplain appearing. The riparian is principally hardwoods – maple and birch - and hemlock. These are mature trees of impressive size and likely still present as harvesting is not feasible in this area due to steep slopes. This reach may be better treated as similar to the stream below the highway bridge (i.e., lower 80 m of stream), with the entire reach (combined reaches 1 & 2) interrupted by the bedrock canyon. Above the canyon there is a transition out of bedrock control to a substrate mostly boulder and cobble, but with increasing amounts of gravel. Gradient remains high (similar to that below the highway bridge) and the habitat is primarily riffle-pool with very little run. There is a debris jam at UTM 0553146E, 5012288N; (see Plate 2) it is a small jam comprised of SWD and some LWD, but appears to be obstructive. Throughout this reach (upstream of canyon) the stream has been becoming gradually less confined, though there remain high steep banks on alternate sides with a small floodplain on the opposite bank. Occurrence of high bank and floodplain alternate (i.e., switch sides of stream. There are bedrock steps at UTM 0553232, 5012062, and these are considered the upper extent of Reach 2. Approximately 50 m downstream of the bedrock steps, the high banks are reduced on either side and true floodplain develops. Within Reach 2 there is very little woody debris in channel. The identified debris jam and small one further downstream (not obstructive and so not location documented) were only noted debris.

**Plate 2:** Photographs of debris jam in Reach 2 of Kelly Brook, West Branch St. Mary's River. Photographs taken August 17, 2011.

There are two possible targets for restoration on this brook – the obstructive debris jam in Reach 2 and the failing bridge at the top of Reach 3. Access to both is by an old logging road immediately to the east of, and closely paralleling, the brook. Ownership of the bridge will need

to be determined and permission obtained prior to removal or modification of that structure. Both bridge and debris jam may be removed with hand tools and power saw. Apart from debris clearing in this stream there is little need for restoration practices. The high gradient canyon/chutes near the mouth of the brook prelude movement into Kelly Brook from the river and so restoration would be aimed above the canyon at resident species. Restoration efforts likely are more effective on streams without passage issues and where access for workers is easier.

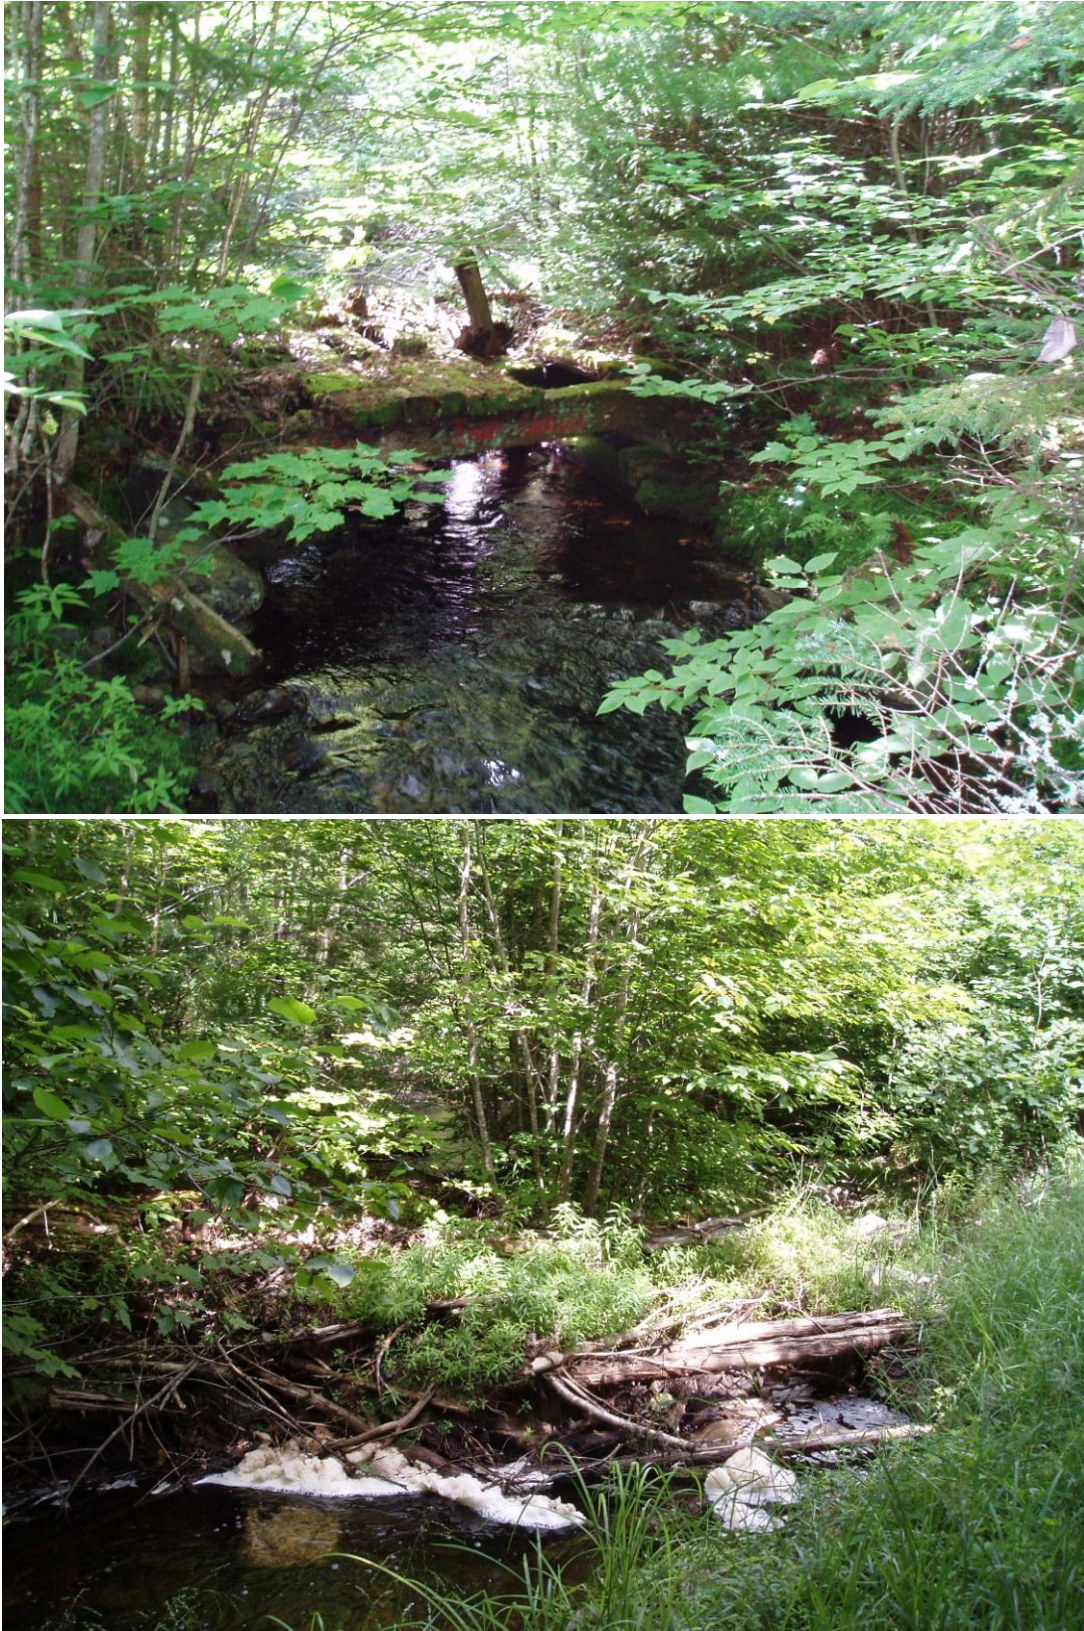
Reach 3 begins about 100 m upstream of bedrock steps. It is an alluvial reach, of lower gradient, with a substrate primarily of gravels and cobble. Undercut banks and meanders are present. Habitat types are riffle (40%), run (40%), pool (20%). There are accumulations of gravel in bars (these absent in Reaches 1 & 2). LWD and SWD are now in stream and functioning. There are some very straightened sections (log driving?). This reach shows sign of impact – highly regular channel width, shallow riffle-run predominating; few and small pools; channel overwidened and flat plain; diagonal riffles. The upstream extent of the survey is an old bridge on a logging road (1.7 km upstream of confluence) (see Plate 3). The bridge is contributing to an obstructive debris jam, pushing high flows onto river right (looking downstream) and cutting new channel.

**Plate 3:** Photographs of decrepit bridge at upper extent of Reach 3 of Kelly Brook, West Branch St. Mary's River. Photographs taken August 17, 2011.

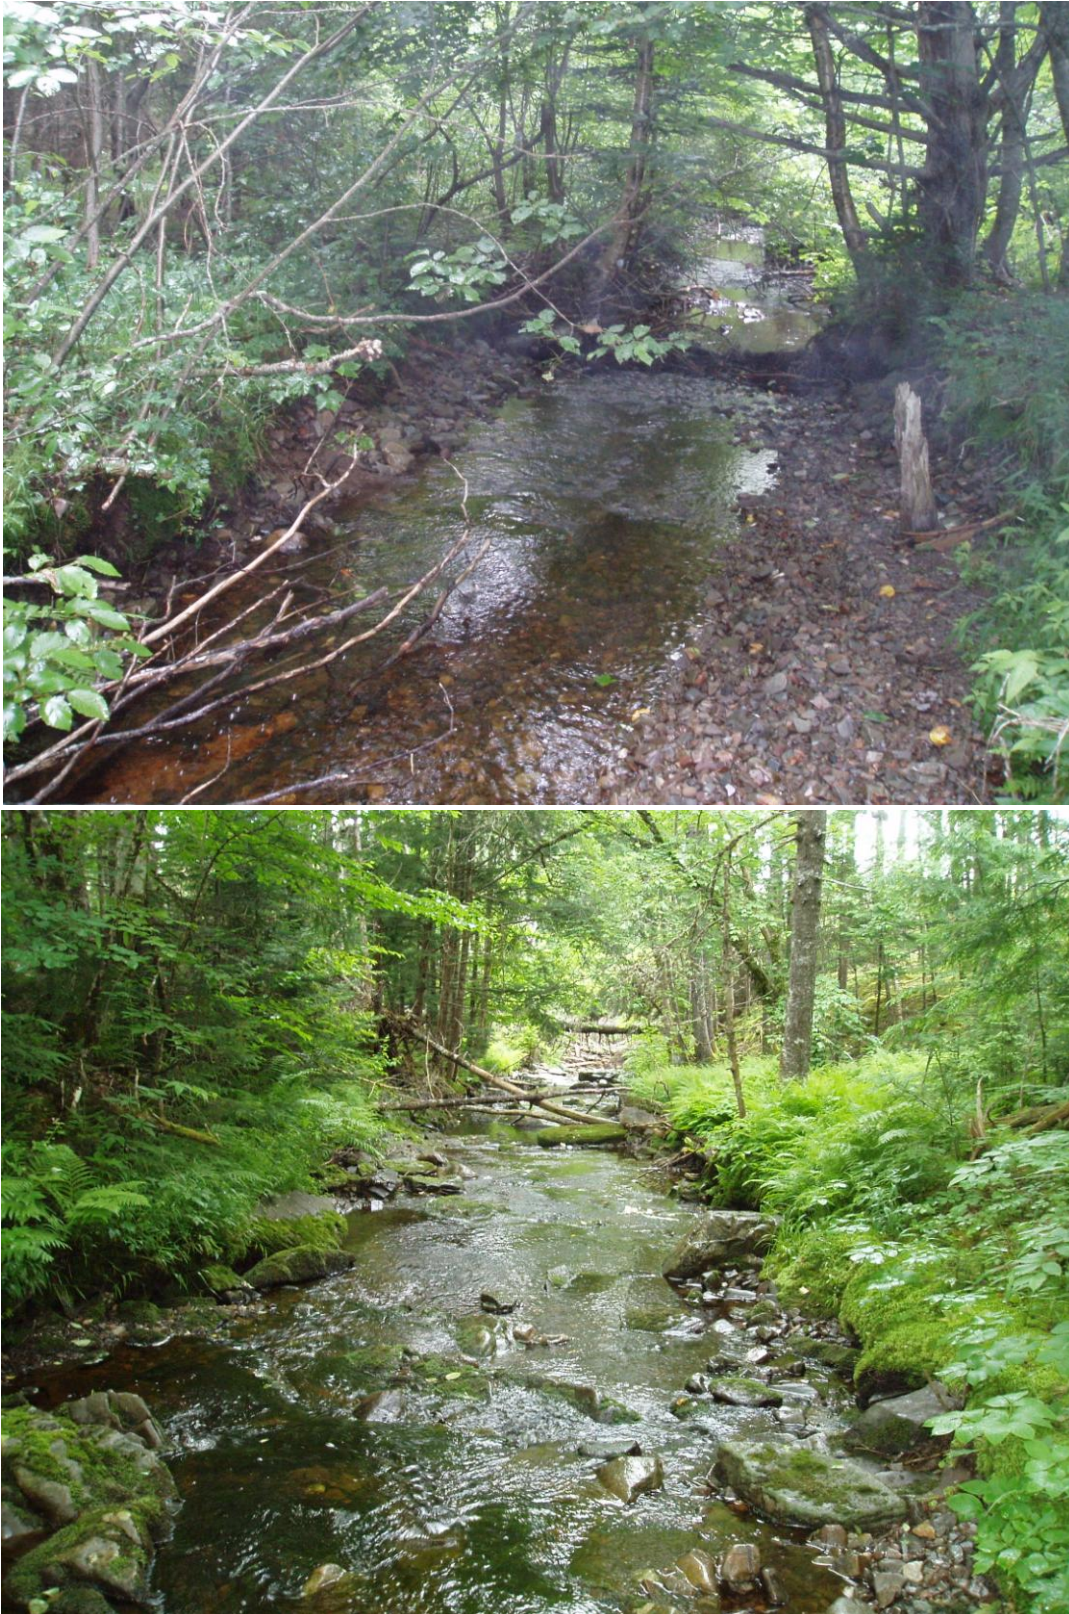
**Plate 4:** Photographs of typical habitat conditions (Reach 1 upper photo; Reach 3 lower photo) in Mitchell Brook, West Branch St. Mary's River. Photographs taken July 28, 2011.

The small debris jams identified in this survey (Reach 2) were cleared by the SMRA summer crew in August. Repeated accumulation of debris at these sites should be monitored and removed as required in the future. Aside from this activity, there is no need for further restoration activity on this brook.

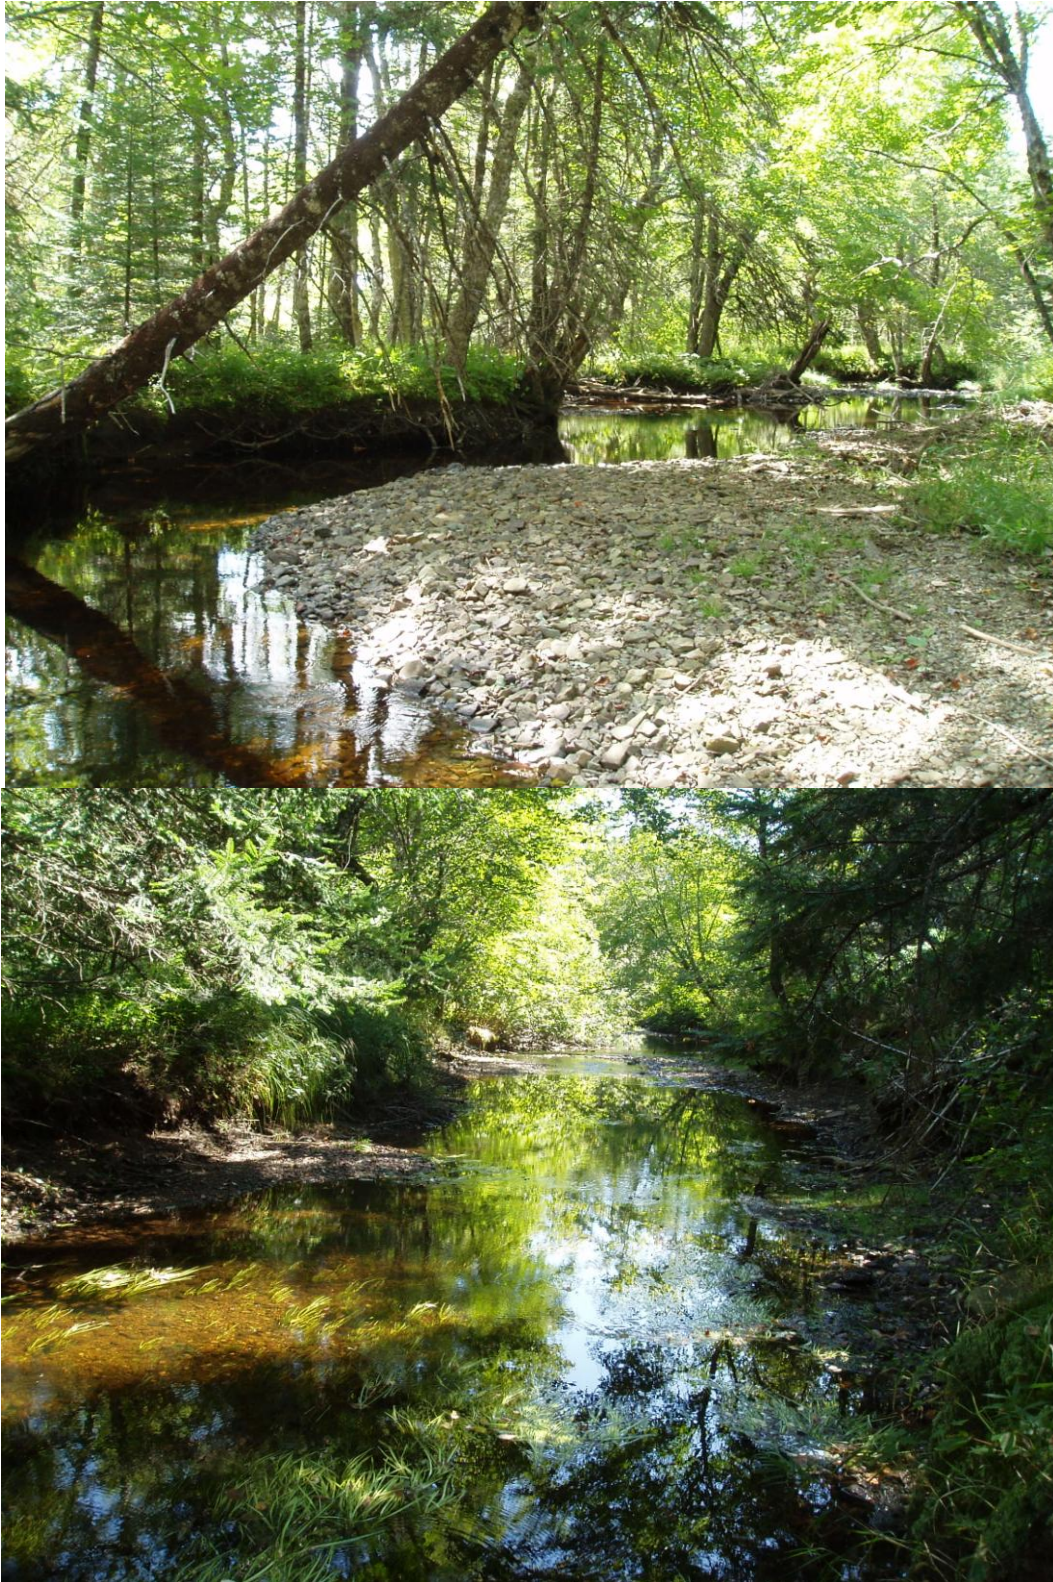
In this reach the channel is overwidened and aggraded. There are several debris jams which have historically altered flow direction and created new channels. Habitat is primarily run (20-35 cm deep), being about 80% run, 15% pool, and 5% riffle. Channel width is 5-8 m. The substrate is composed of fines (10%), small gravel (20%), large gravels (40%), small cobble (25%), and large cobble (5%). Aggradation, as large unvegetated gravel and cobble bars, is

**Plate 5:** Photographs of typical habitat conditions (Reach 2 upper photo; Reach 1 lower photo) in Ross Brook, West Branch St. Mary's River. Photographs taken September 12, 2011.

The principal issues associated with human impacts on this stream are (i) excess LWD/SWD (debris), (ii) aggradation (gravel and cobble), (iii) overwidening of channel, and (iv) shallowing of channel (though not severe as deep runs remain frequent). There is good riparian providing shade. Restoration potential is low for this brook. The majority of the surveyed stream is not salmon habitat (gradient too low), but is reasonable trout habitat (deep pools and runs). The large number of fish observed suggest habitat is adequate to maintain a large population. Access for restoration purposes to this brook is very difficult, as only one old road/trail is present to get to the brook. For this survey I walked across the West Branch from the south side than half a kilometre downstream to confluence of Ross Brook and the West Branch. For these reasons, no physical restoration is recommended for this system at this time.

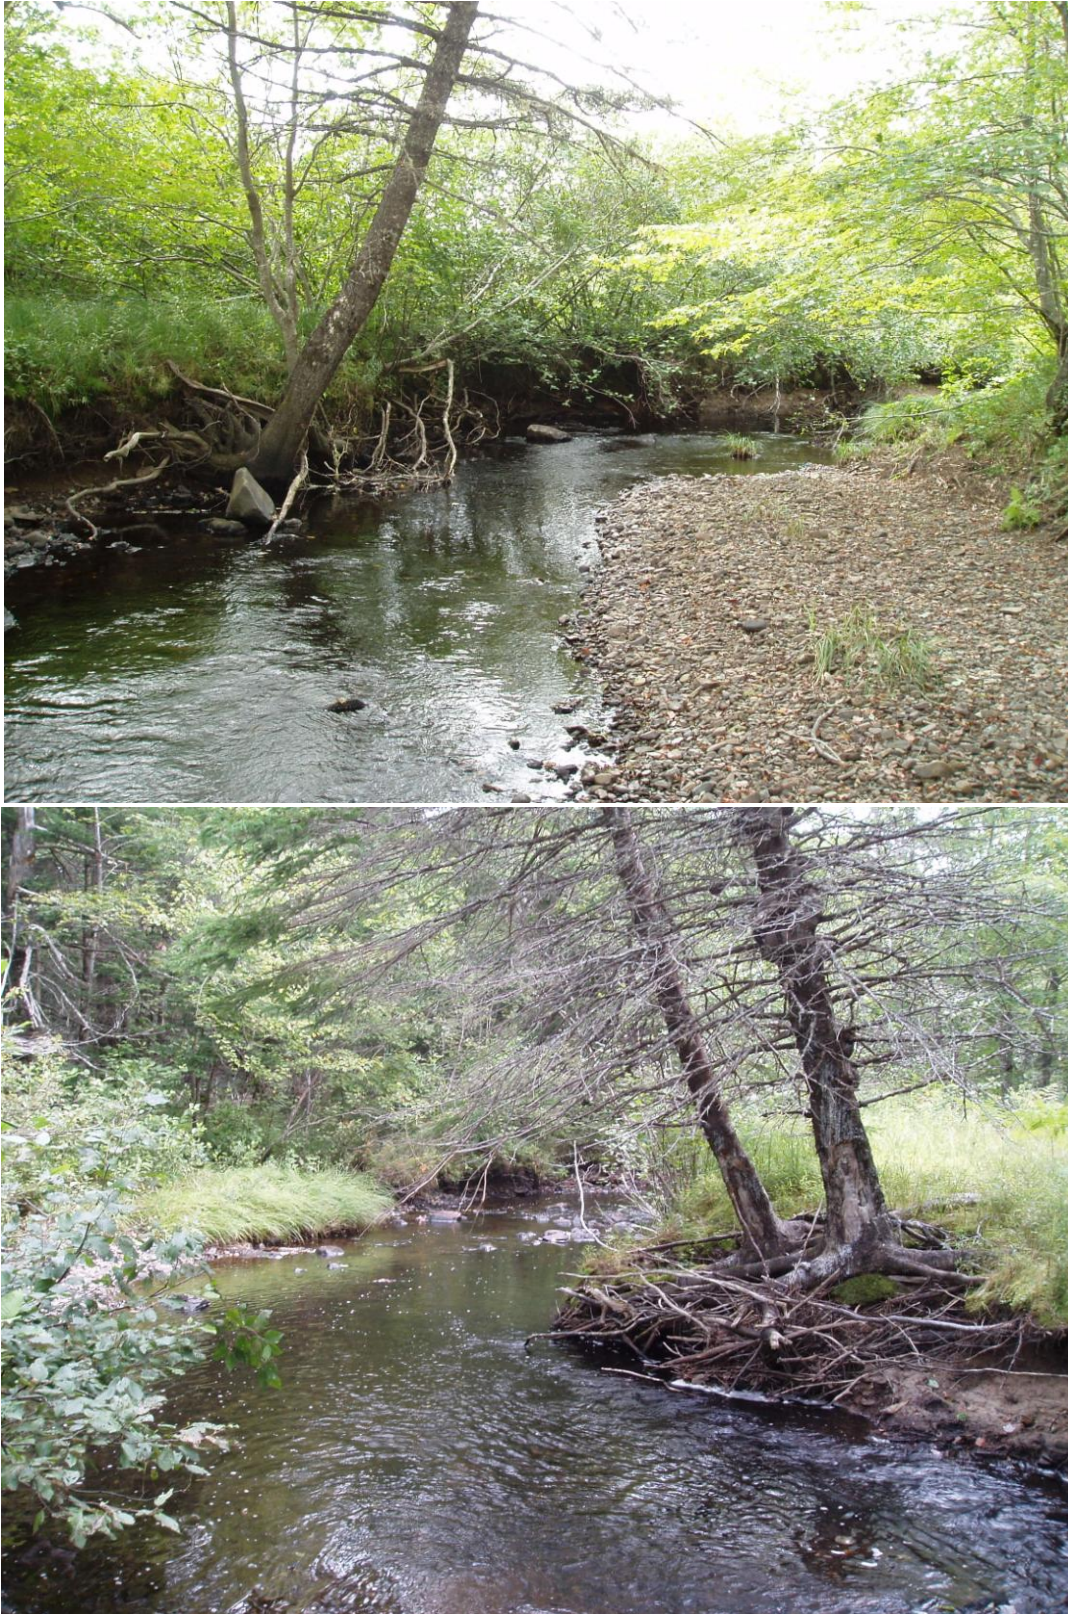
**Plate 6:** Photographs of typical habitat conditions (Reach 1 upper photo; Reach 2 lower photo) in Bryden Brook, West Branch St. Mary's River. Photographs taken September 13, 2011.

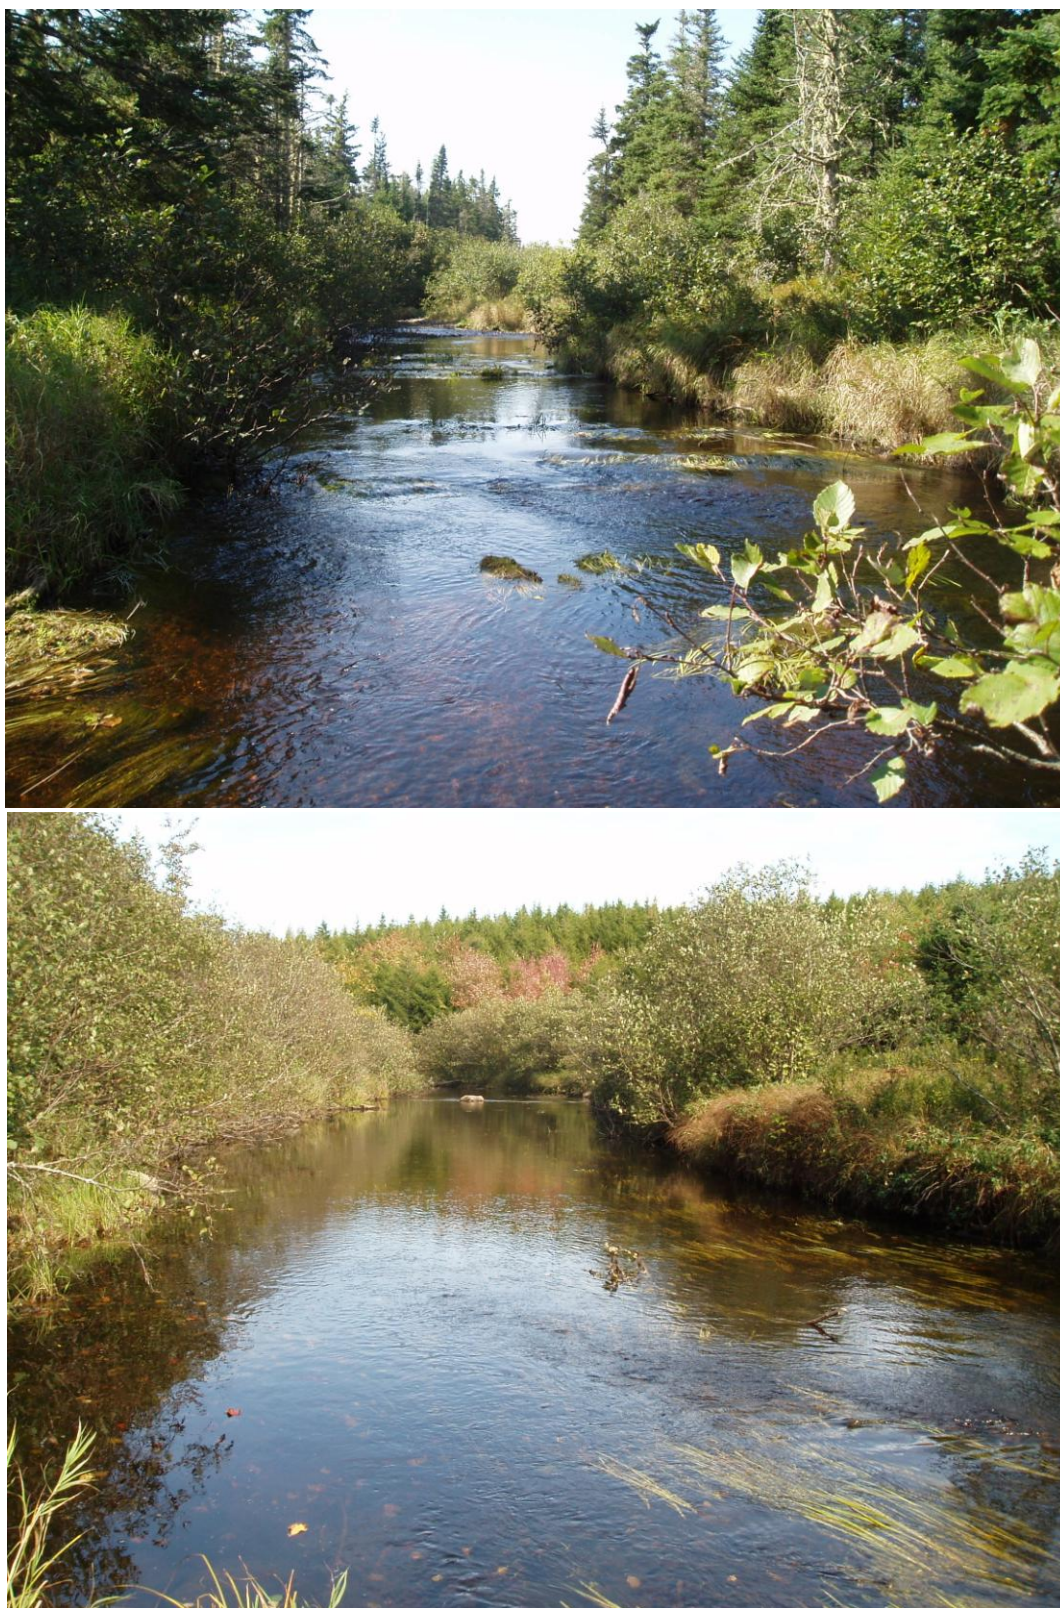
**Plate 7:** Photographs of typical habitat conditions (Reach 1 upper photo; Reach 4 lower photo) in Nelson River, West Branch St. Mary's River. Photographs taken September 30, 2011.

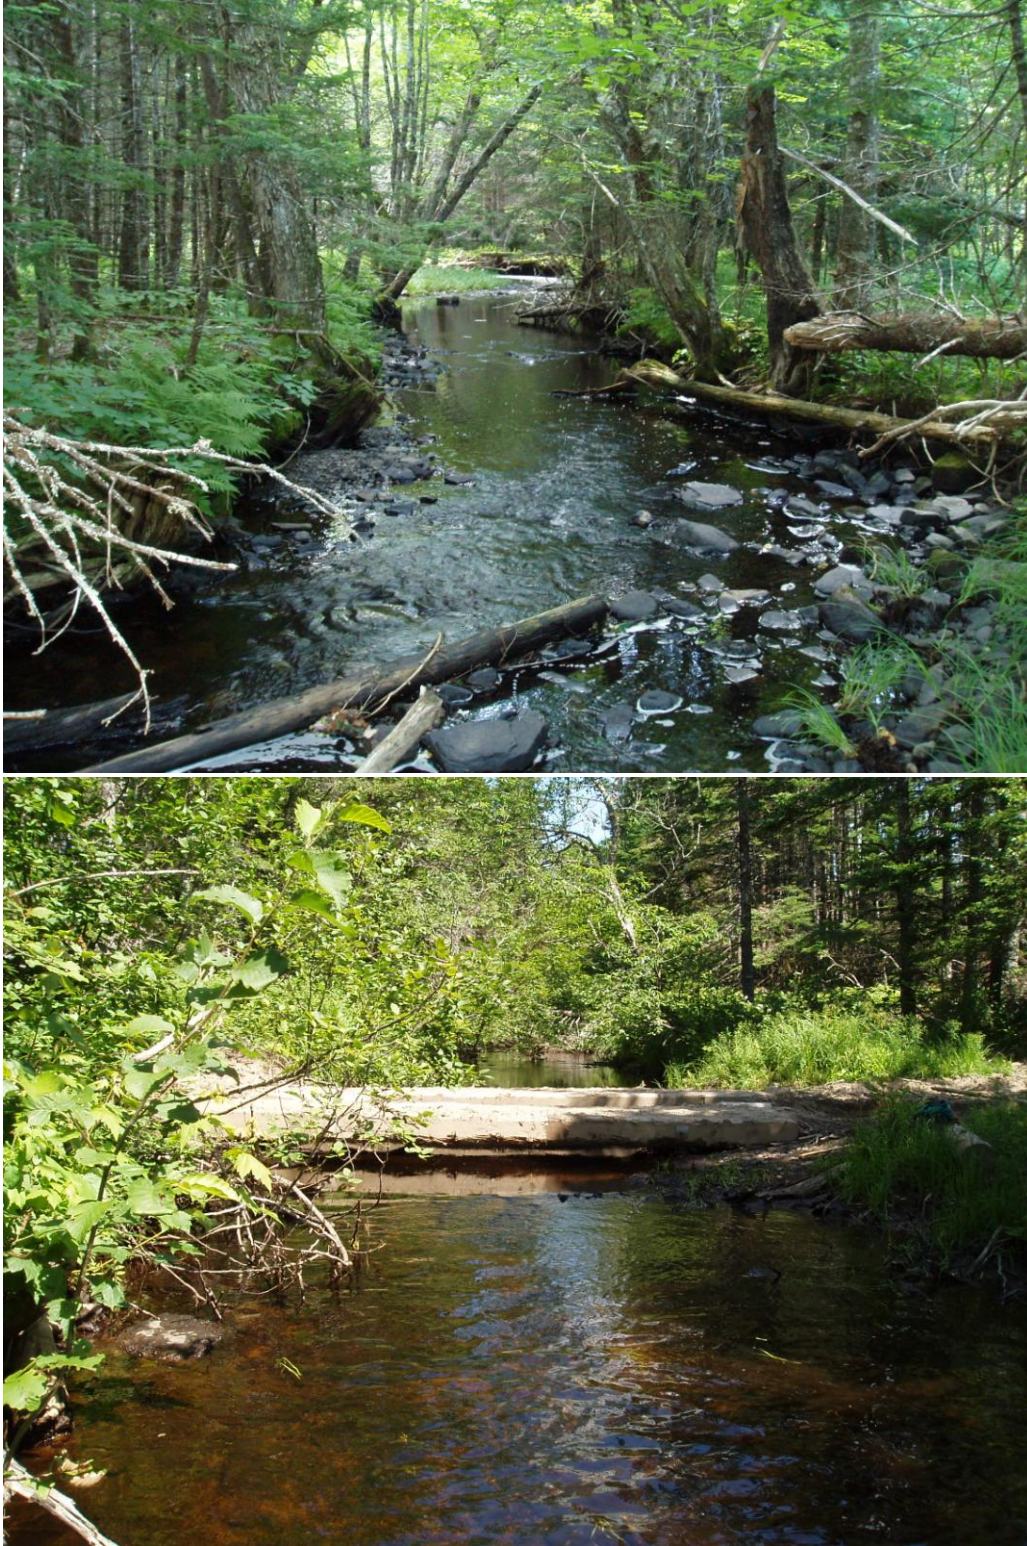
**Plate 8:** Photographs of typical habitat conditions (Reach 1 upper photo; Reach 4 lower photo showing temporary bridge with little clearance) in Big Meadow Brook, East Branch St. Mary's River. Photographs taken July 25, 2011.

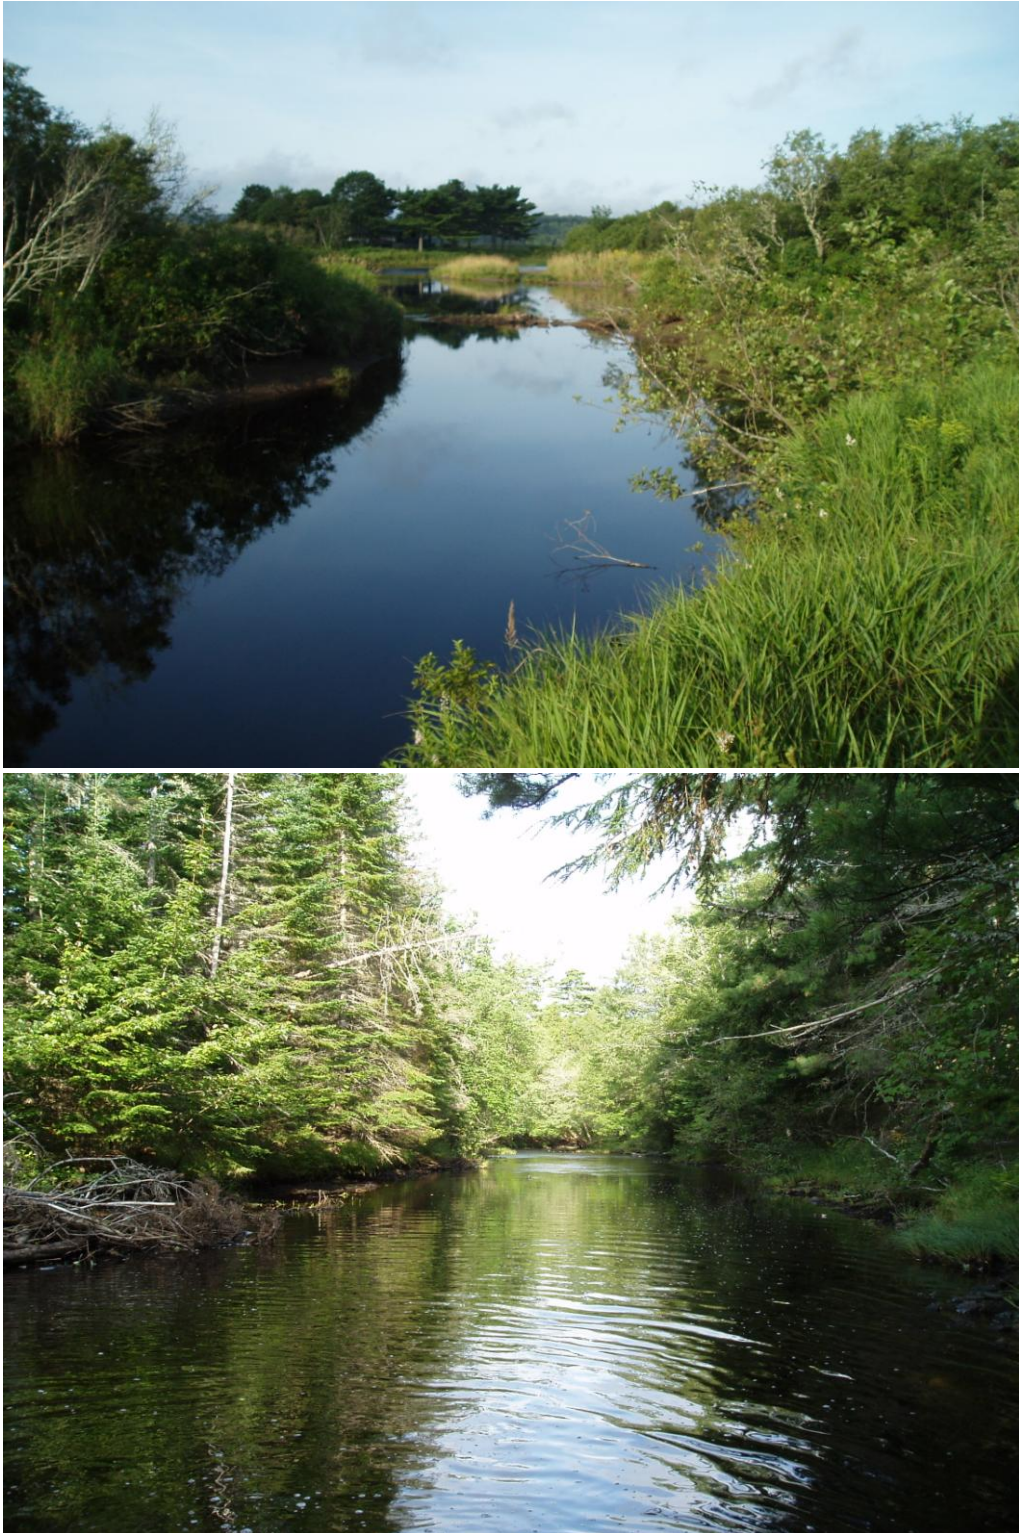
The habitat issue in McKeen's Brook is a preponderance of a single habitat type (run in this case) at the expense of riffles and pools, and the homogeneity of the channel in terms of width, grade, and sinuosity. Run habitats will support salmon and trout, but access to a variety of habitats (riffles for rearing salmon, pools for trout and salmon to retreat to under conditions of low flow and elevated temperature, space under cobble for overwintering) would increase capacity of the stream to rear salmonids. Standard restoration techniques to create riffles and pools are limited on McKeen's Brook for a variety of reasons. The width and inferred power of the stream (as evidenced by having little LWD) suggests channel-crossing structures such as digger logs may not be successful. Rock work (e.g., rock horseshoes, vortex weirs, boulder groupings), while likely to be successful, are limited in placement due to relatively poor road,

**Plate 9:** Photographs of typical habitat conditions (Reach 1 upper photo – confluence with East Branch; Reach 3 lower photo) in McKeen's Brook, East Branch St. Mary's River. Photographs taken August 22, 2011.

Recommendations for restoration, taking these limitations into account, are for half-log devices and log bank covers (see NSSA 2005 and Adams and Whyte, 1990 for design of these structures) downstream of the Highway 7 bridge (Reach 1) and deflectors upstream of this bridge (Reaches 2 and 3). Reach 1 should include 15-20 half log structures and 4-6 bank cover devices over the 600 m of this reach. These structures will provide shading and protection from overhead visual predators. These will need to be installed with sufficient depth or armouring to protect them from ice-scour. While not replacing the function of pools, these devices will mimic some of their necessary characteristics.

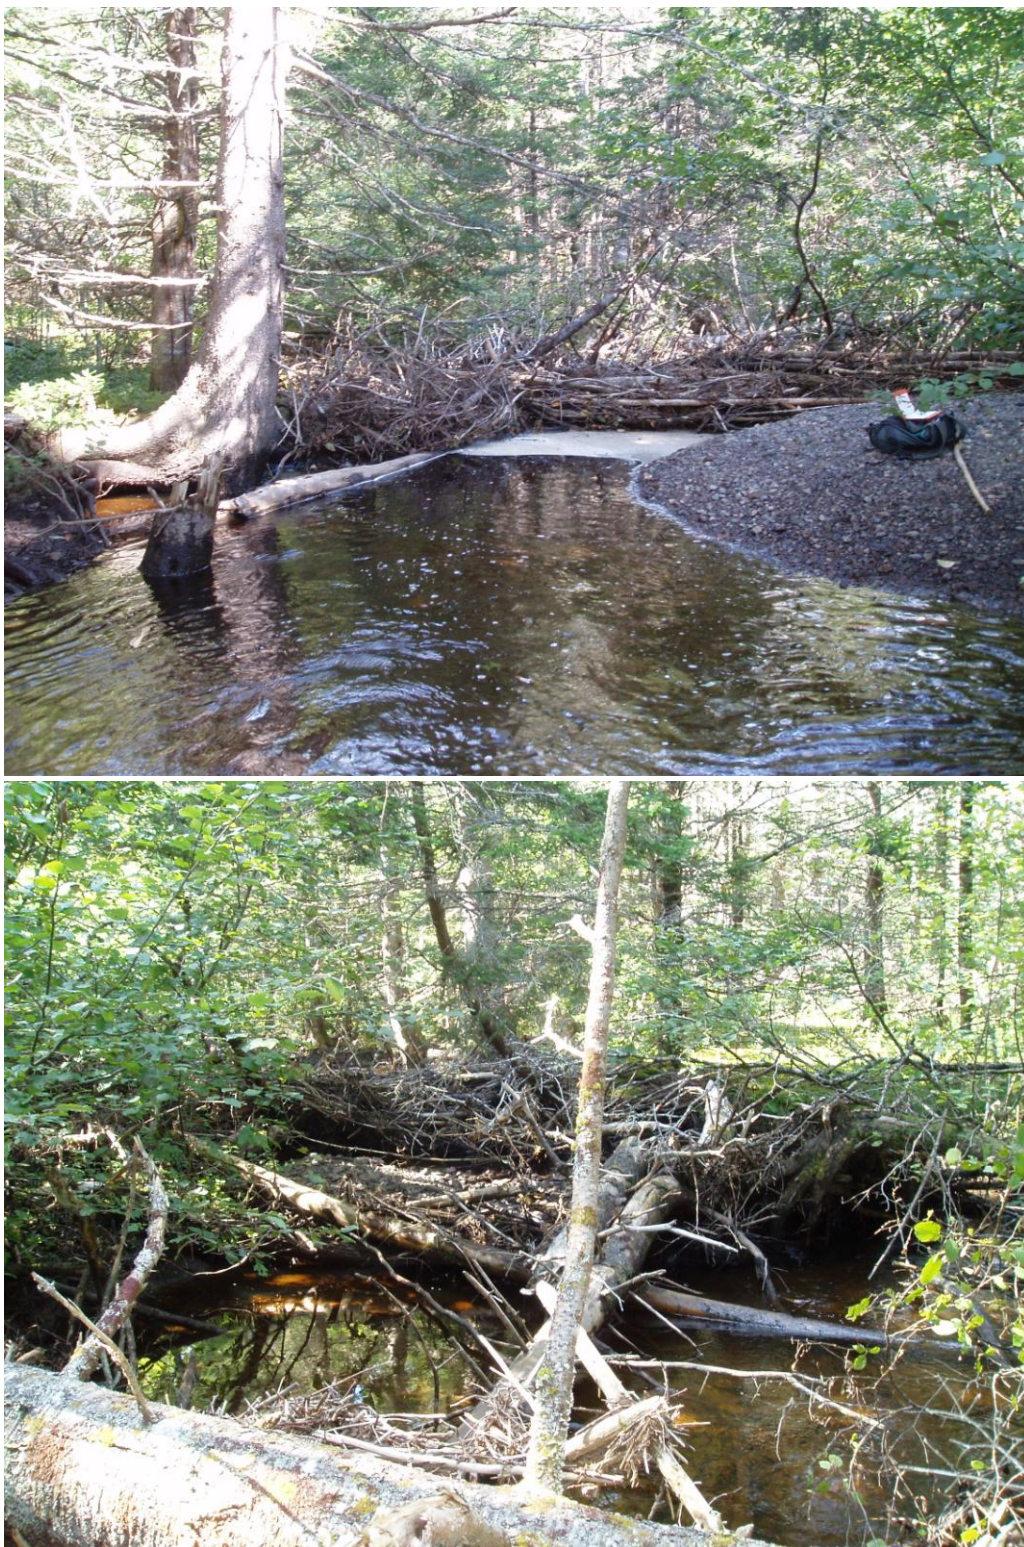
**Plate 10:** Photographs of large debris jam on reach 2/3 boundary of Bogg's Brook, North Branch St. Mary's River. Photographs taken September 22, 2011.

Within Bogg's Brook the removal of the large debris jam at the border of Reaches 2 and 3 is recommended. This jam is large and interfering with water flow and likely fish passage upstream. Work should include selective remove of material to allow proper flow and restore flow to single channel. Work can be accomplished with chainsaw and hand tools. This is high priority as it is cutting new channel and is the only unstable channel feature seen on the survey

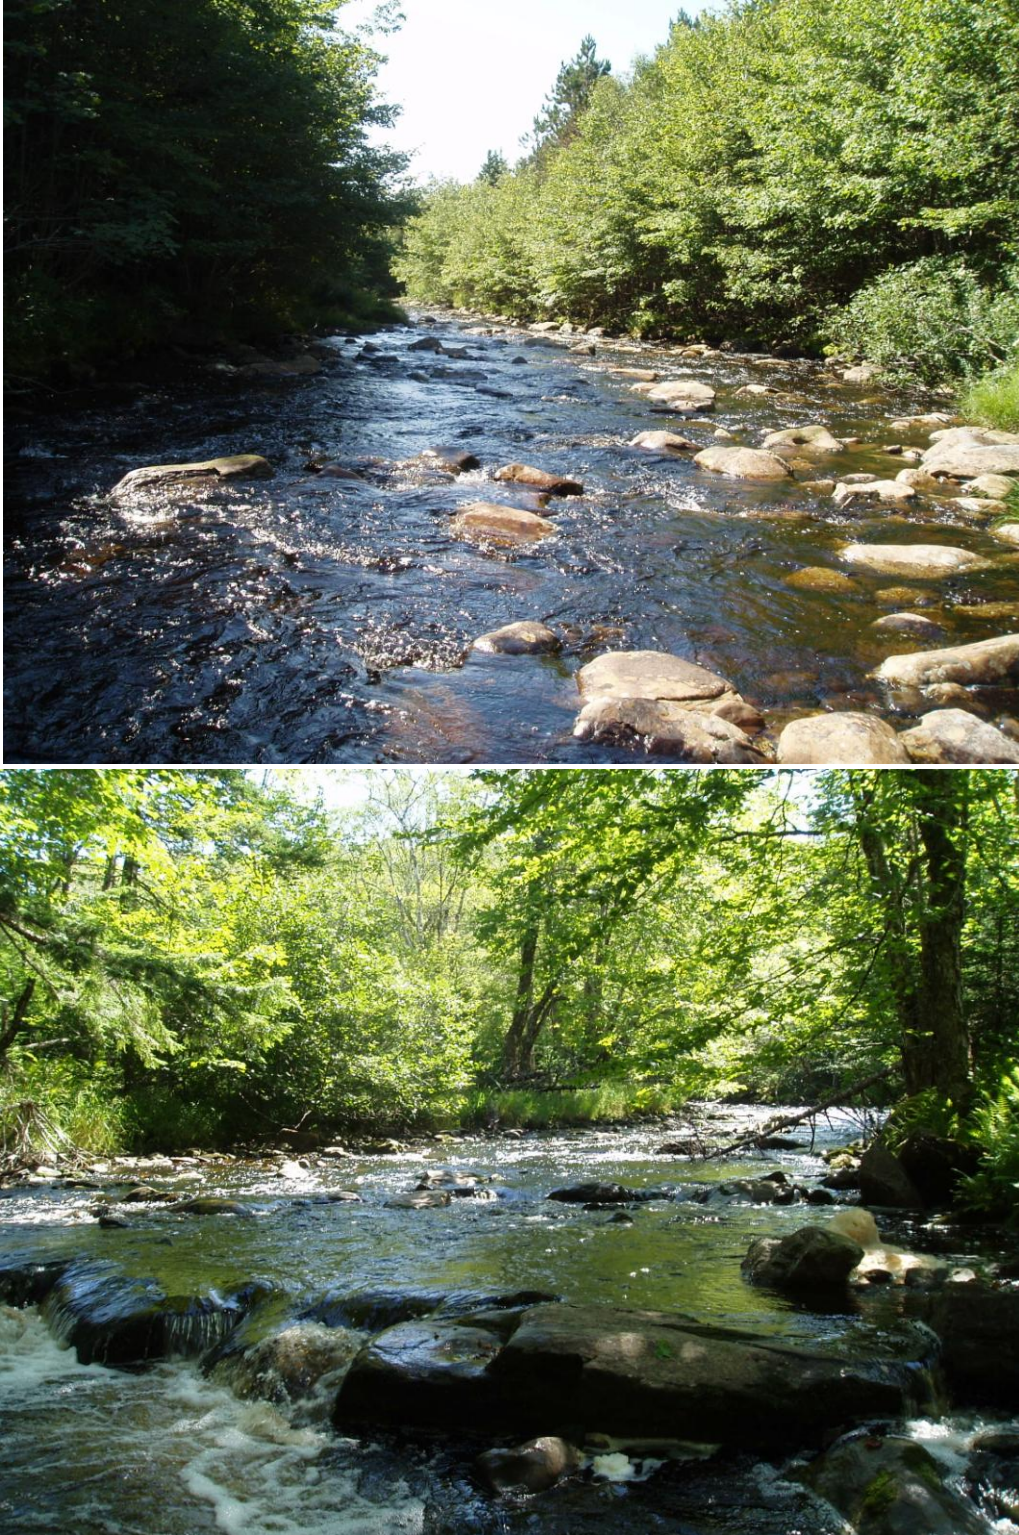
The habitat issue in Archibald's Brook is a preponderance of a single habitat type (riffle in this case) at the expense of pools.. Riffle habitats are excellent for rearing salmon, but access to pools is also important for use under conditions of low flow and elevated temperature. As well, brook trout prefer pools and their absence will reduce trout use. Within Archibald's Brook, however, the major habitat issue is less likely to be physical habitat and more likely low pH. Based on 78 pH samples taken in 1990, 1991, and 2009, mean pH of this brook is 5.44 (SD=0.59 units; range 4.6-6.9 pH units; from Mitchell, 2011). Archibald's Brook (Stillwater) has been identified by Mitchell (2011) as one of the few brooks in the St. Mary's with sufficiently low pH to likely pose a pH-risk to Atlantic salmon. For this reason, physical habitat restoration is not viewed as a constructive use of resources as it is most likely not the limiting factor, but rather the limitation is imposed by low pH. No physical restoration is recommended for this system at this time.

**Plate 11:** Photographs of typical habitat conditions (upper photo – upstream of Highway 7 bridge; lower photo near upstream extent of survey) in Archibald's Brook (Stillwater), Main Branch St. Mary's River. Photographs taken July 19, 2011.
