# Restoration of the West Branch of the St. Mary's River

Report prepared for the Atlantic Salmon Endowment Fund of Fisheries and Oceans Canada

November 26, 2014 St. Mary's River Association Prepared by: Charlie MacInnis and Andrea Flynn

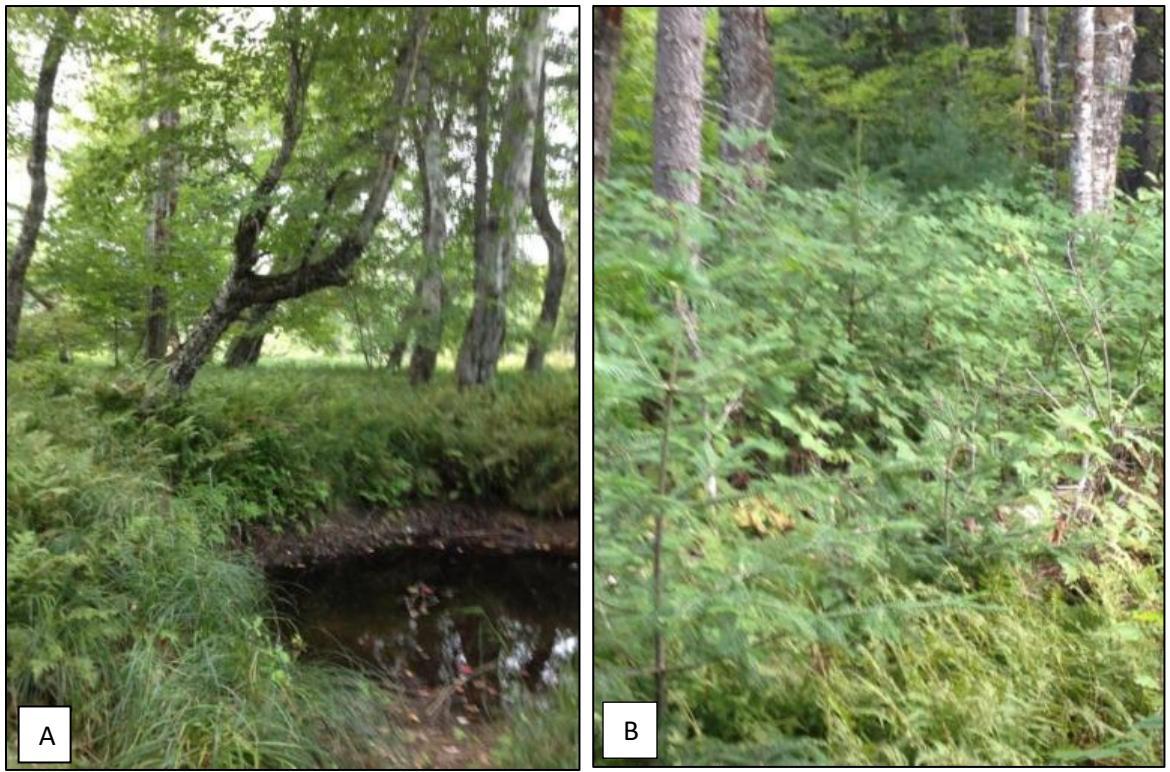
Figure 6. A) Ice scour in the floodplain has resulted in unnatural vegetation patterns that appear almost "park-like". B) Picture taken just 30cm higher than picture A and in the same area, represents what the vegetation should look like.

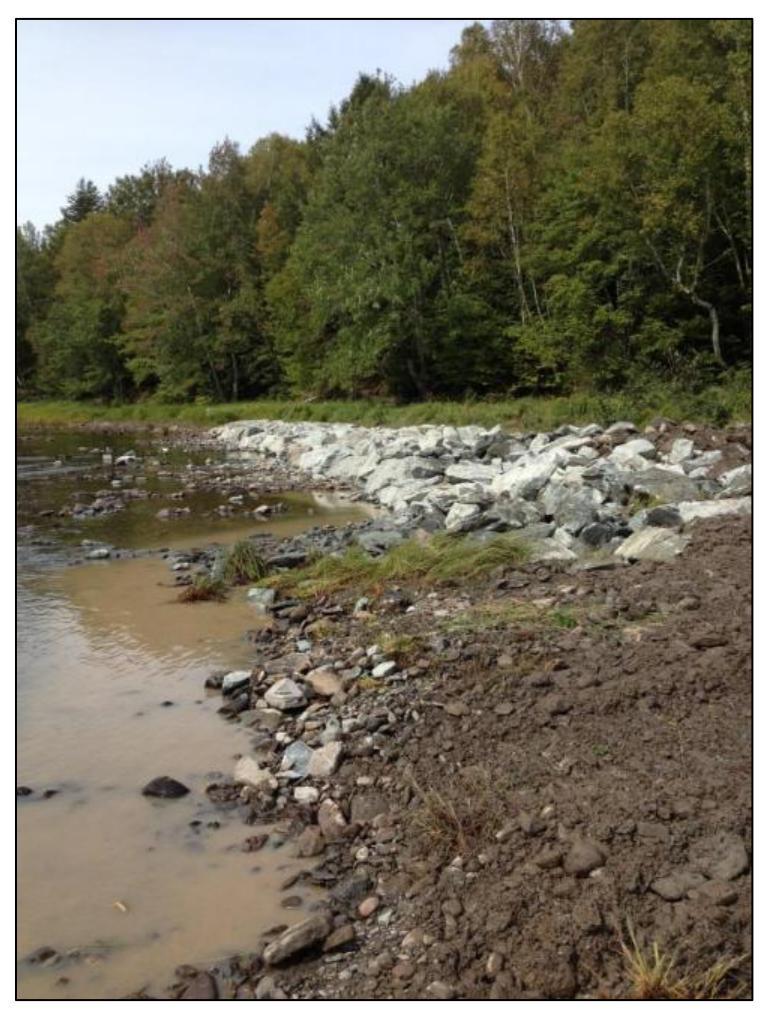
Figure 10. Some bank protection installed at Site 5 of this project.

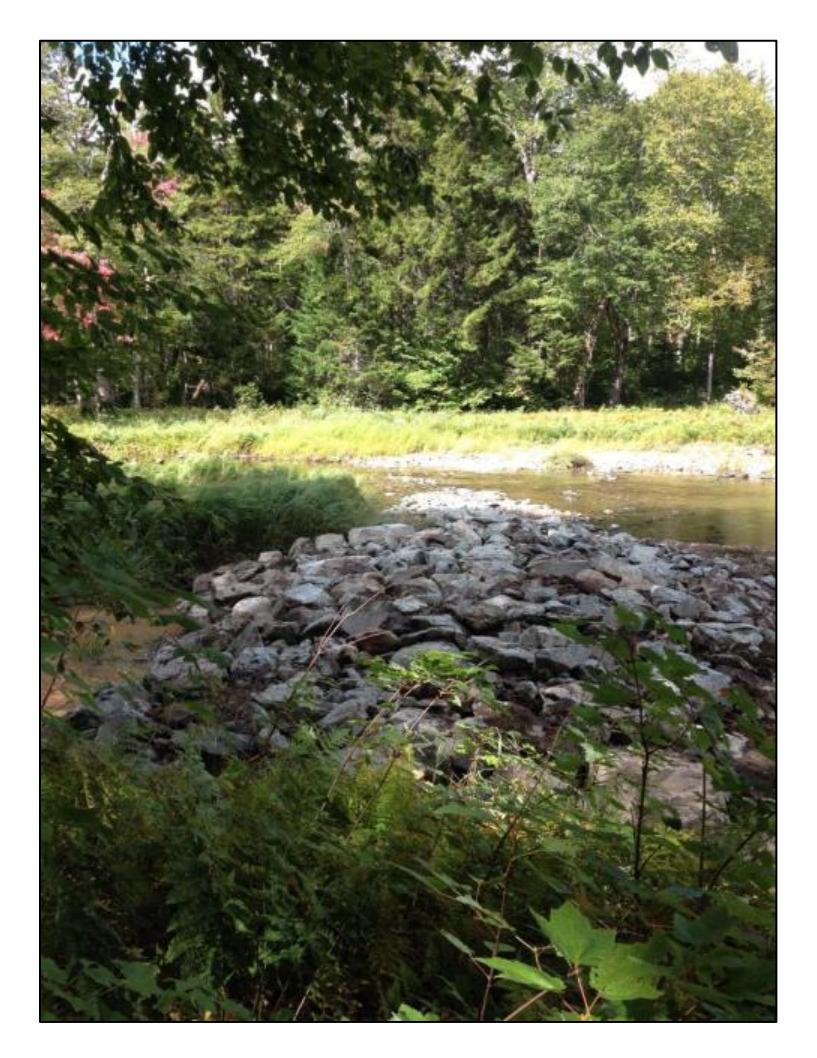
Figure 13. Rock sill with channel blocker site 5.

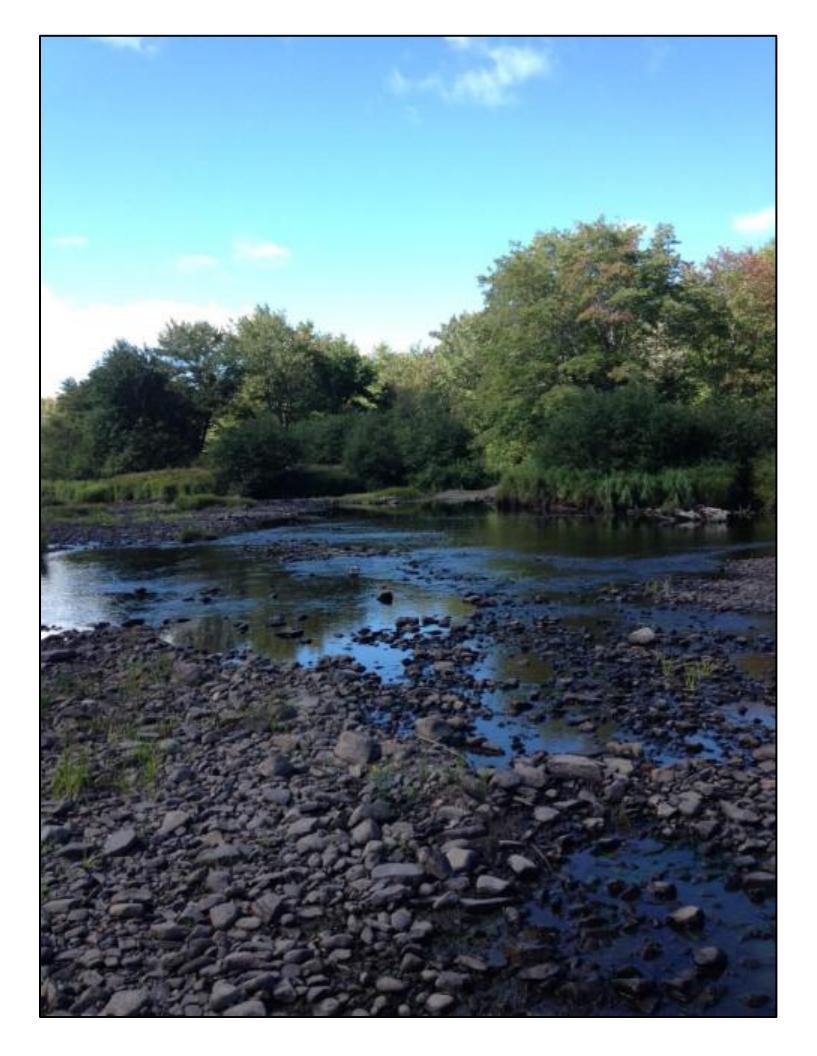
Figure 1. Lower Bryden's Brook, below Site 1. This site has been identified as critical habitat to restore. Access to this site will be difficult as it is approximately 1400 m from the road to the site, 400 m of which is across old farm field, now scoured by floods. This site is similar to ones where there is a very wide channel and lack of pools.

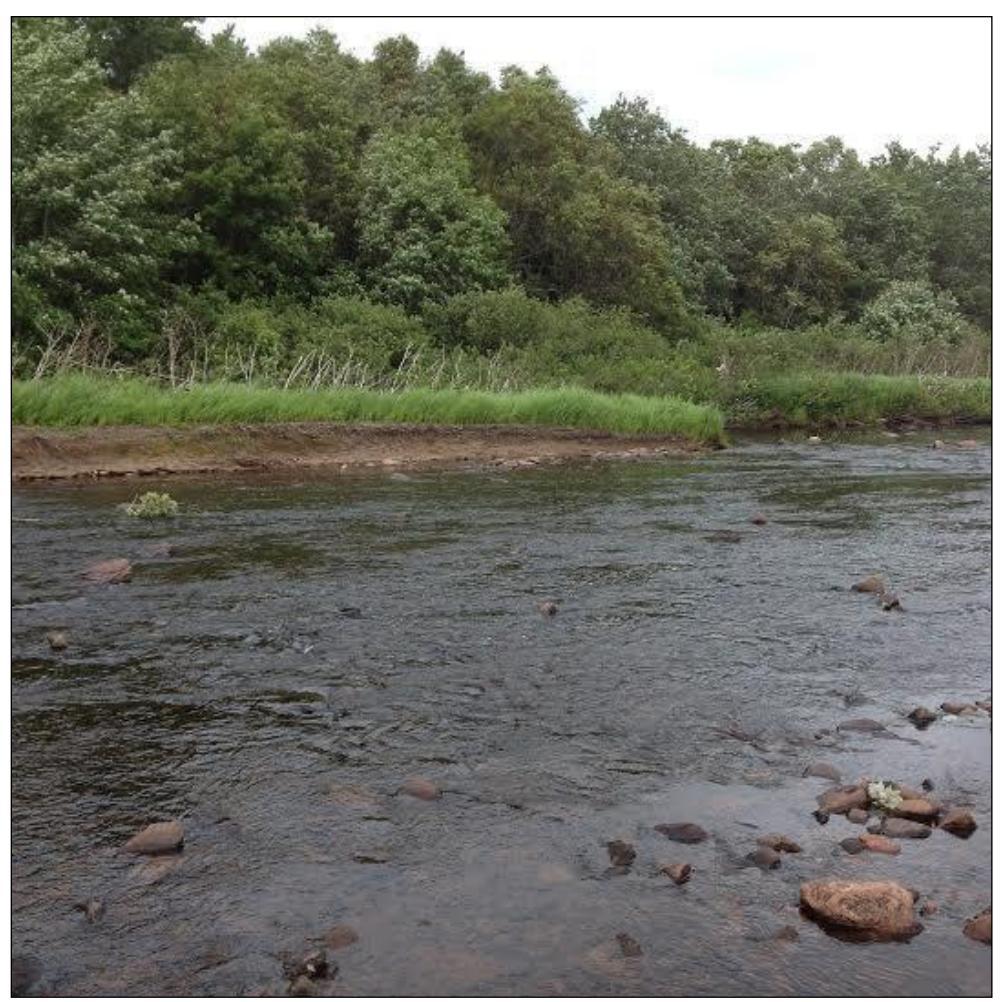
Figure 2. This site is at Upper Bryden Brook, about 600 metres downstream of Site 2. A holding pool will be created at this site as the existing pool is only a metre deep and 12 square metres. A series of rock sills will also be constructed and a breech will be repaired.

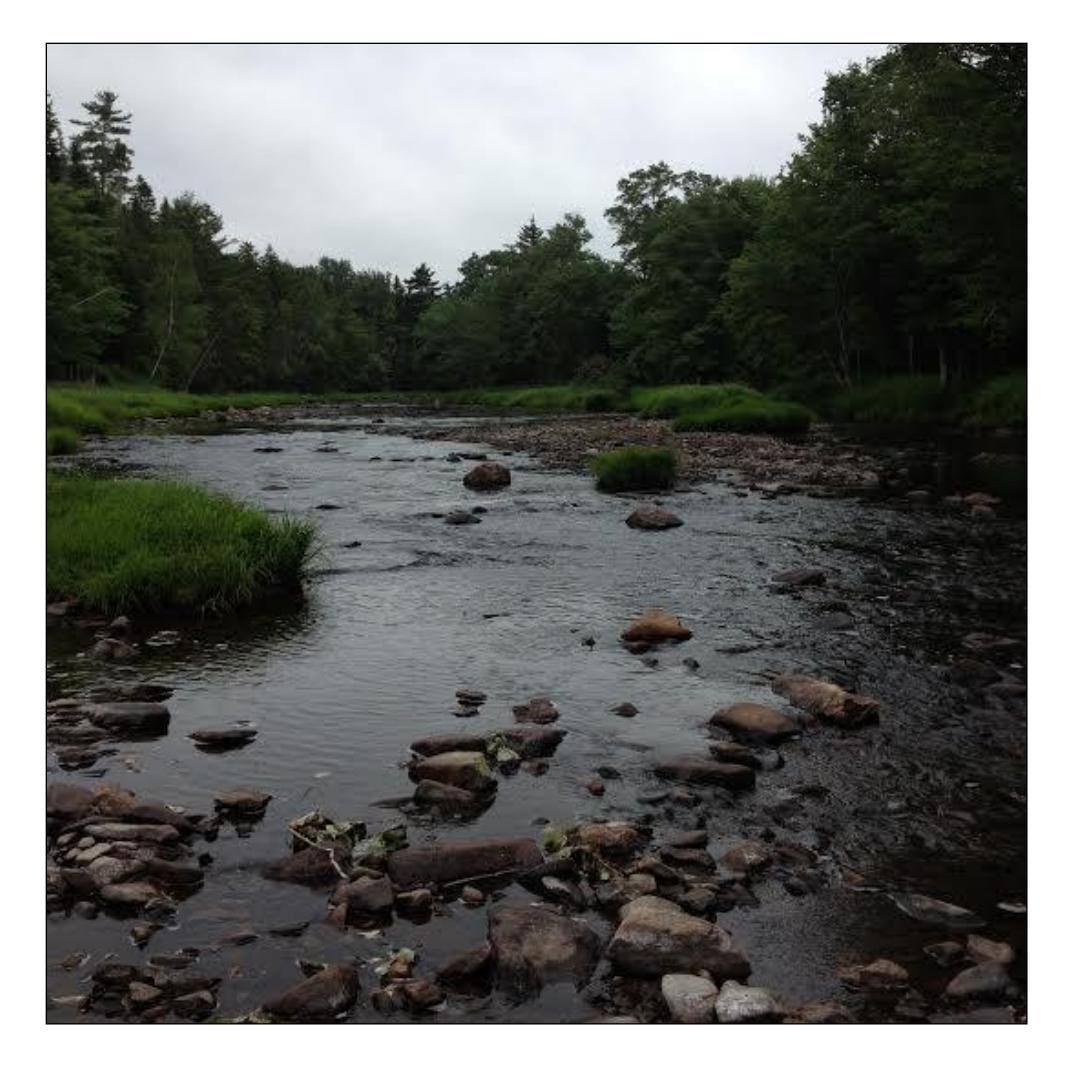
Figure 4. This picture was taken about 400 metres downstream of Site 2. This is a typical over-widened channel, with a wetted width of about 45 metres. A series of rock sills will be installed here as well as a series of deflectors to help narrow the river and encourage it to stay in one channel downstream. There are also several breeches in this area, which will need to be repaired.

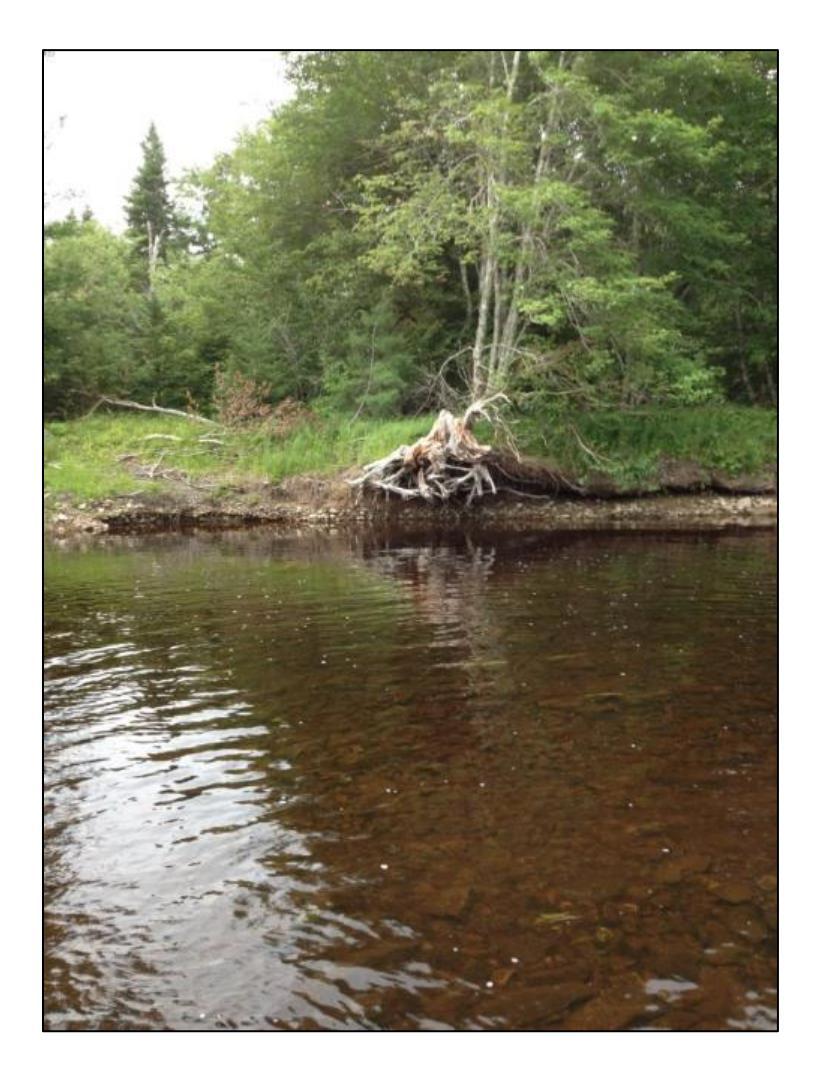
Figure 5. Site where deflector will be installed.

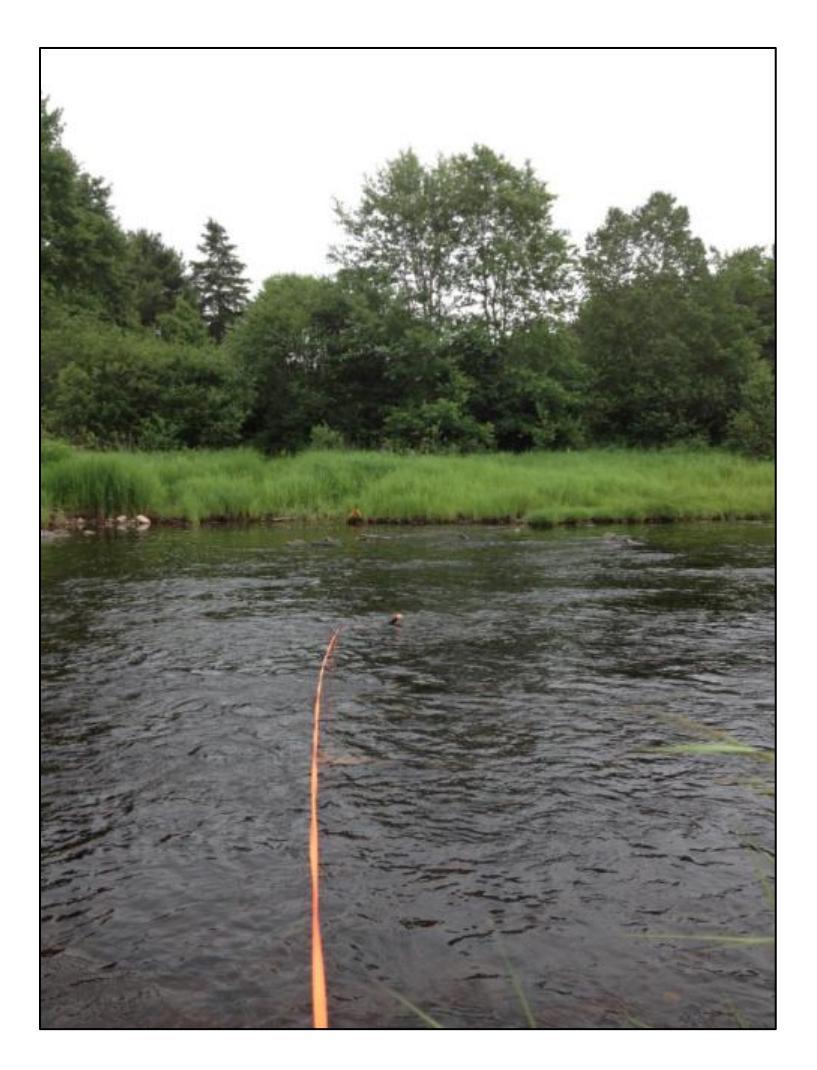
Figure 7. A sill will be constructed here.

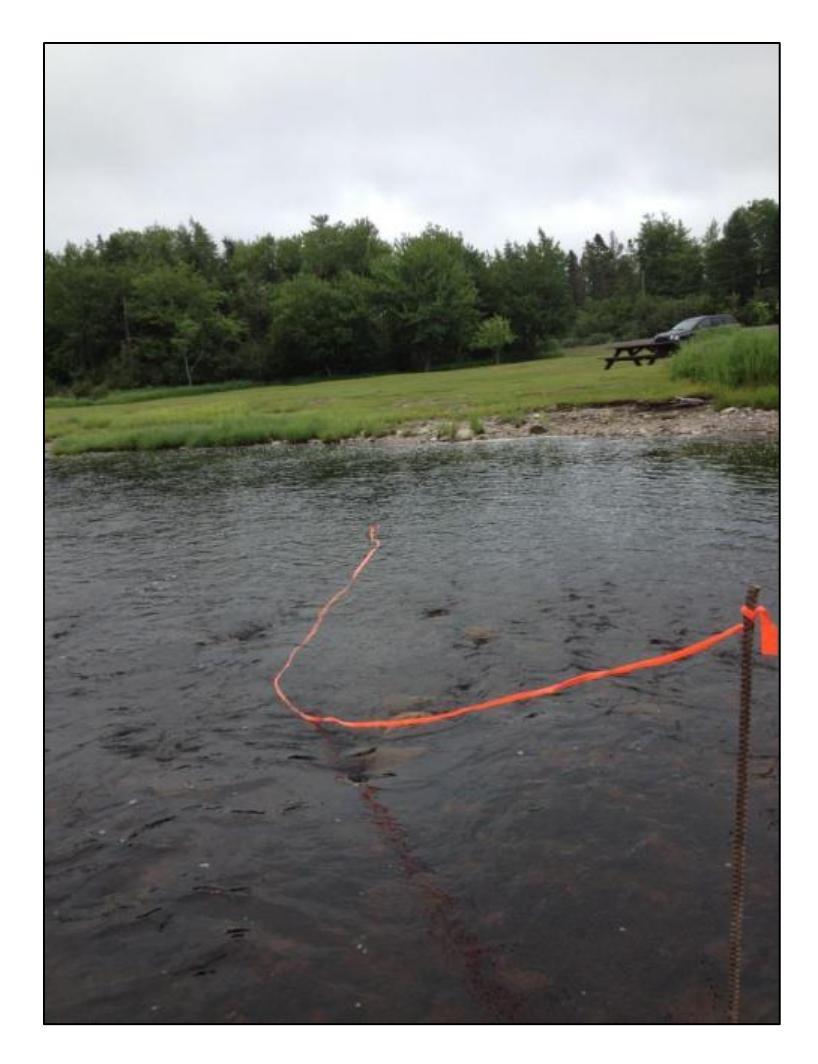
Figure 8. This is just below where the sill will be constructed. Note that the flow is directed toward the bank due to a diagonal bar; therefore, bank protection is required and a rock sill was installed to restore channel flow to the middle of the stream.

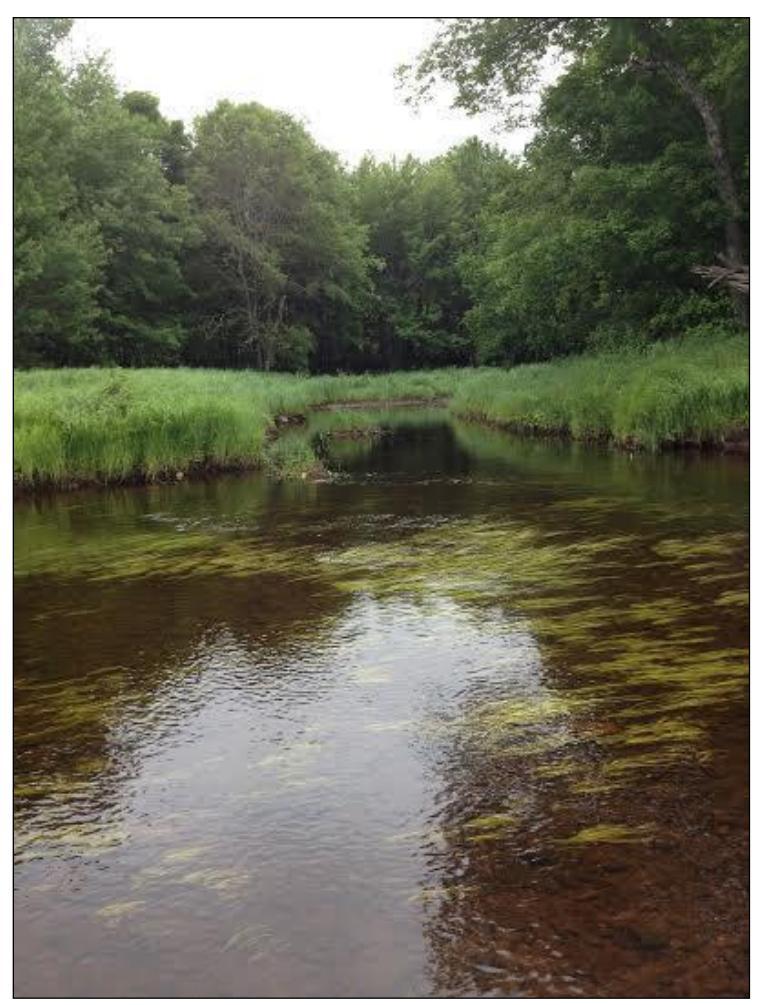
Figure 9. This is one of the channel breeches. It is on the left bank looking downstream. It is six metres wide and will require a channel blocker.

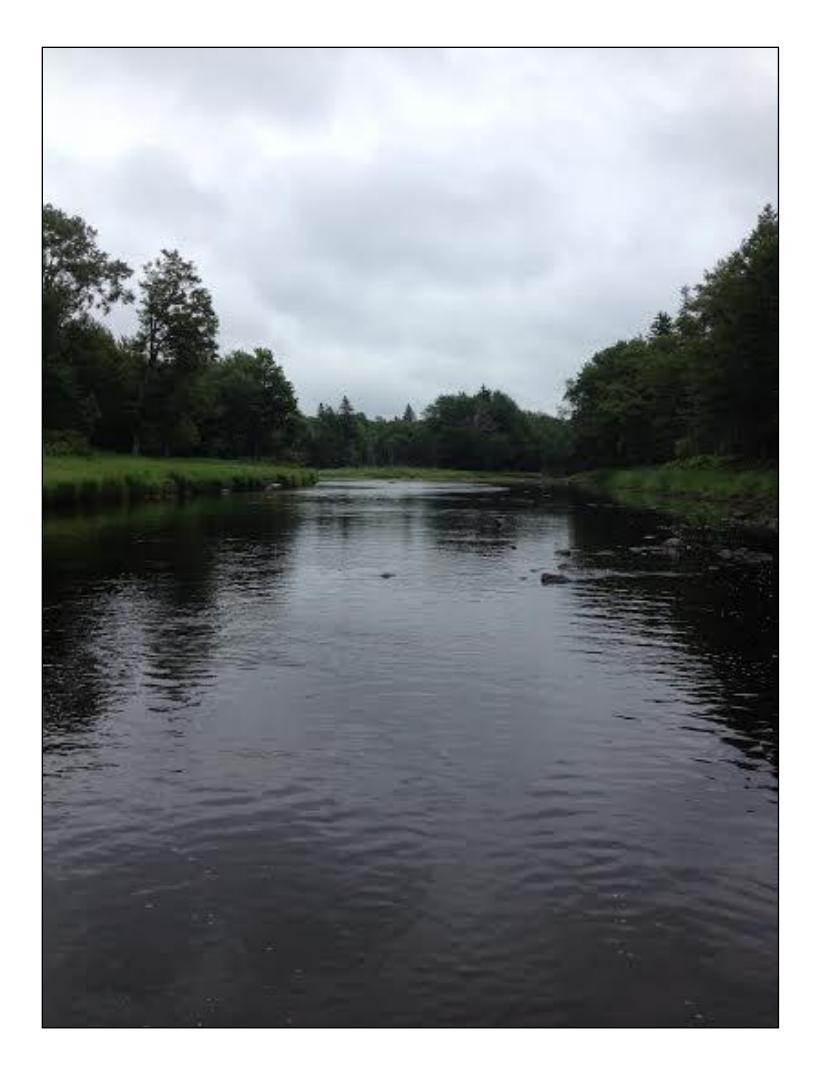
Figure 10. This picture is looking downstream towards the channel breech, which is on the true right side.

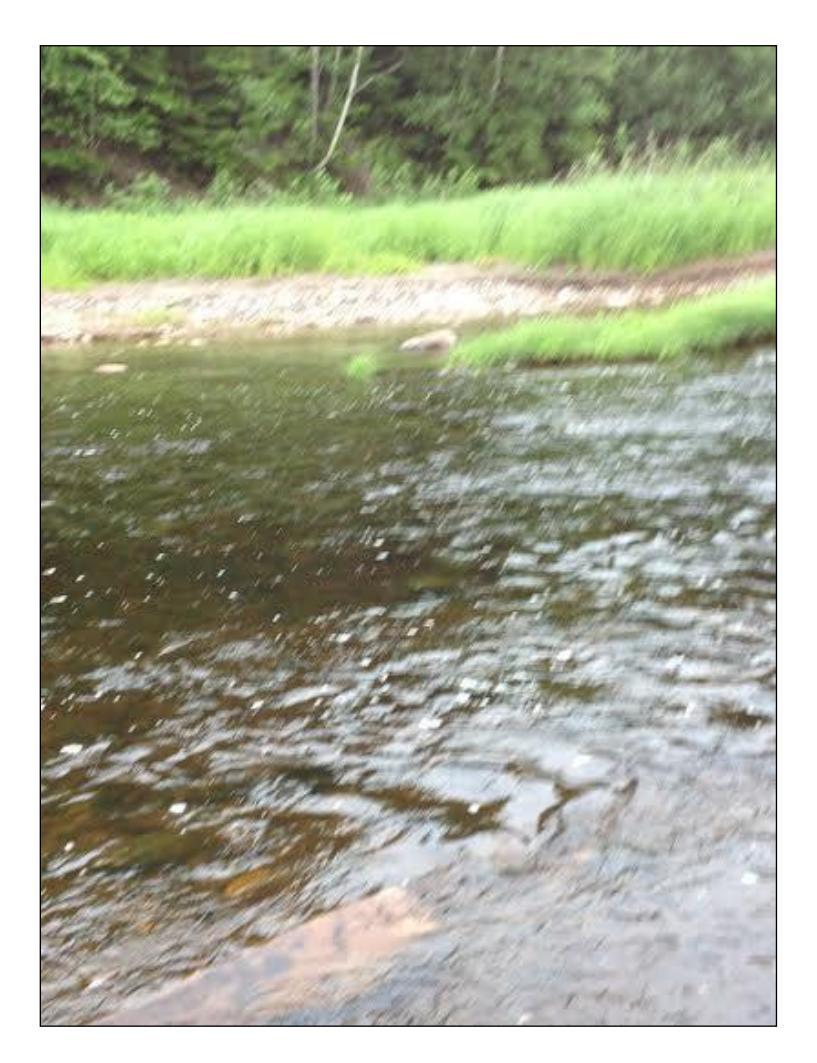
Figure 14. Before picture. This is a site requiring a sill. It is at the end of the access road. Additional rock will be required here to tie the sill into the eroding bank. The wetted width is 28 metres here, which is about double what it should be.

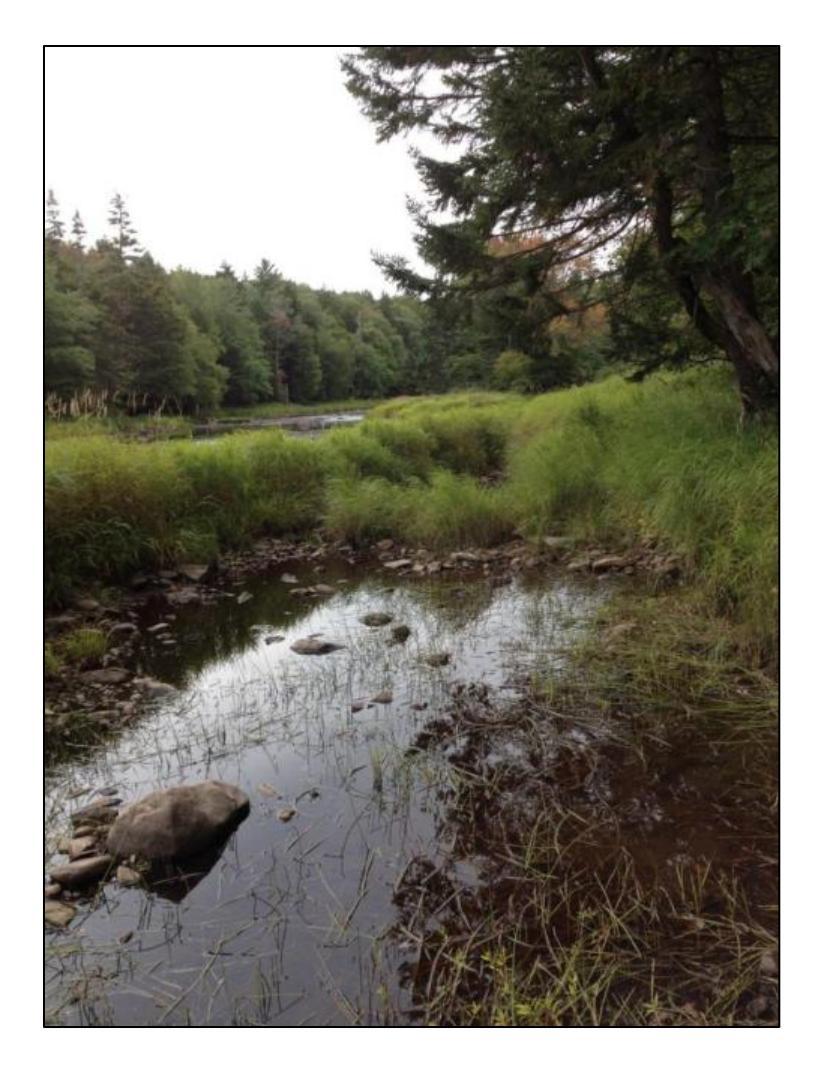
Figure 15. Before picture of the channel breech below where sill two will be constructed.

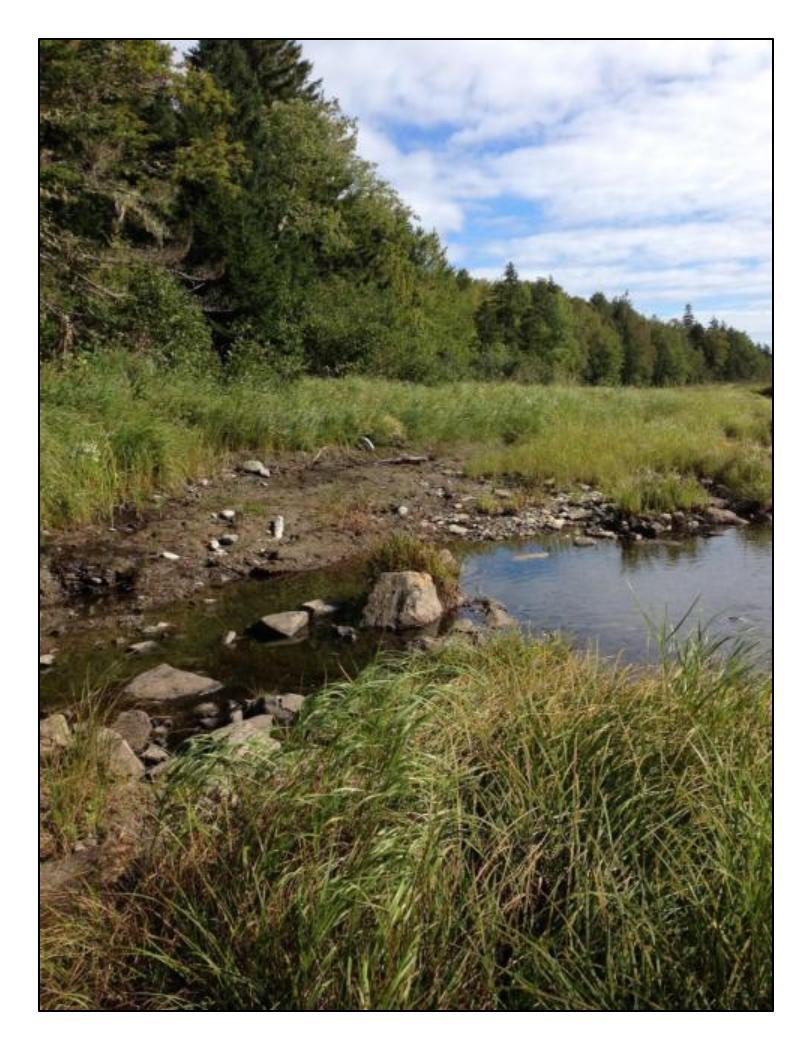
Figure 16. Before picture of above where sill three is to be constructed. Bank needs recurving towards the sill.

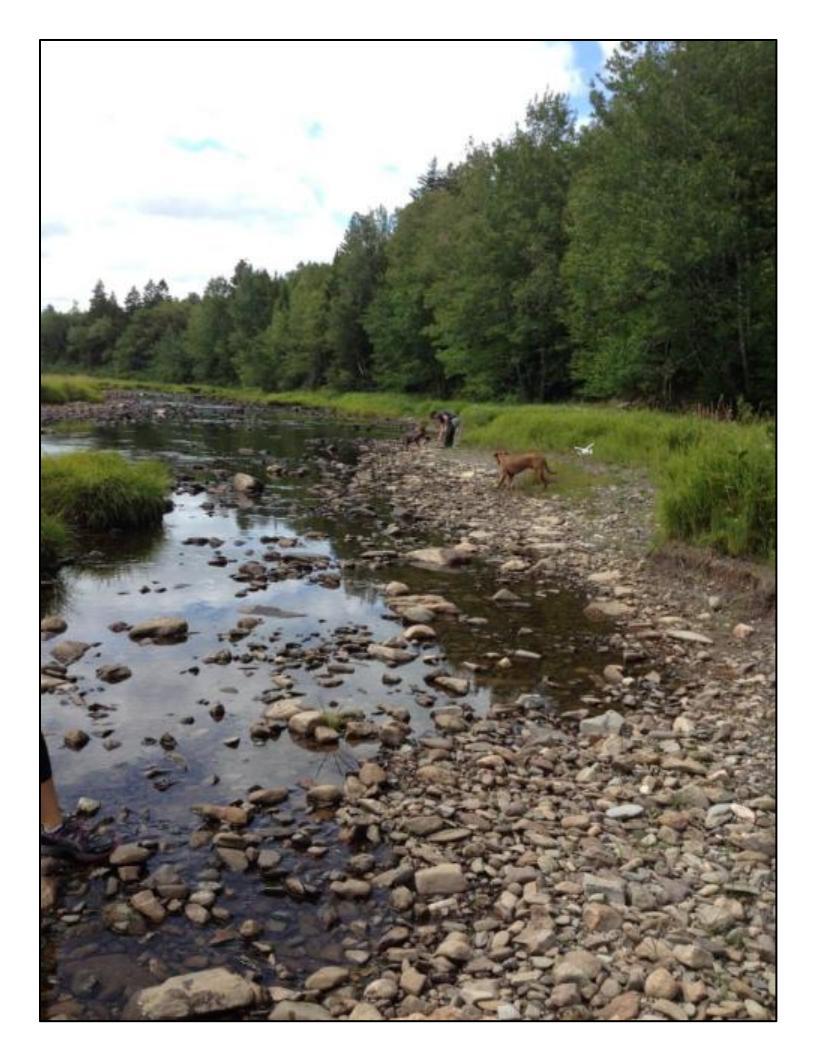
Figure 17. This is just below where sill number three will be placed.

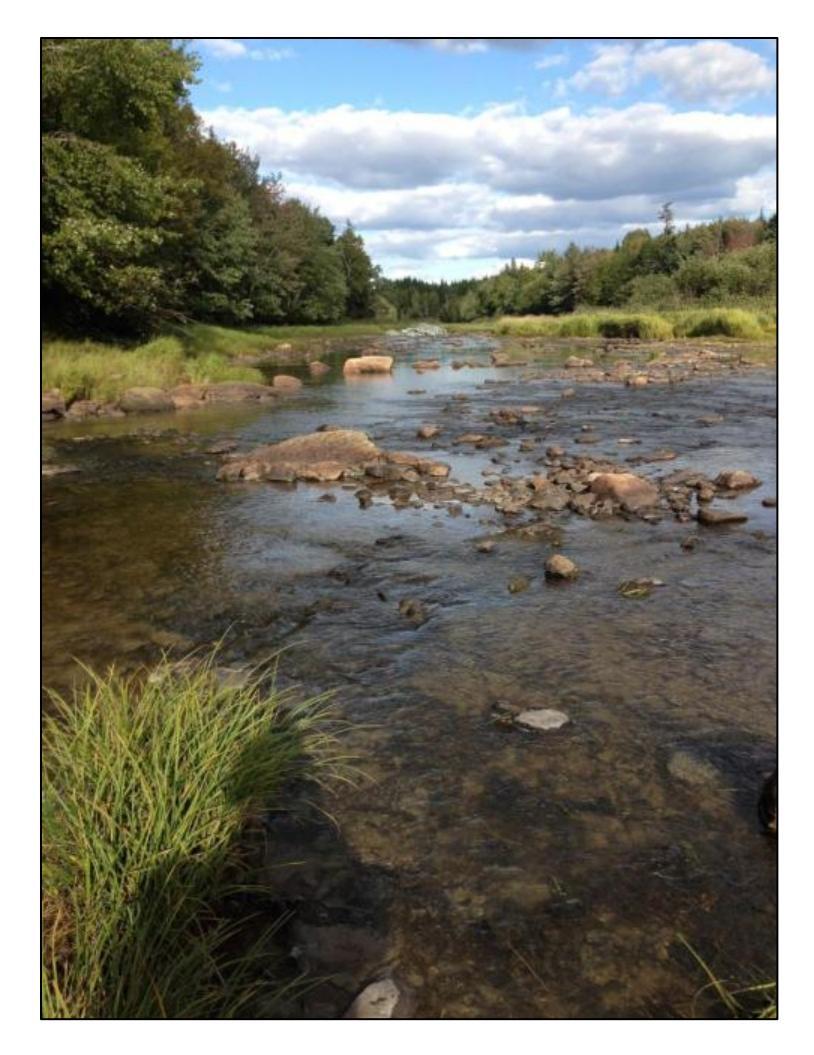
Figure 18. Before picture of below where sill four is to be constructed. Note that the large rock is buried in gravel.

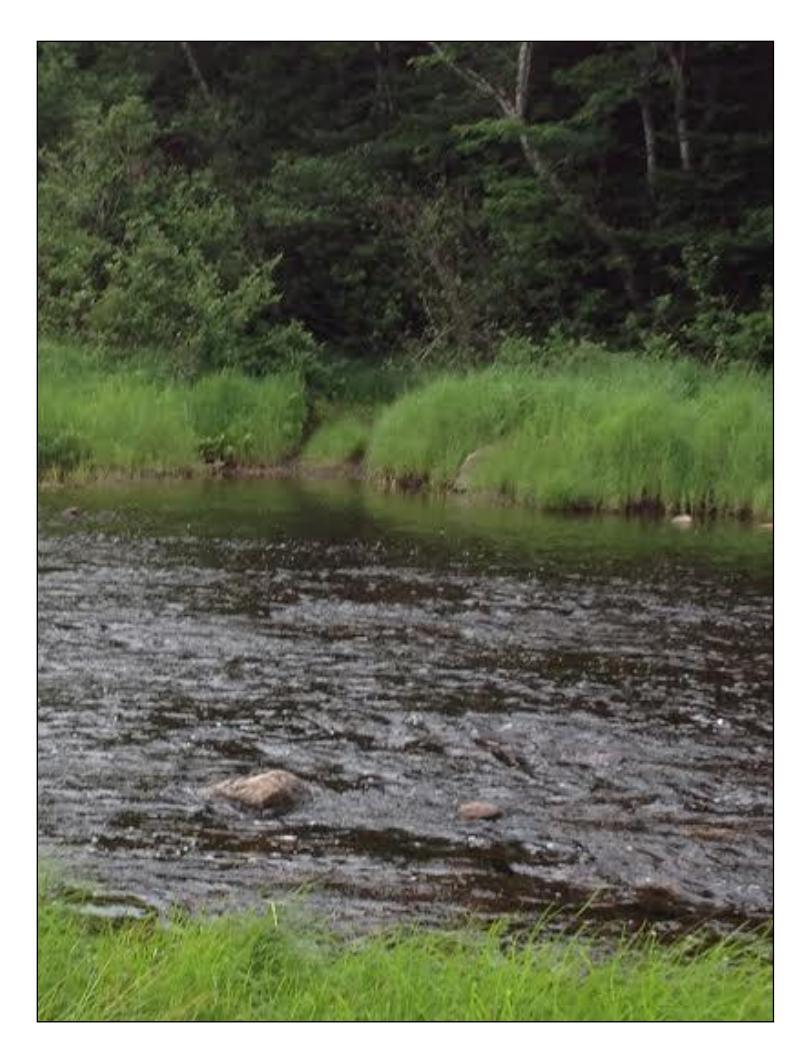
Figure 19. This is a Fording (crossing) site where access will need to be blocked. A rock sill will be constructed in this location.

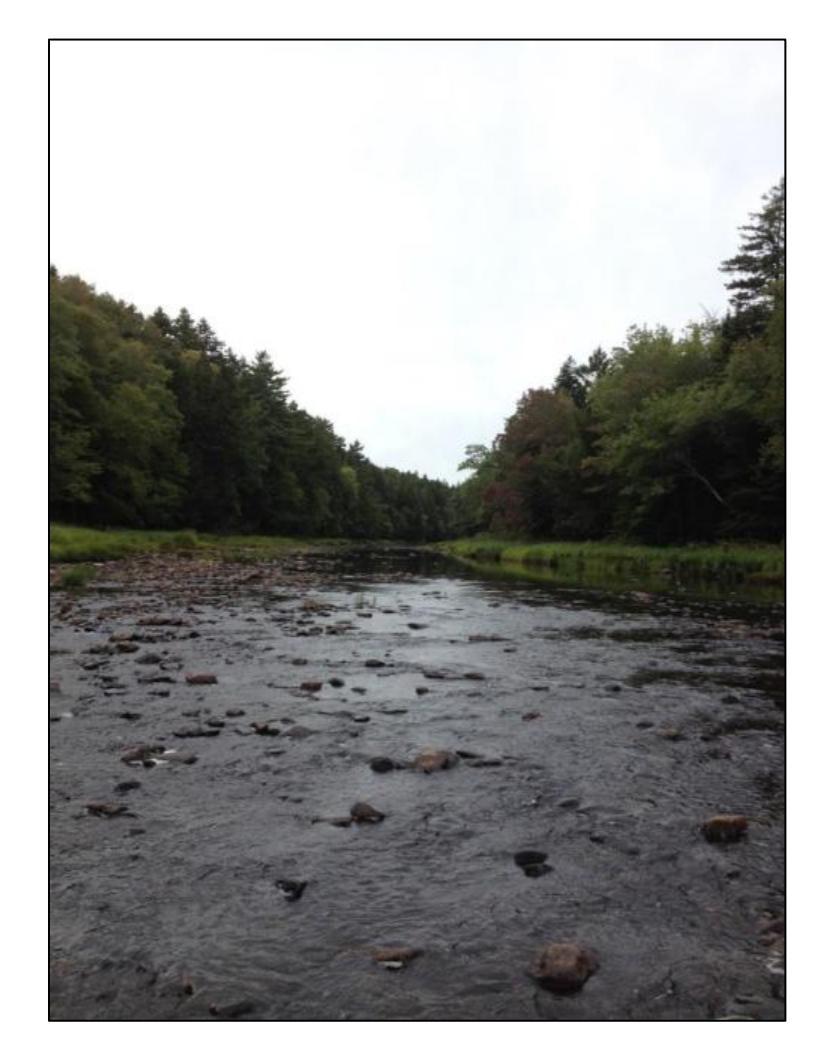
Figure 20. This site is 65 m wide at low flow. It will require a reconstructed point bar with groynes built into it. Major excavation will be required. Work on this site alone will likely cost \$50,000. Much of the upper river looks like this the exception of areas with bedrock.

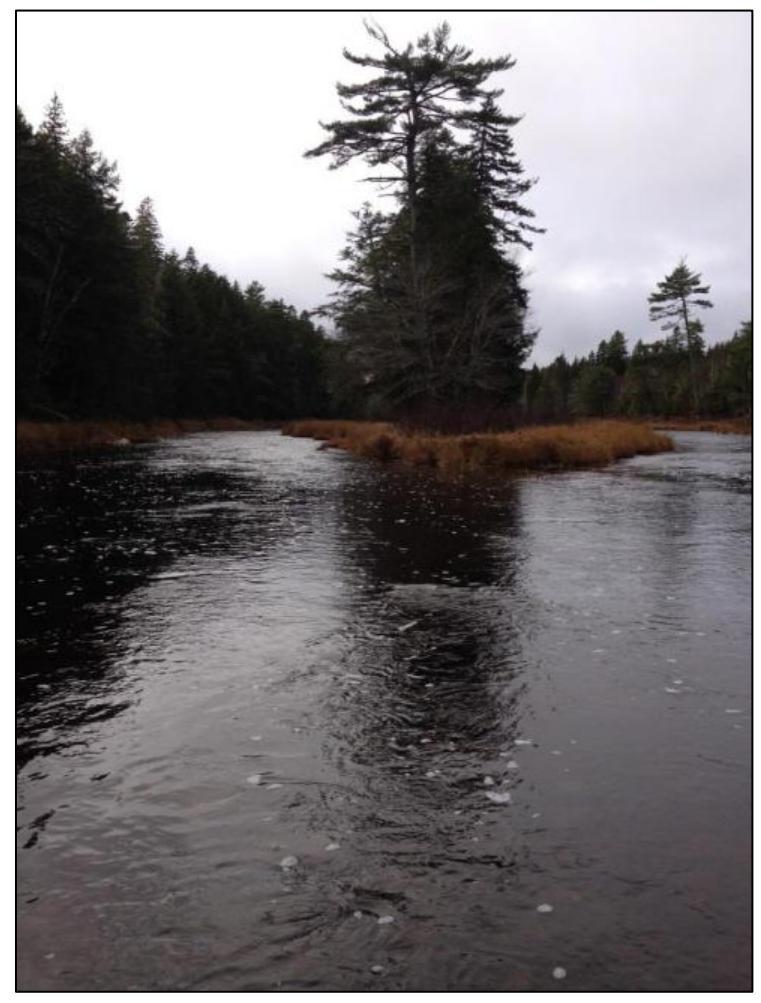
Figure 21. Mid-channel islands, which are typical in the upper West branch. These complicate the restoration design process and increase costs. Sills and bank work will be required, with deflectors below each sill to develop point bars and help narrow the channel to its proper width. Due to the variable conditions in these upper sections, additional surveying will be required prior to restoration work.

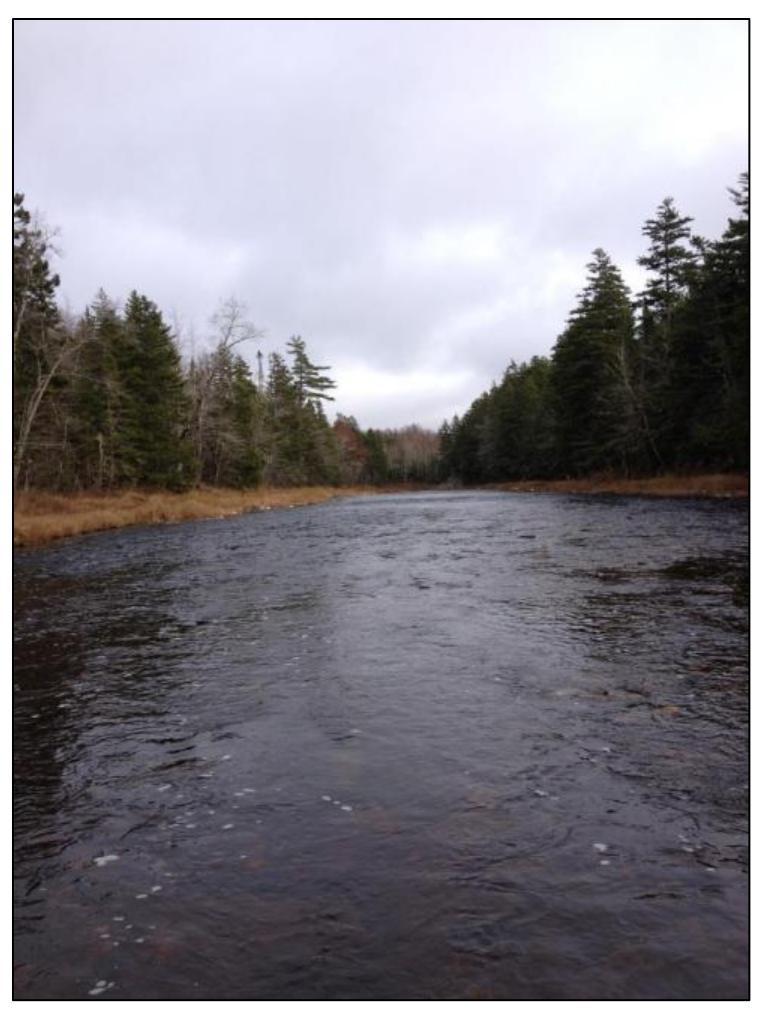
Figure 22. This is the typical view below mid-channel islands. The river is scouring around the islands and depositing bed load below them, developing very wide channels. There are also very confined bedrock sections, which are contributing to this problem.

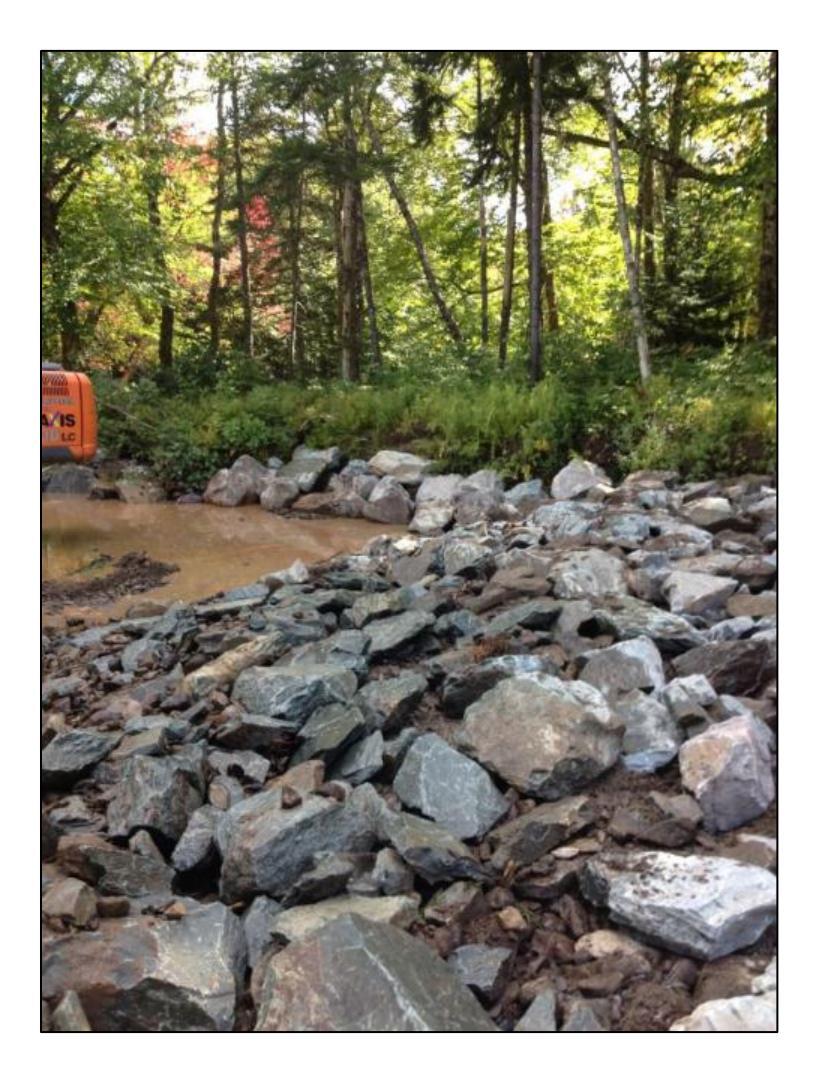
Figure 1. Channel blocker at upper sill.

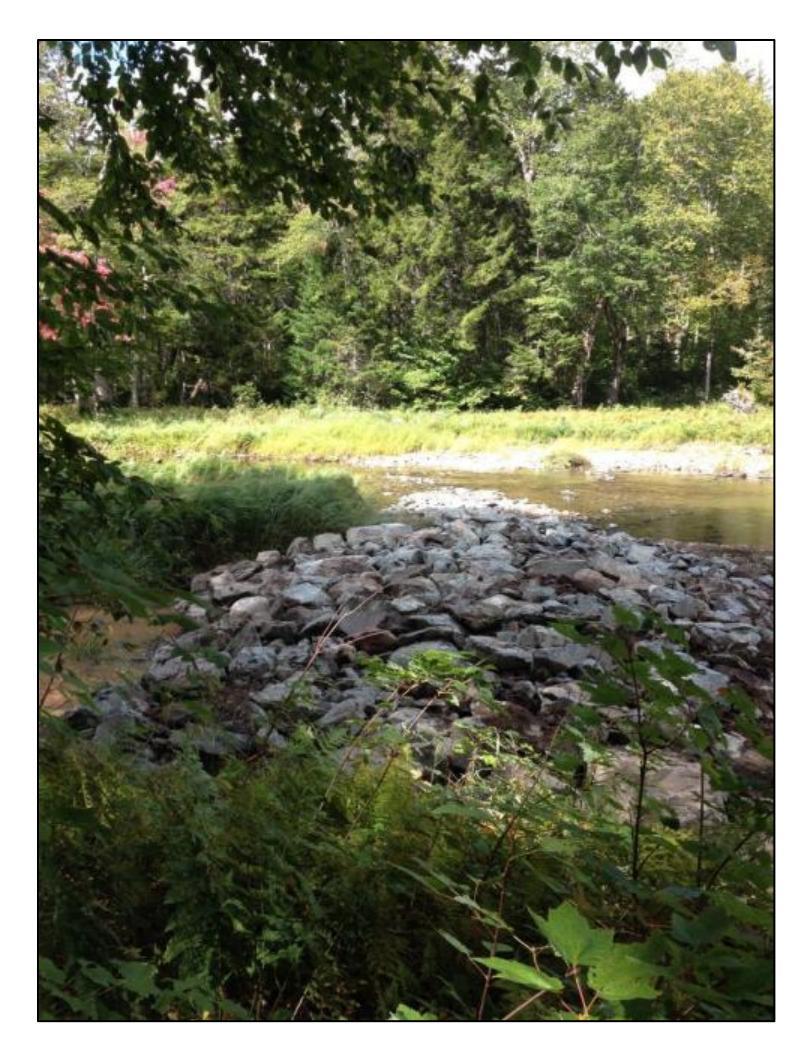
Figure 2. Rock sill with channel blocker at the upper sill (same as previous photo, but a different view).

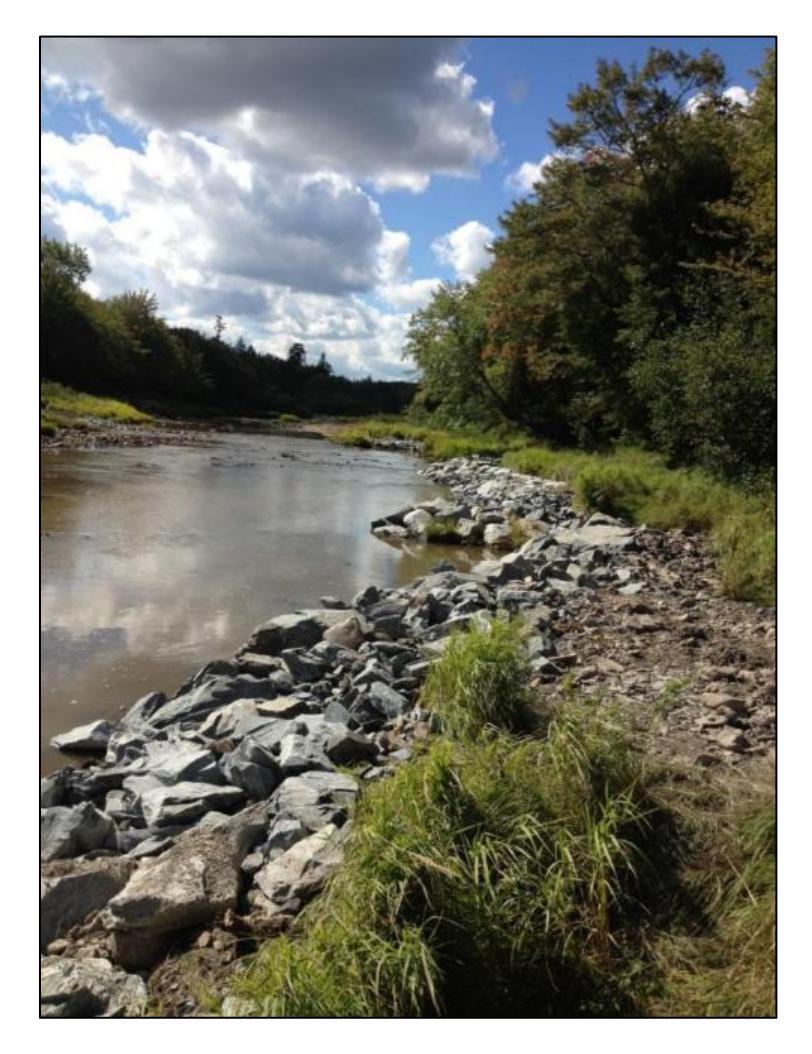
Figure 3. This is looking below sill number two, a deflector was constructed to re-profile the current to the middle of the river.

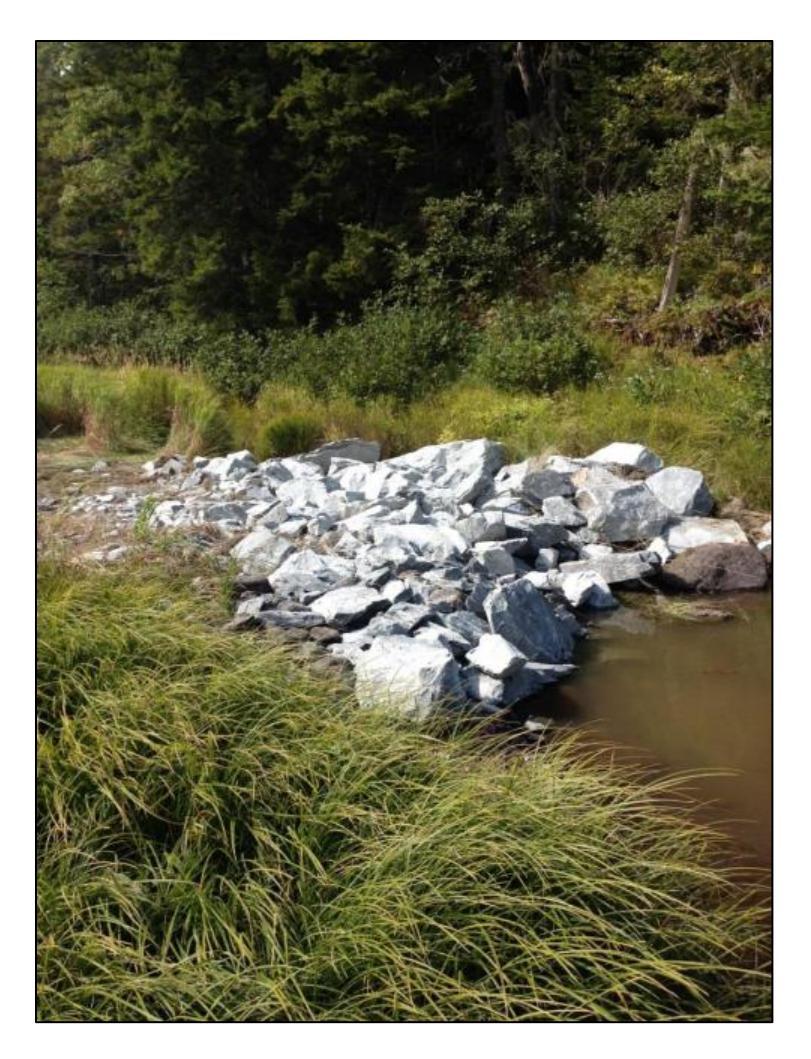
Figure 4. Channel breech repair below sill 2.

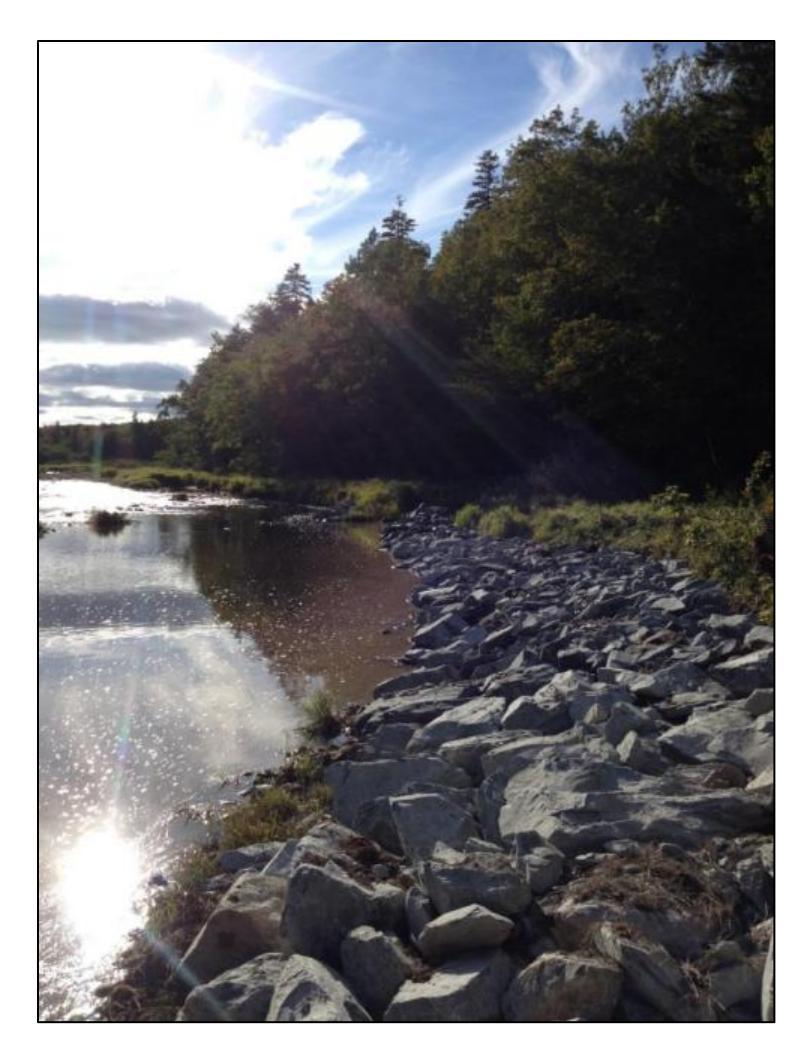
Figure 5. This is the bank work below sill two. Note the 4:1 slope on the bank instead of the normal 2:1 slope. This will assist in the planting of native trees and grasses later.
