# Restoration of the West Branch of the St. Mary's River

Report prepared for the Atlantic Salmon Endowment Fund of Fisheries and Oceans Canada

November 26, 2014 St. Mary's River Association Prepared by: Charlie MacInnis and Andrea Flynn

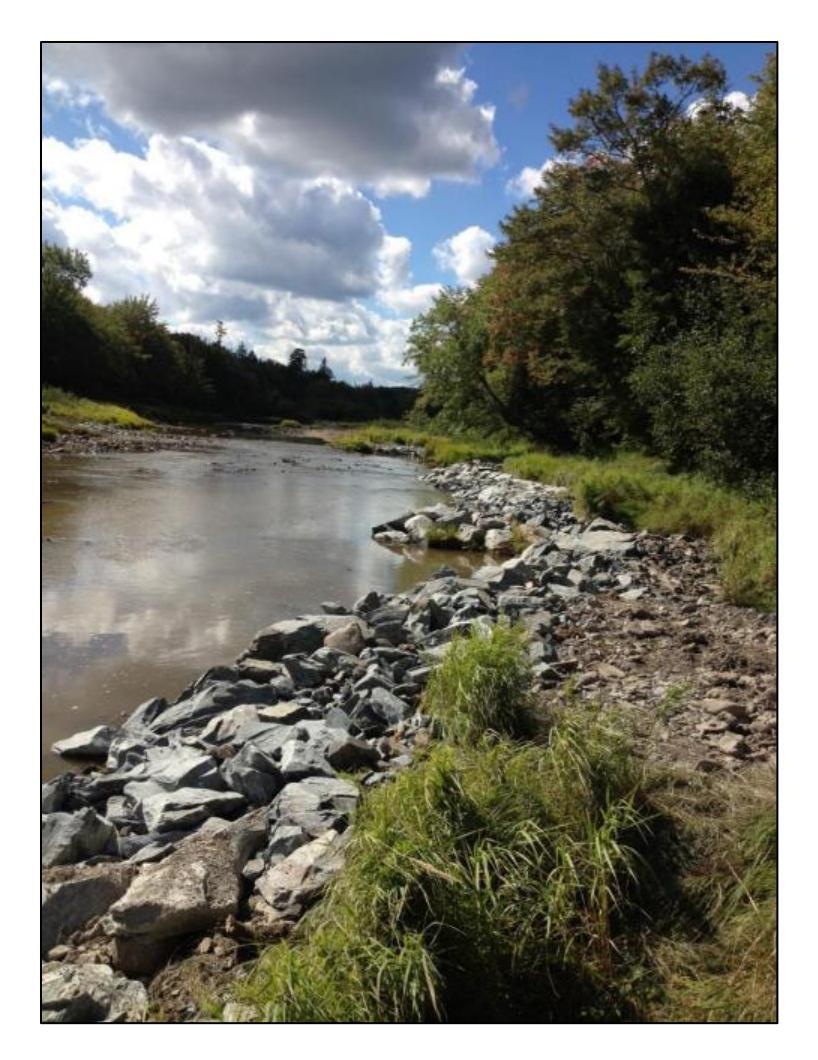
Figure 6. Deflector below sill 2.

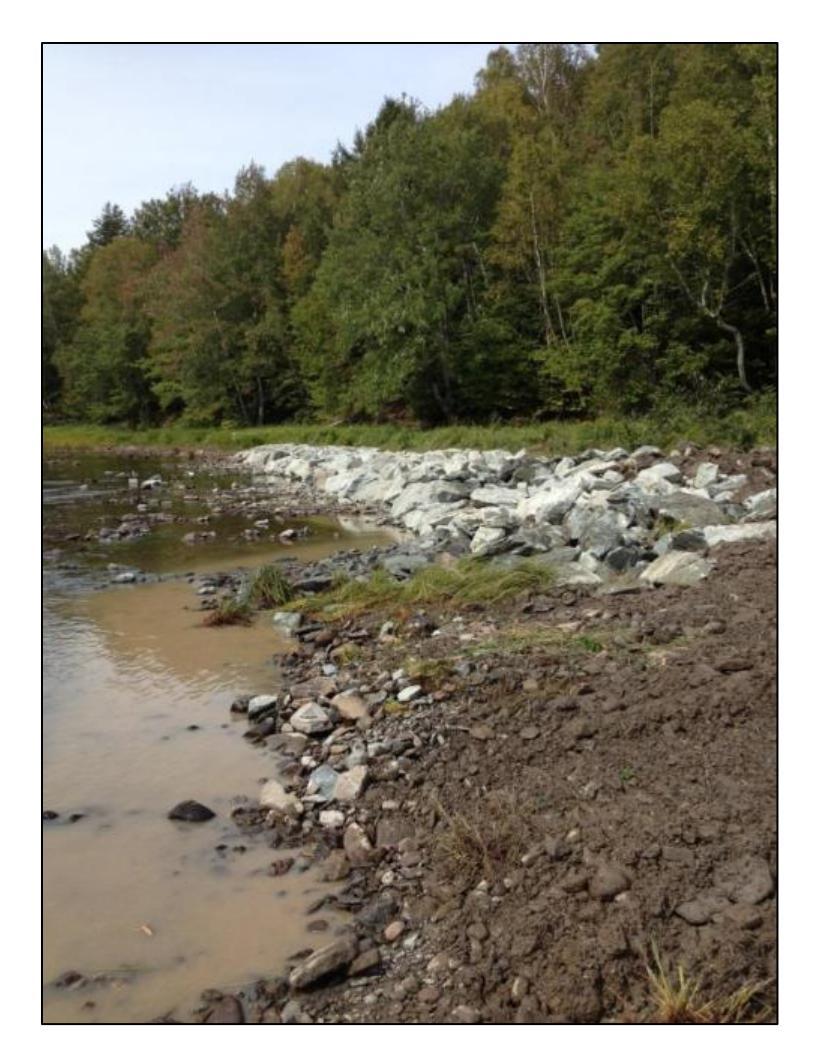
Figure 7. Sill number three. This site required a repair to a channel breech and reshaping on the channel.

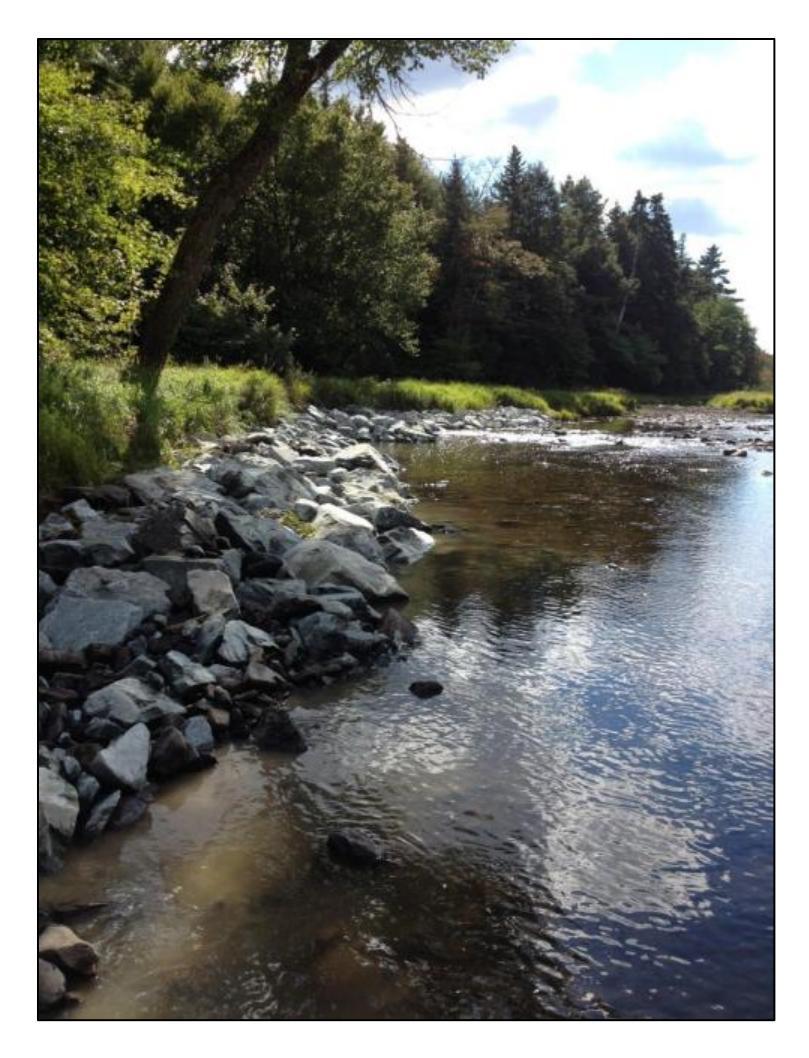
Figure 9. Below sill five. The bank has been re-profiled and a 3 m deflector is tied into the bank.

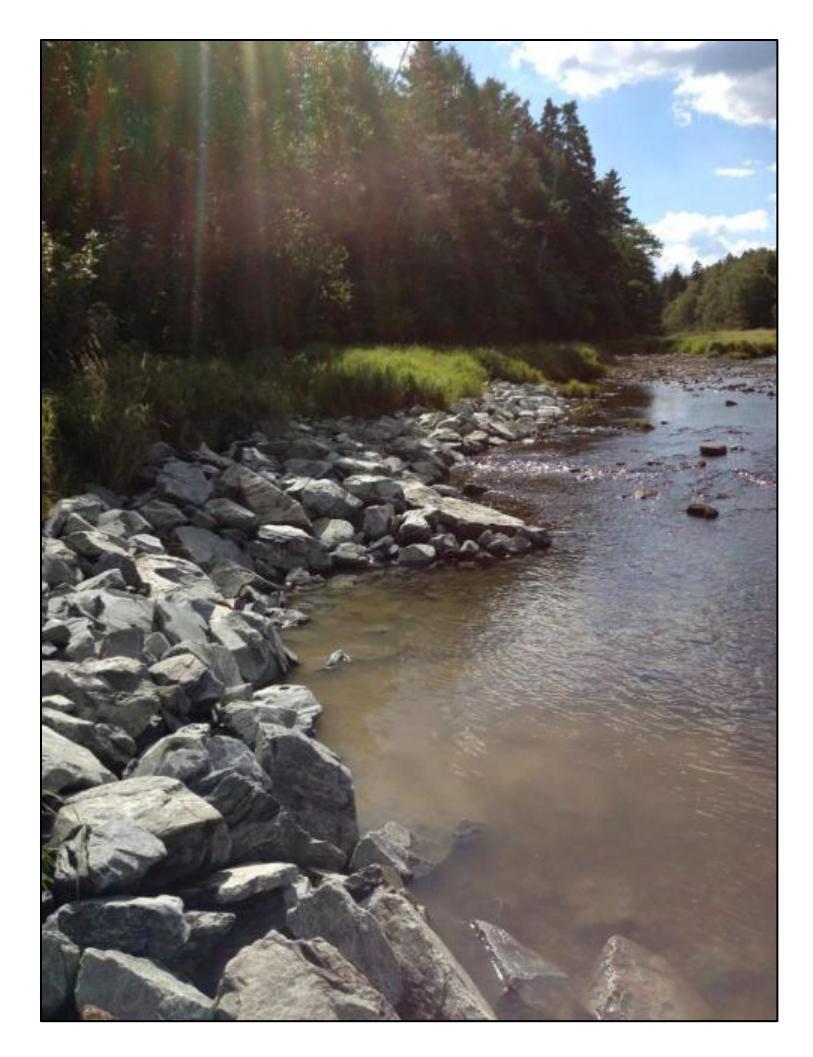
Figure 10. The deflector below sill five.

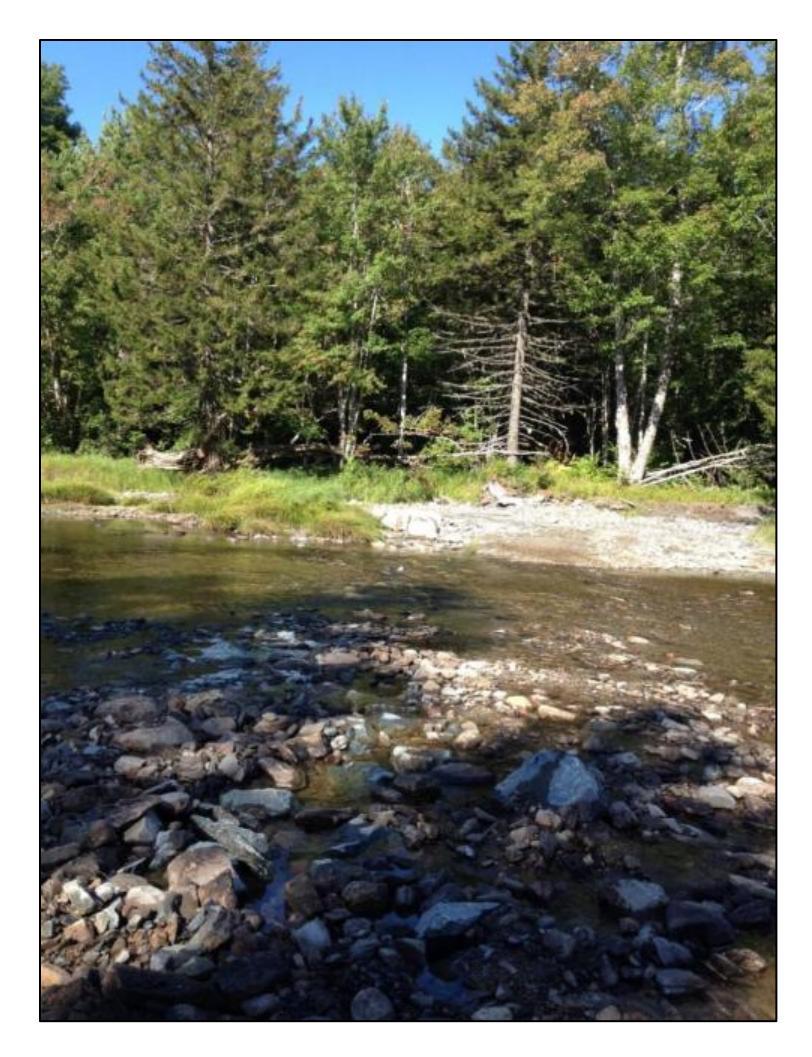
Figure 11. View across sill 6. Filled cobble into rock sill.

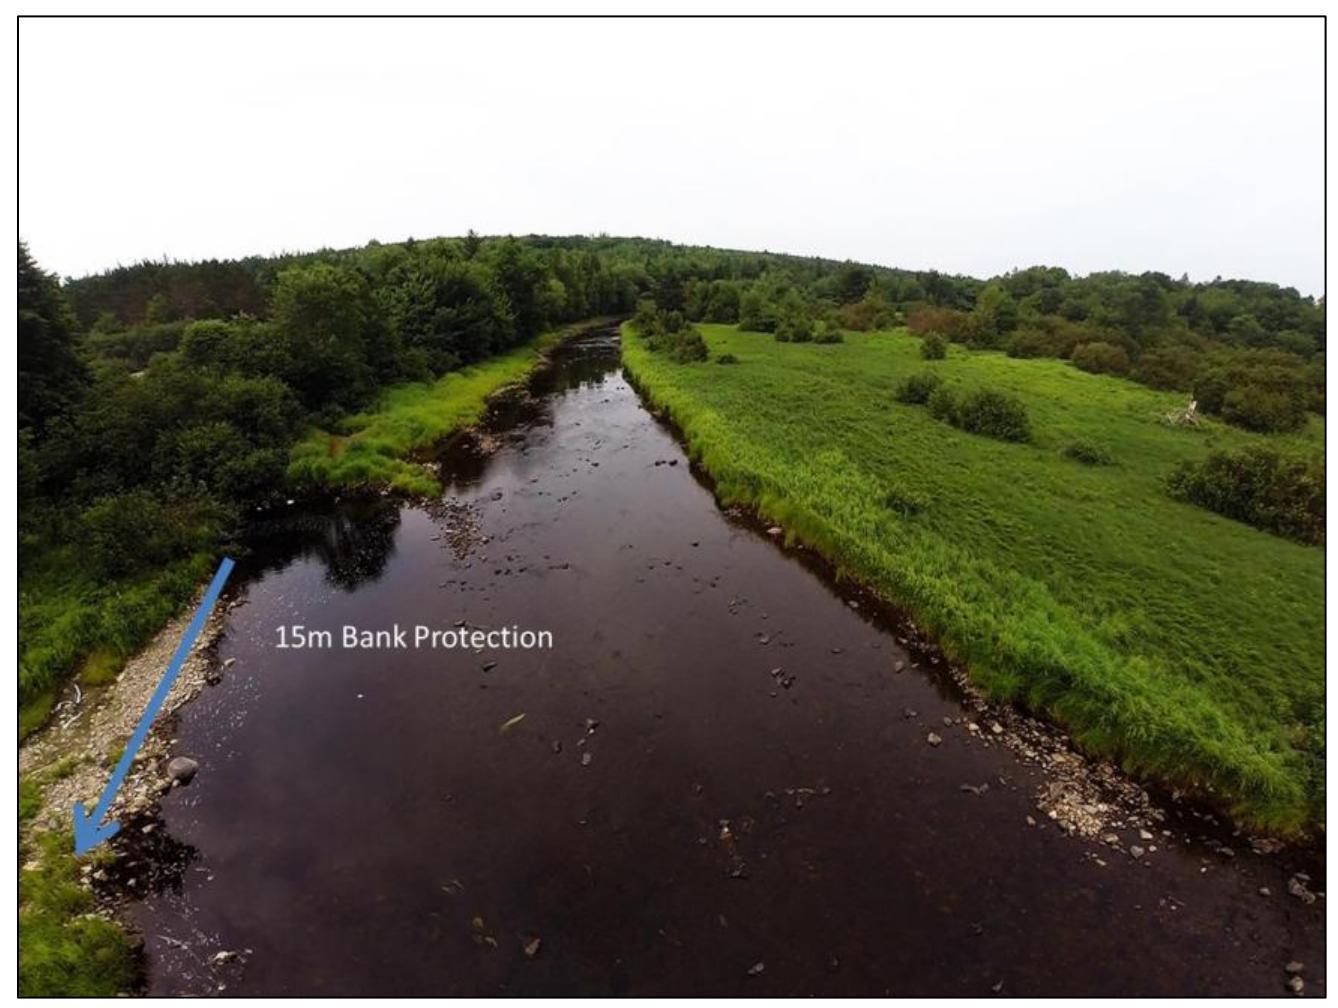
Figure 1. 15m of bank protection required.

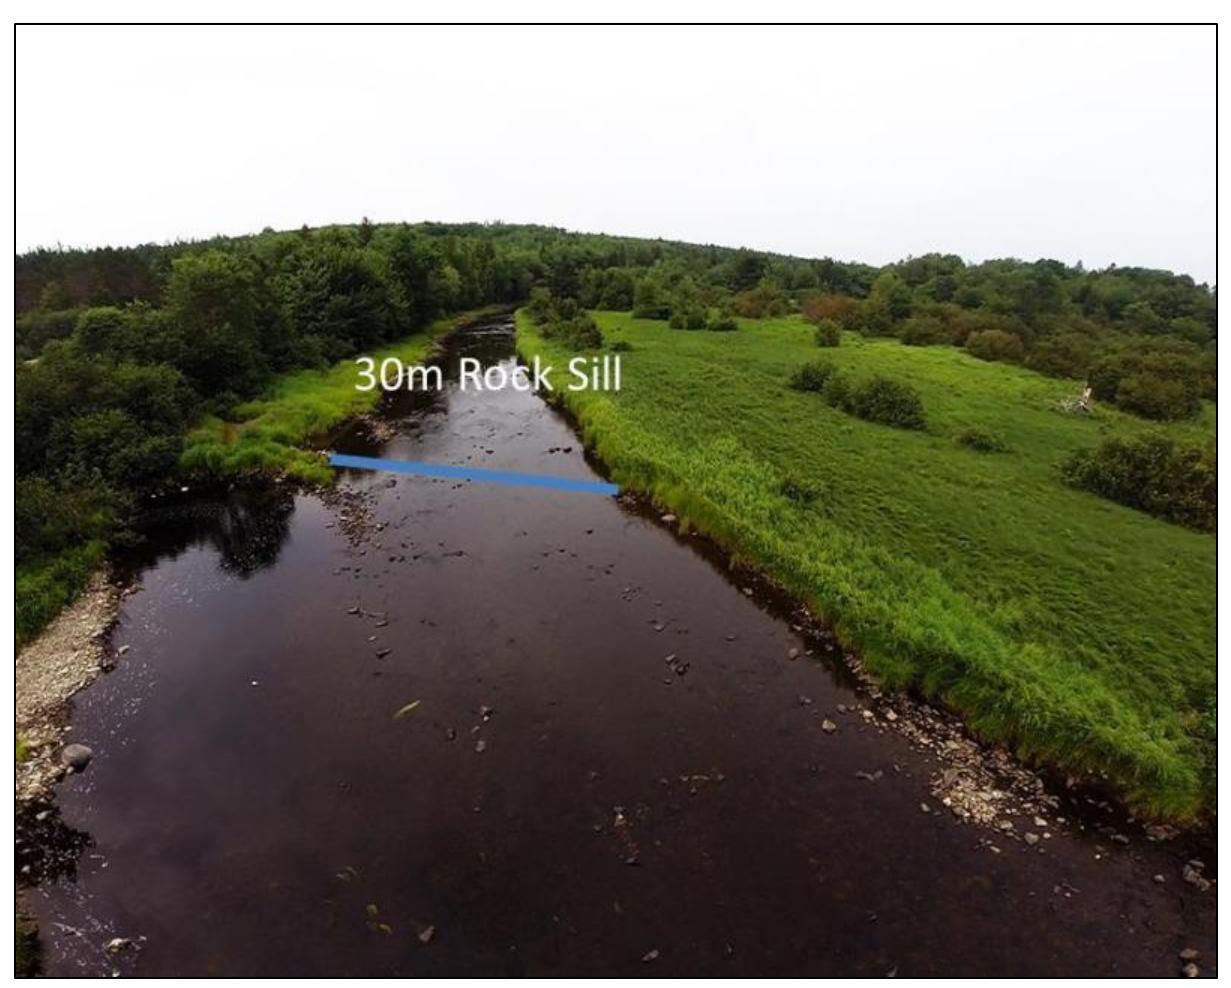
Figure 2. 30m rock sill required.

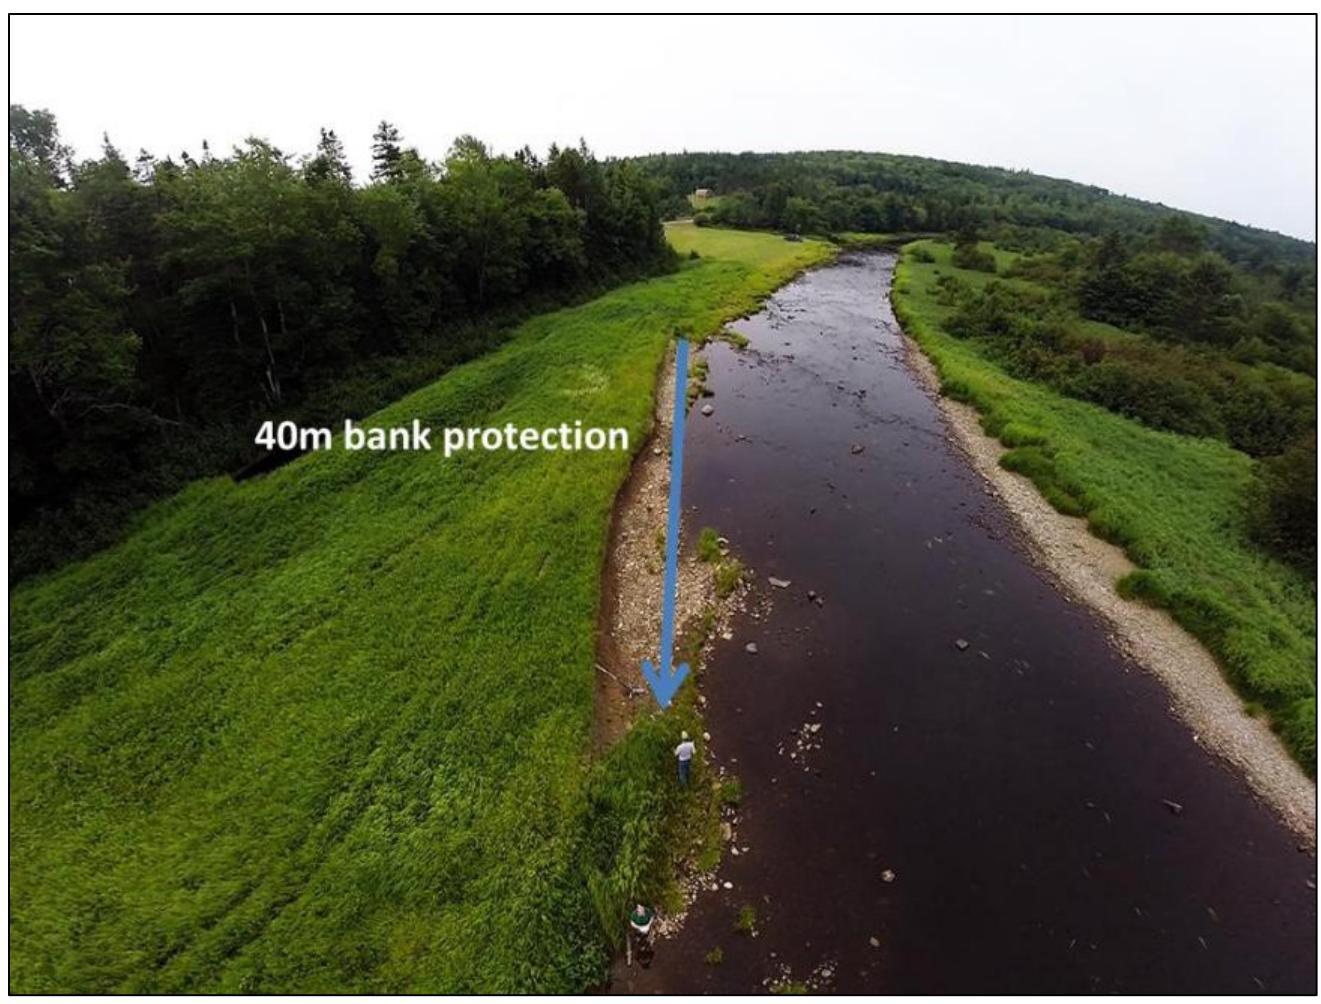
Figure 3. 40m of bank protection required.

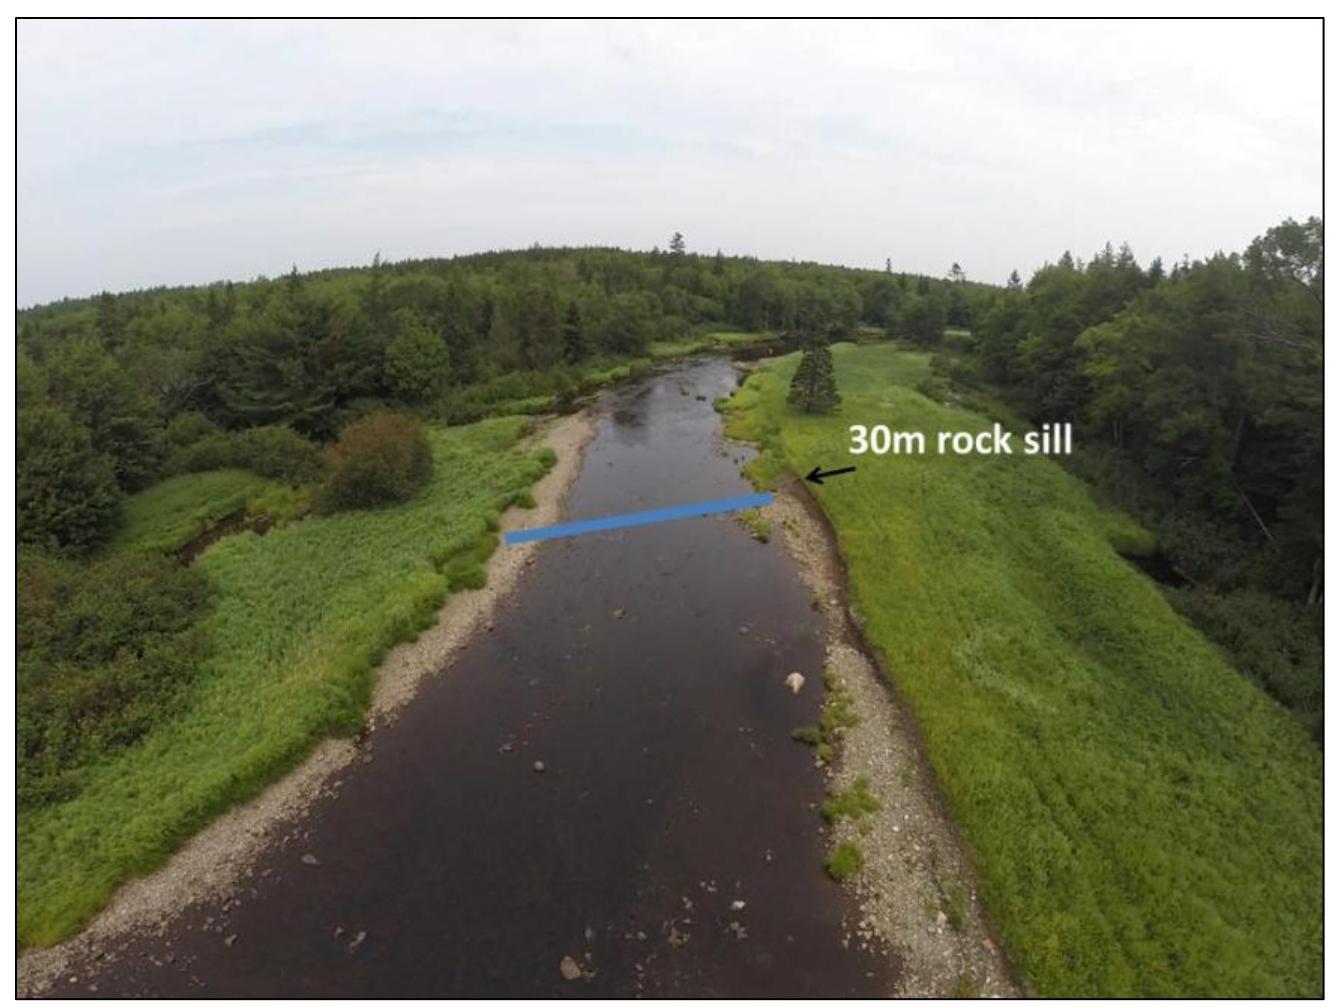
Figure 4. 30m rock sill required.

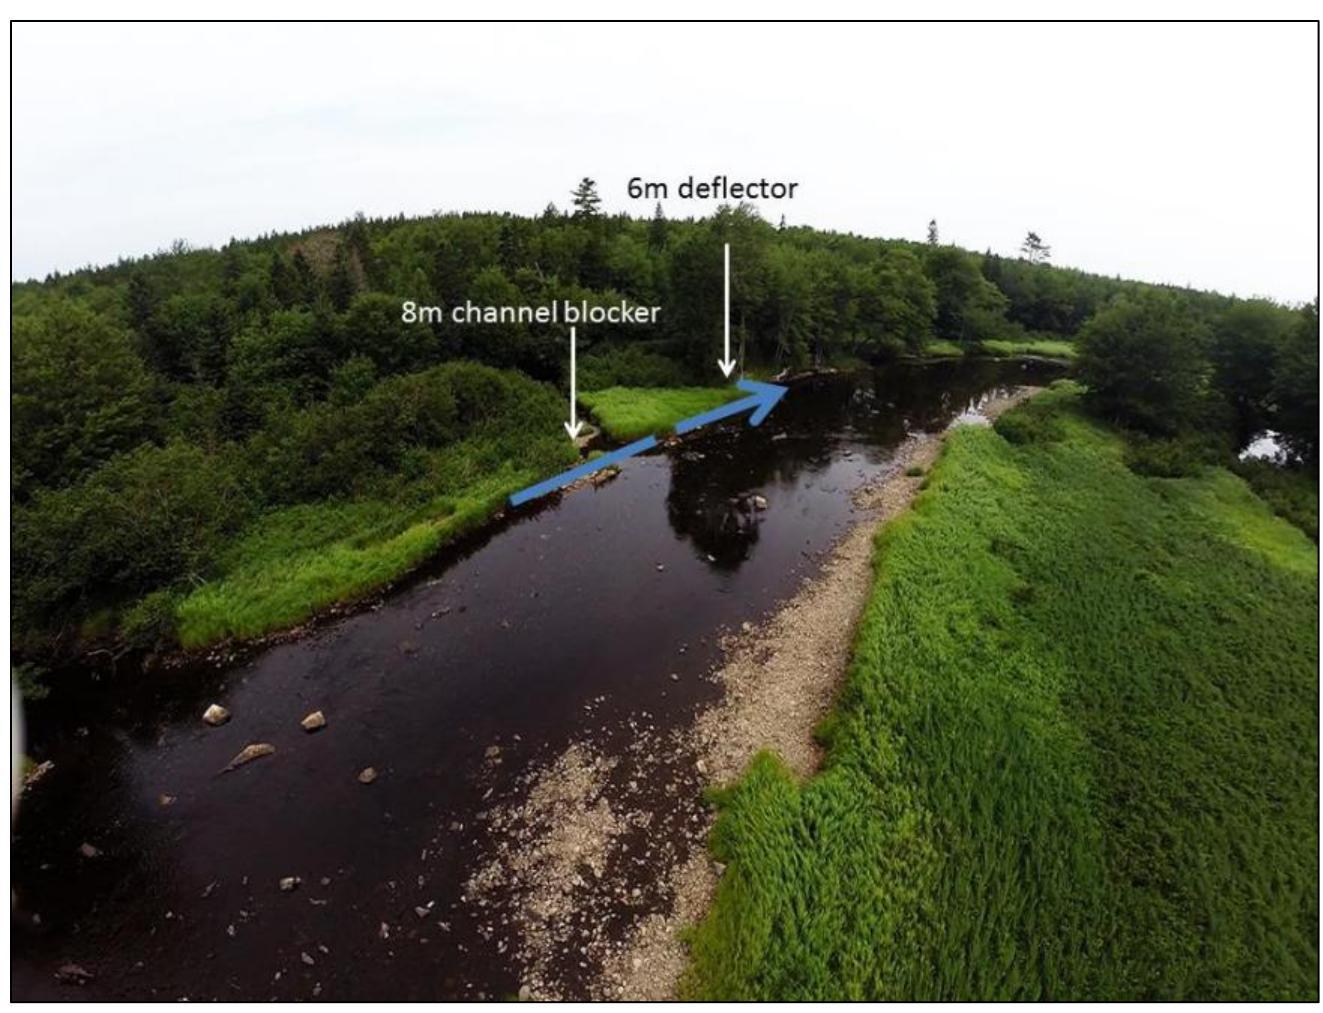
Figure 5. 8m channel blocker and a 6m deflector required.
## Site 2 (after pictures)

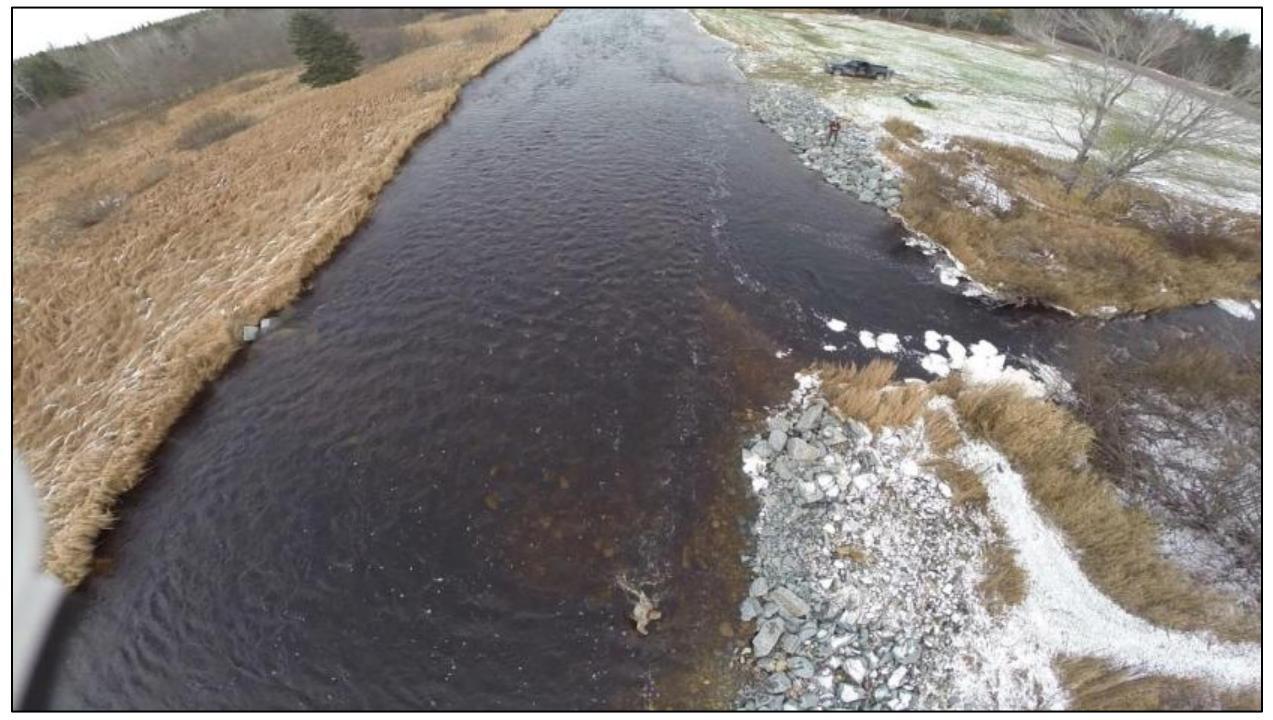
Figure 6. 30m rock sill and bank work (looking downstream).

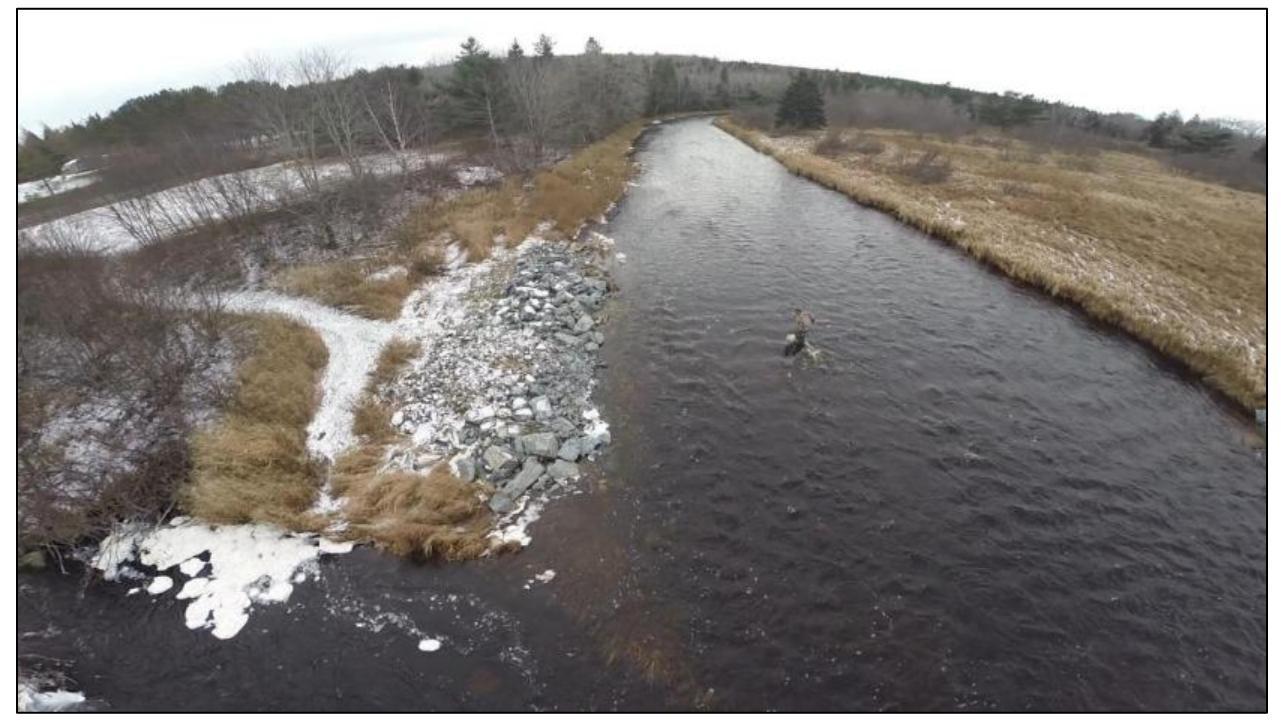
Figure 7. 30m sill and bank work (looking upstream).

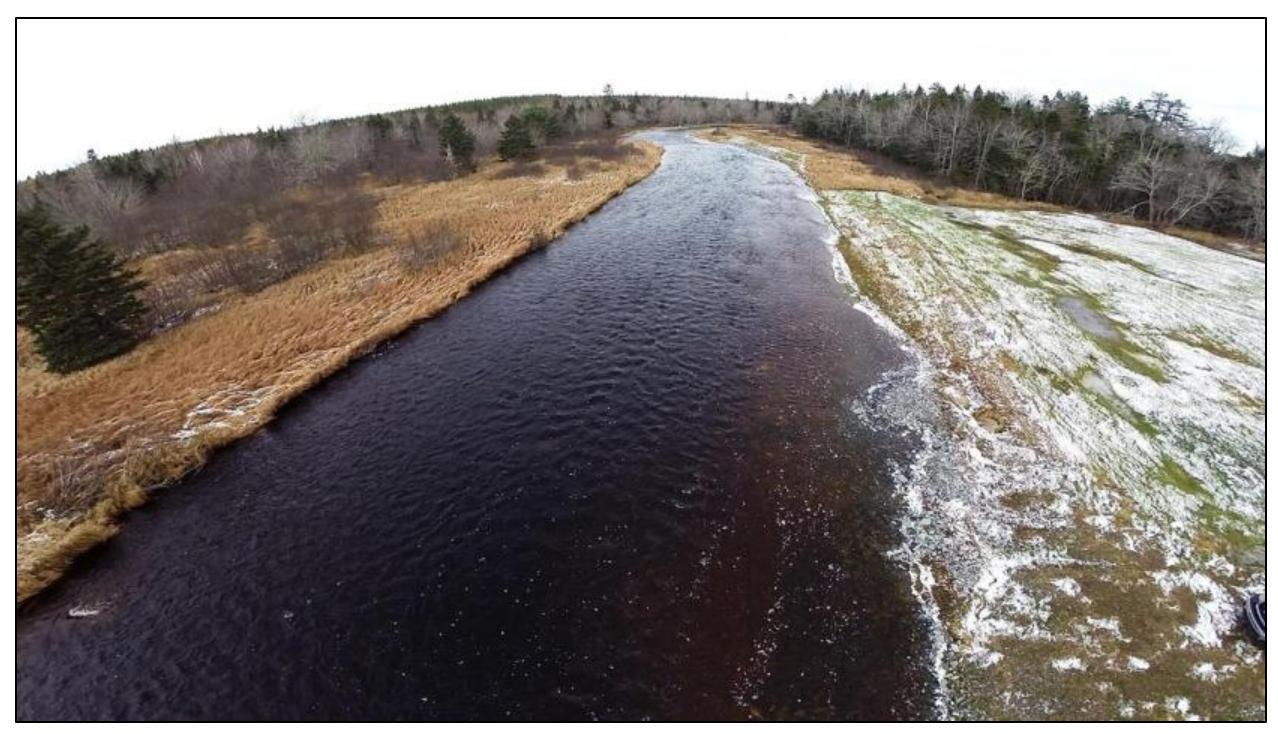
Figure 8. Looking downstream toward bank protection and 30m rock sill.

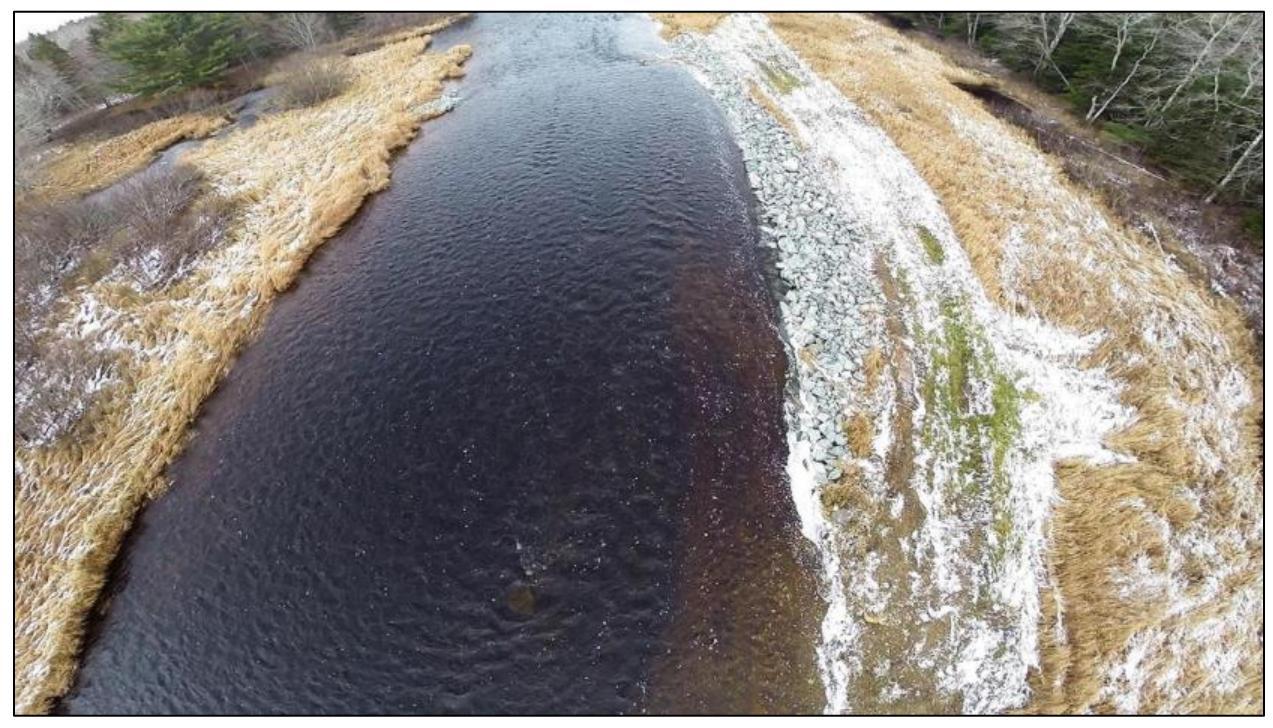
Figure 9. 40m of bank protection.

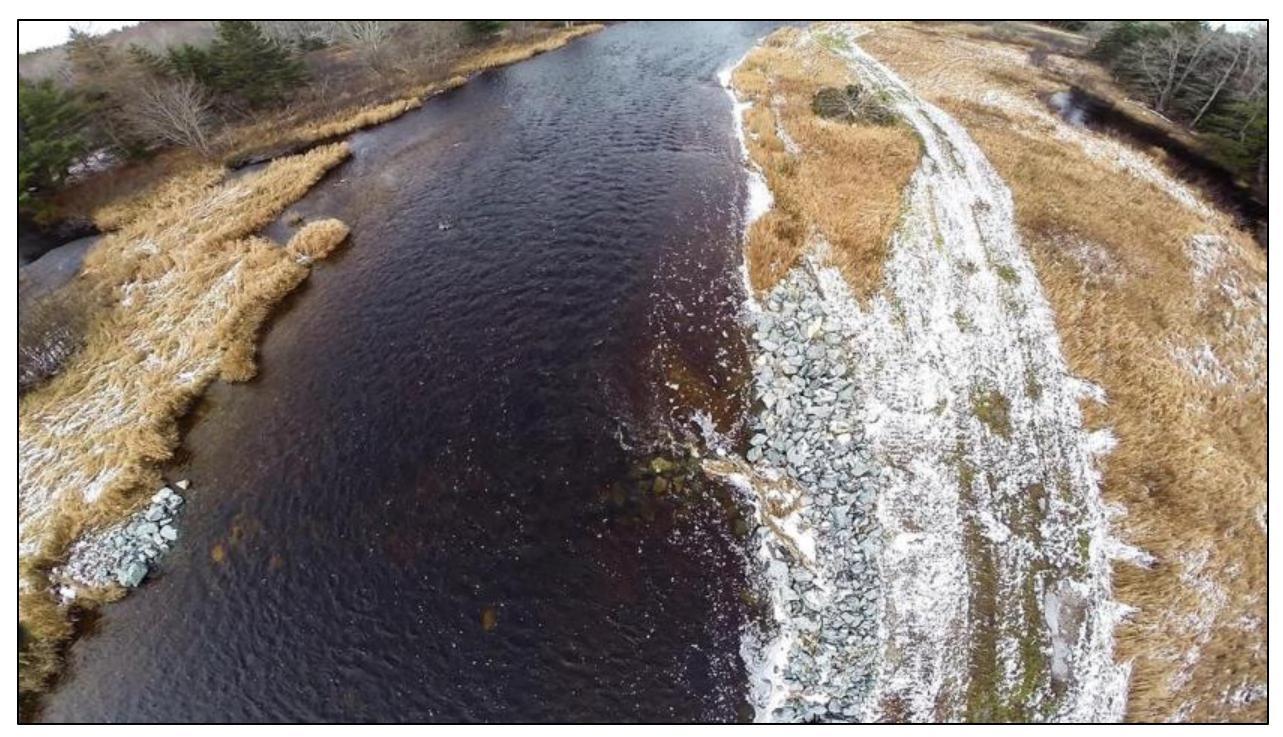
Figure 10. 30m sill.

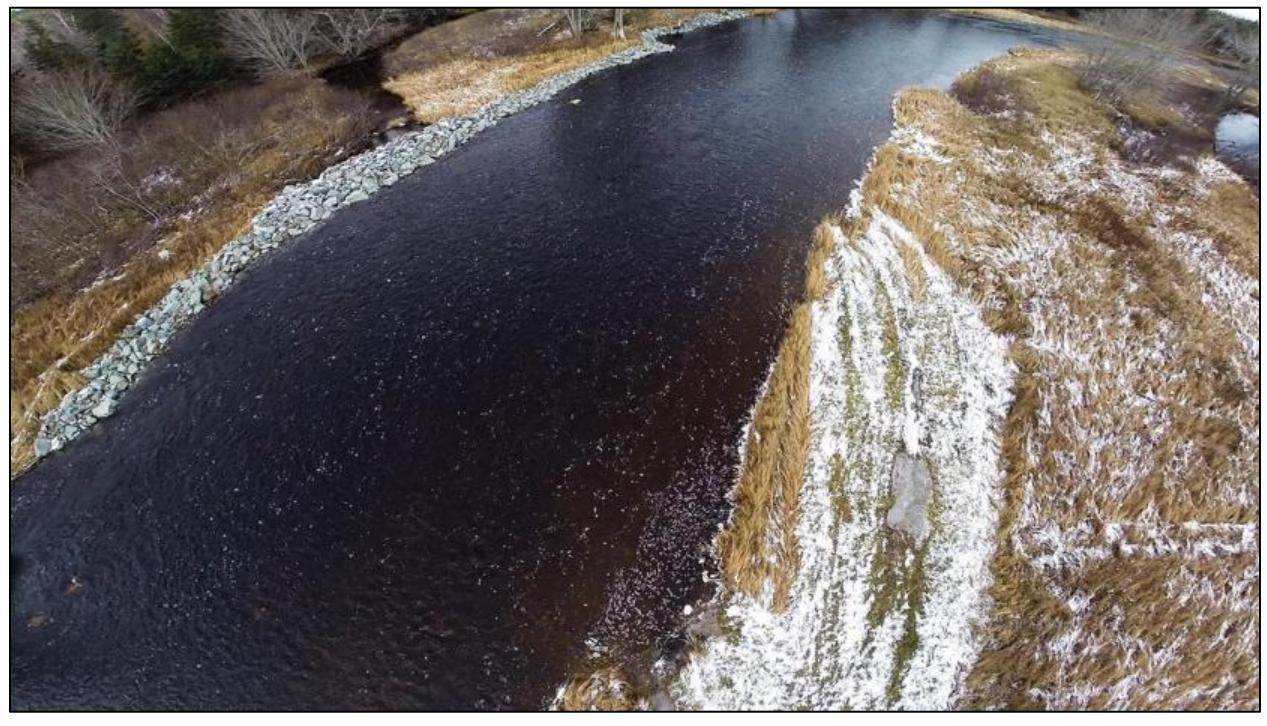
Figure 11. Channel blocker and deflector (looking downstream).

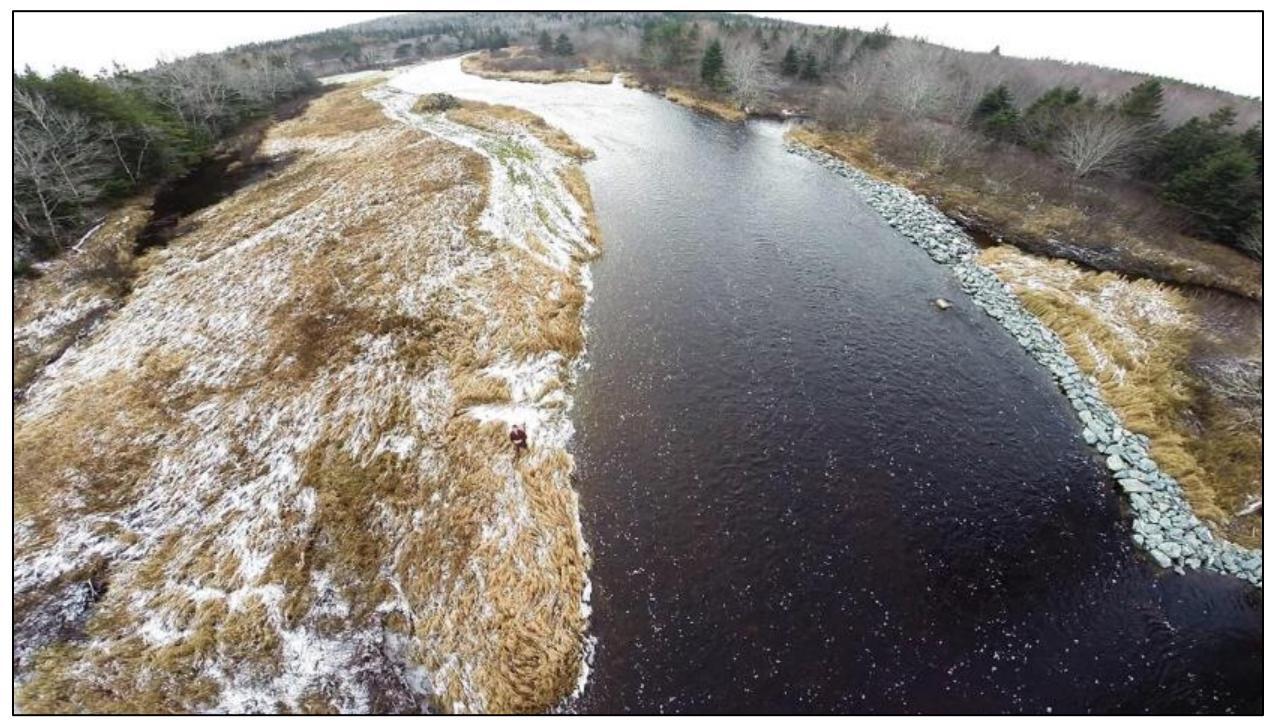
Figure 12. Channel blocker and deflector (looking upstream).

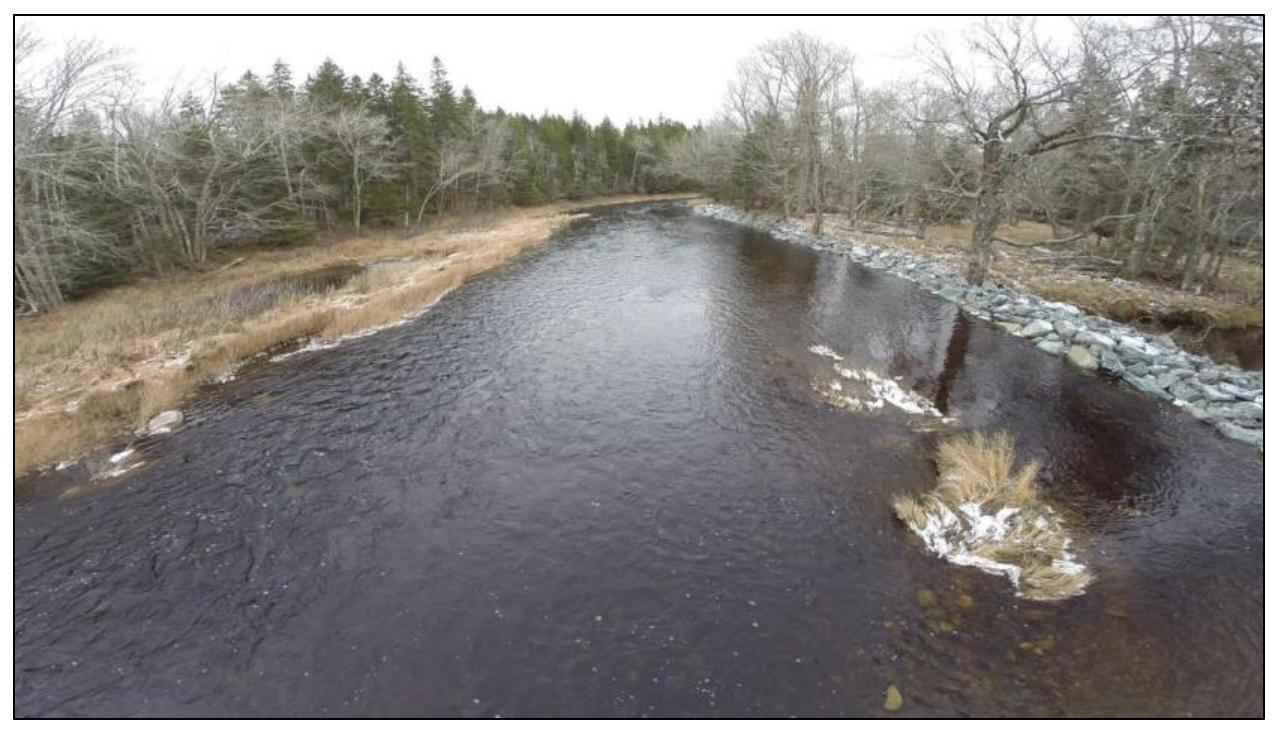
Figure 14. Bank protection, November 2014.

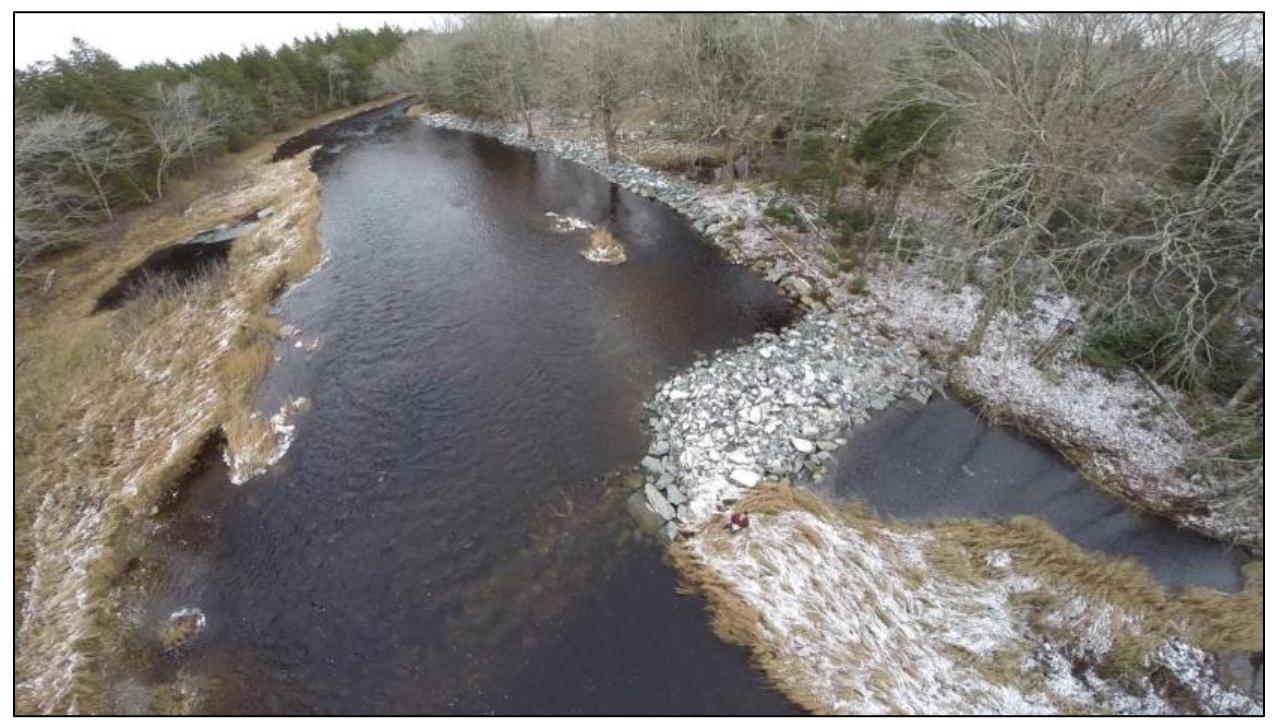
Figure 15. Sill and channel blocker, November 2014.

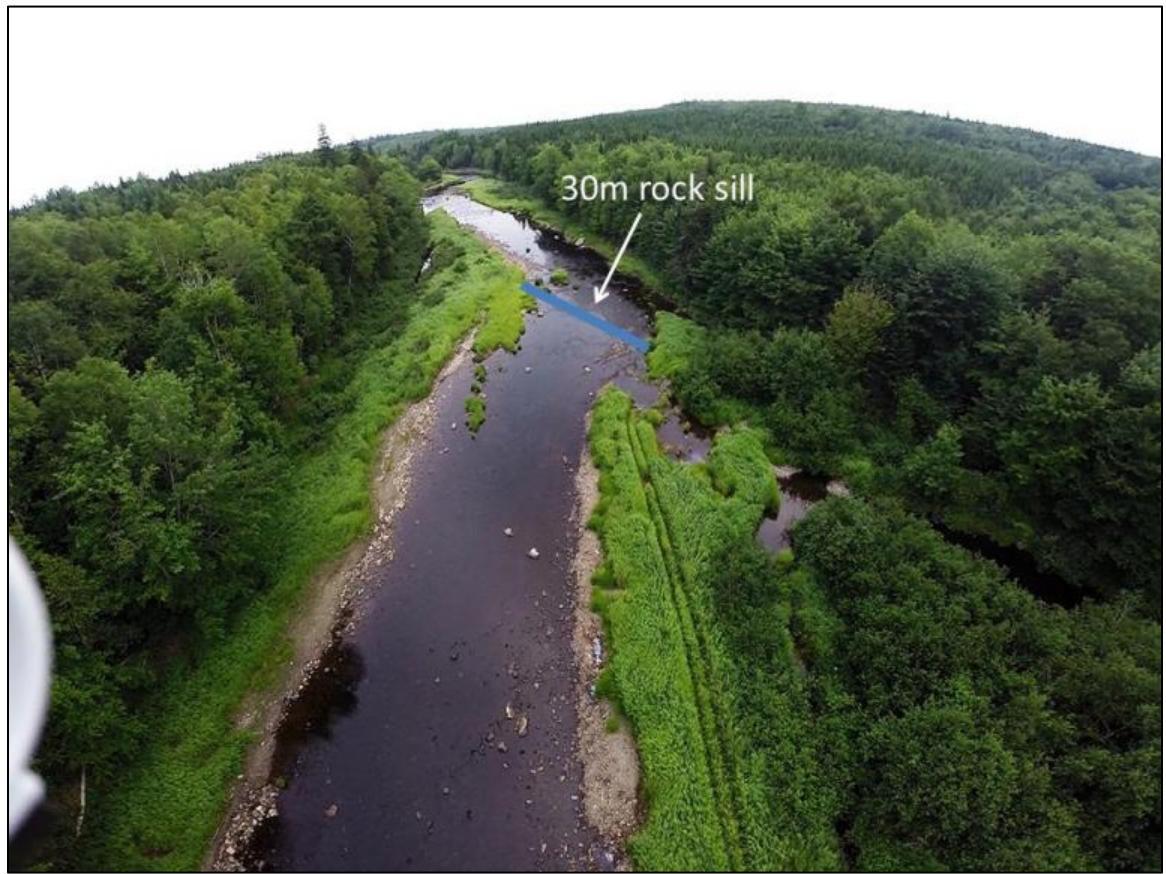
Figure 16. 30m rock sill required.

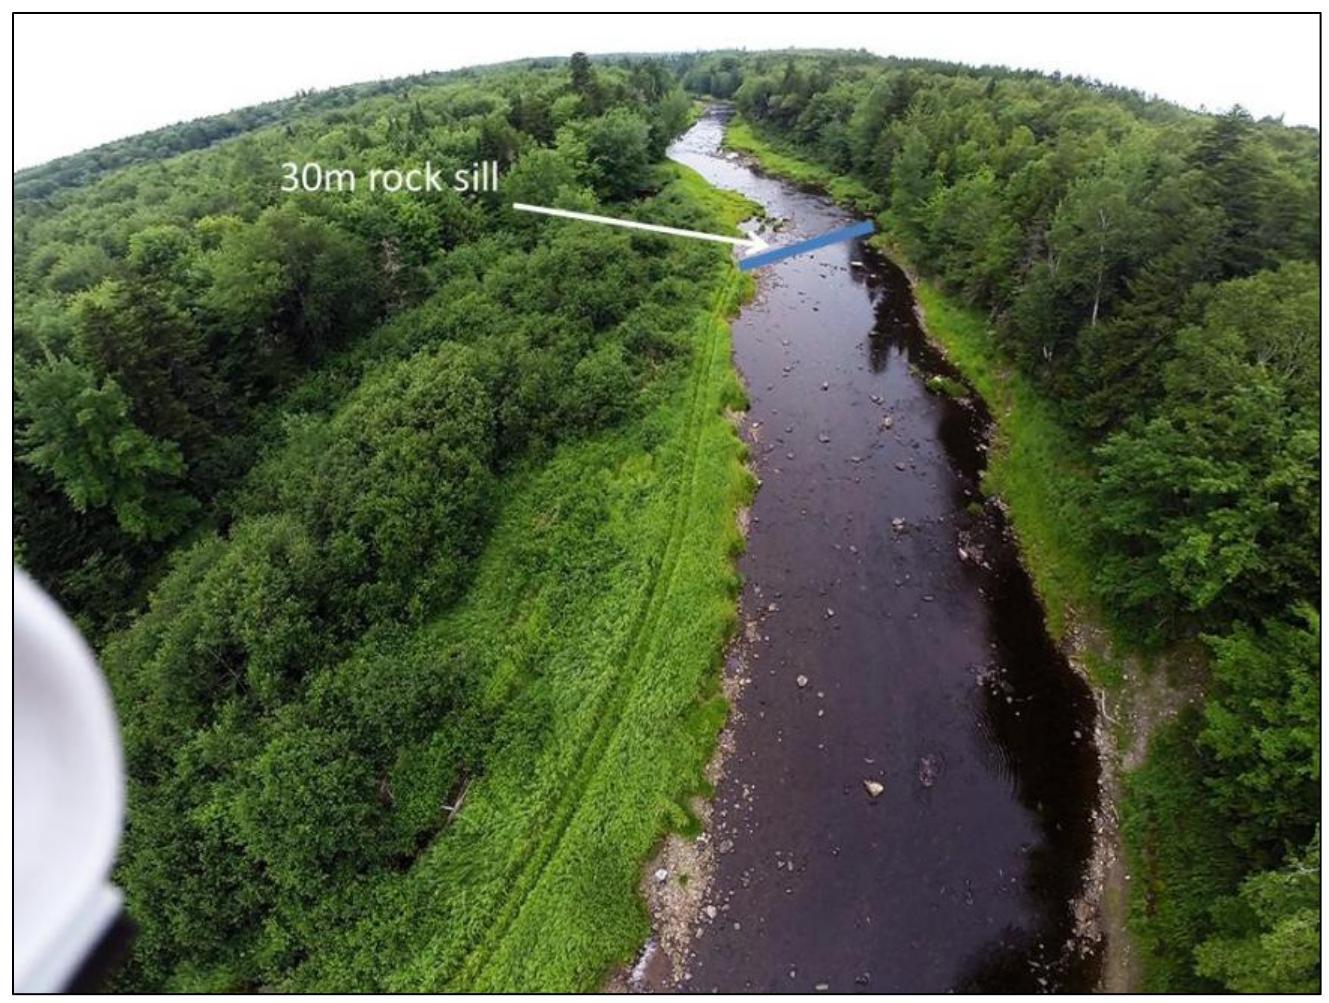
Figure 17. 30m rock sill required.
