**DETAILED SURVEYS AND RESTORATION PLANNING FOR TWO STREAMS IN THE ST.
MARY'S RIVER WATERSHED**

CAMPBELL'S BROOK & SUTHERLAND'S BROOK.

St. Mary's River Association Technical Report #013

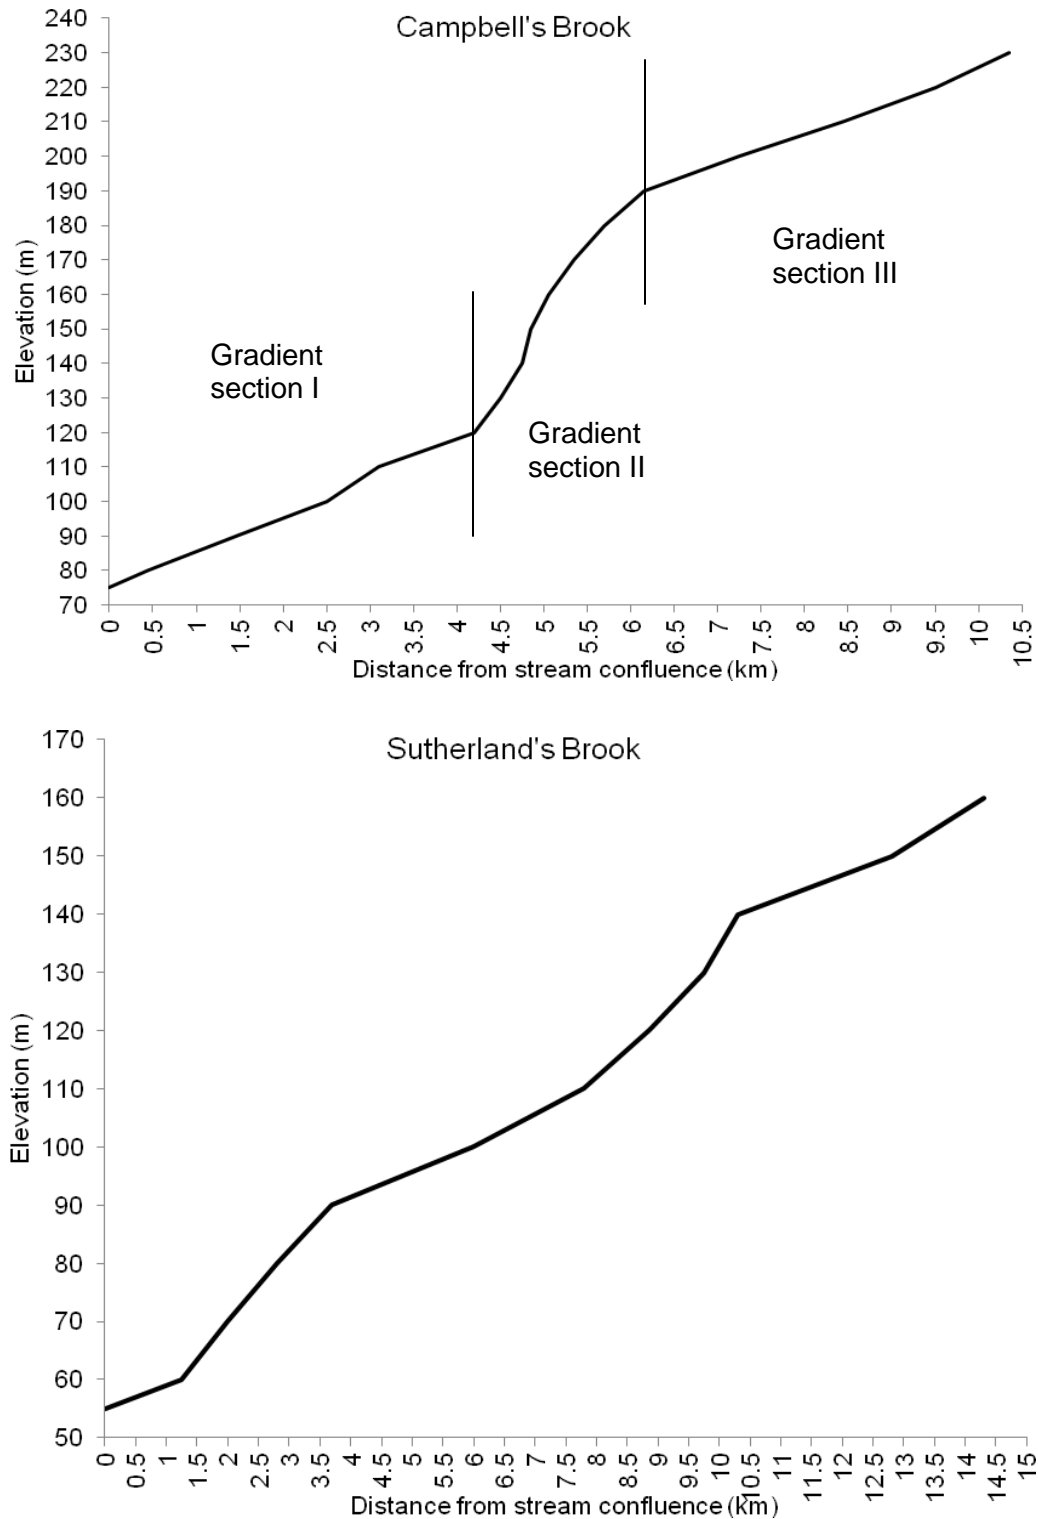
Figure 2: Longitudinal profiles of Campbell's Brook and Sutherland's Brook from confluence with St. Mary's River upstream along longest branch shown on 1:50,000 scale NTS map.

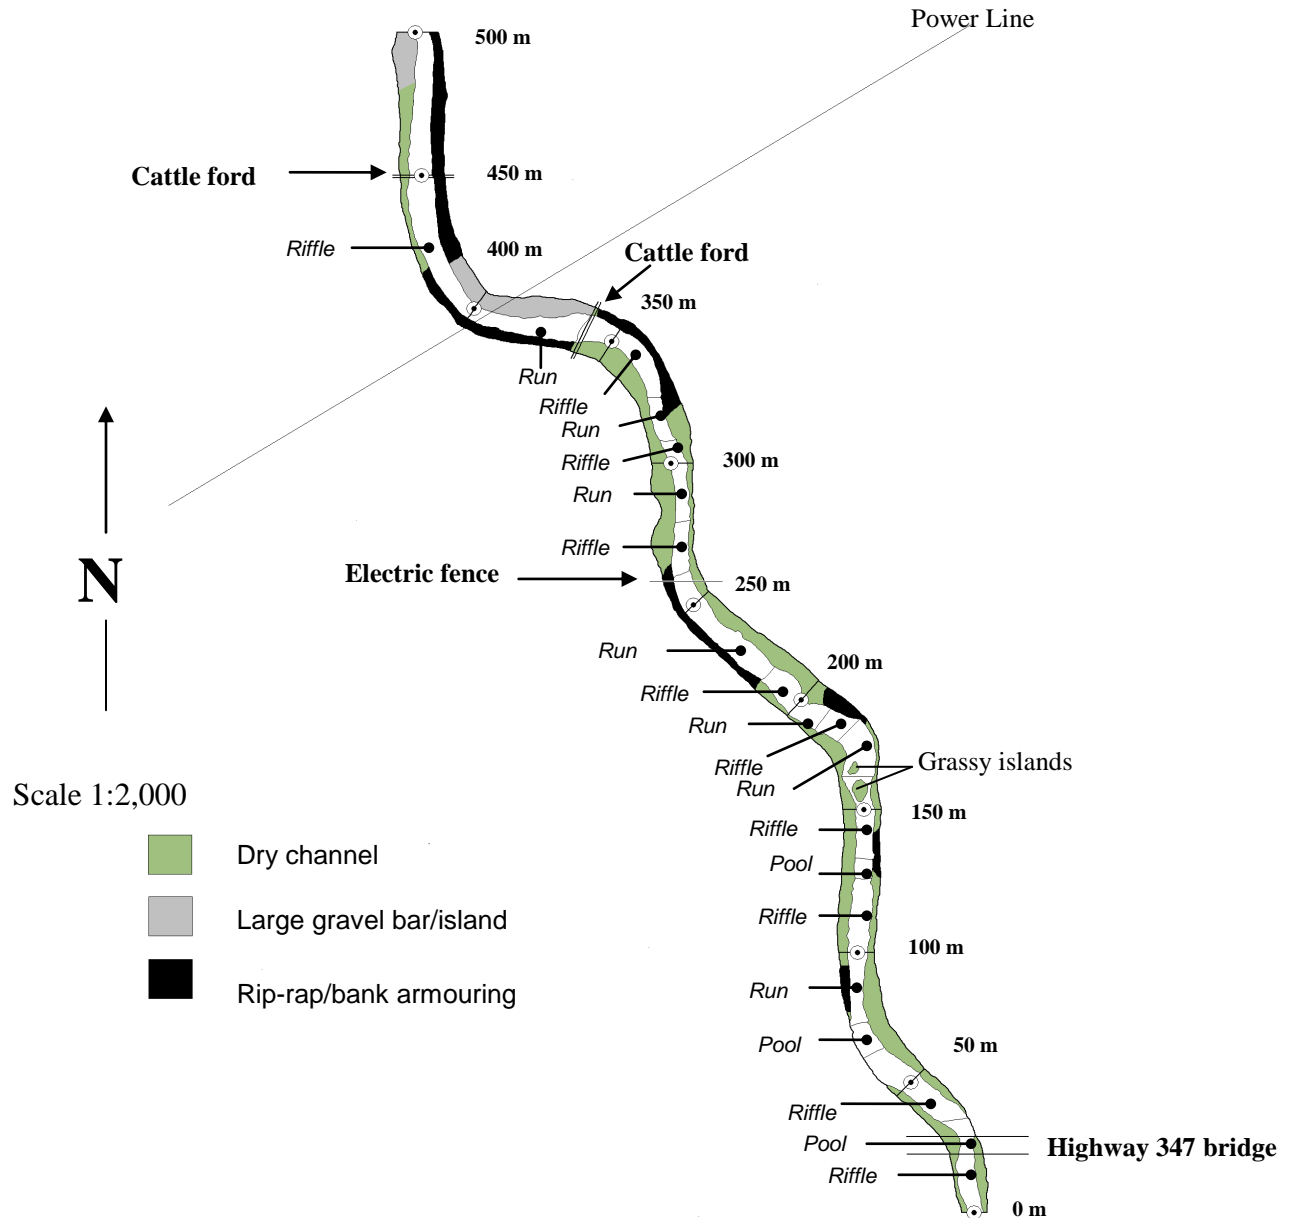
Figure 3(A): Map of Campbell's Brook based on field survey August-September, 2011 showing habitat distribution and key channel features. Map shows Campbell's Brook from confluence with East River, St. Mary's (0 m) upstream for a distance of 500 m.

The surveyed section of Campbell's Brook between 250 and 1,100 m is highly modified. There is extensive rip-rapping used for bank protection (approximately 500 m linear length of rip-rap on alternating banks) imparting to the channel a limited meander or sinuosity (Table 2, Figure 3). This channel modification has significantly impaired natural channel function as evidenced by the dominance of a single habitat type (riffle) over this modified section. Riffle accounts for 65% of total linear habitat and run for the remaining 35% (Table 2). Riparian condition is also highly modified with little to no overstream vegetation and isolated stands of trees providing shade (Figure 4). Cattle use of the surrounding fields is apparent and there are five identified cattle fords crossing the stream. The channel is overwidened by approximately 30 % over that calculated based on drainage area (Table 2). Upstream of the modified section, the stream flows through an intact riparian forest but exhibits continued channel straightening (likely due to historical log driving?); indeed it appears to have lower sinuosity upstream than in the modified section. Riffles continue to dominate and substrate size is similar to that within the modified section. Downstream of the modified section, there is again an intact riparian condition of young forest, and meander has increased over the 250 m between the downstream end of the agricultural fields and the confluence with the East Branch, St. Mary's River.

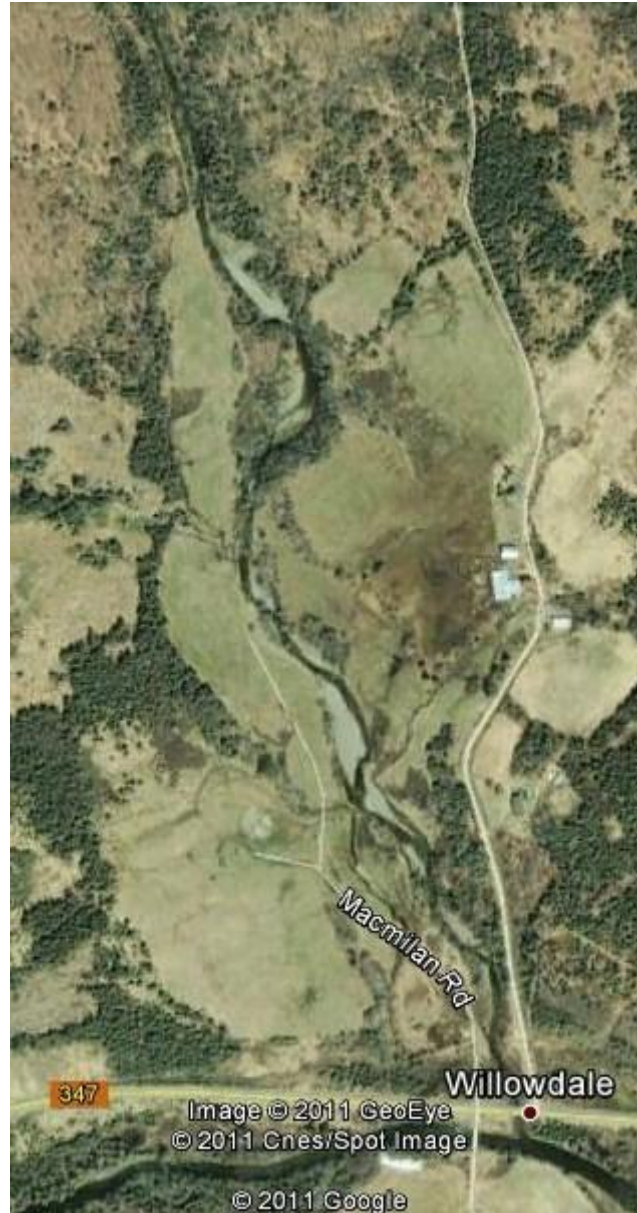
Figure 4: Aerial view of Campbell's Brook from Google Earth illustrating large gravel bars, road access to stream, and sporadic presence of riparian forest

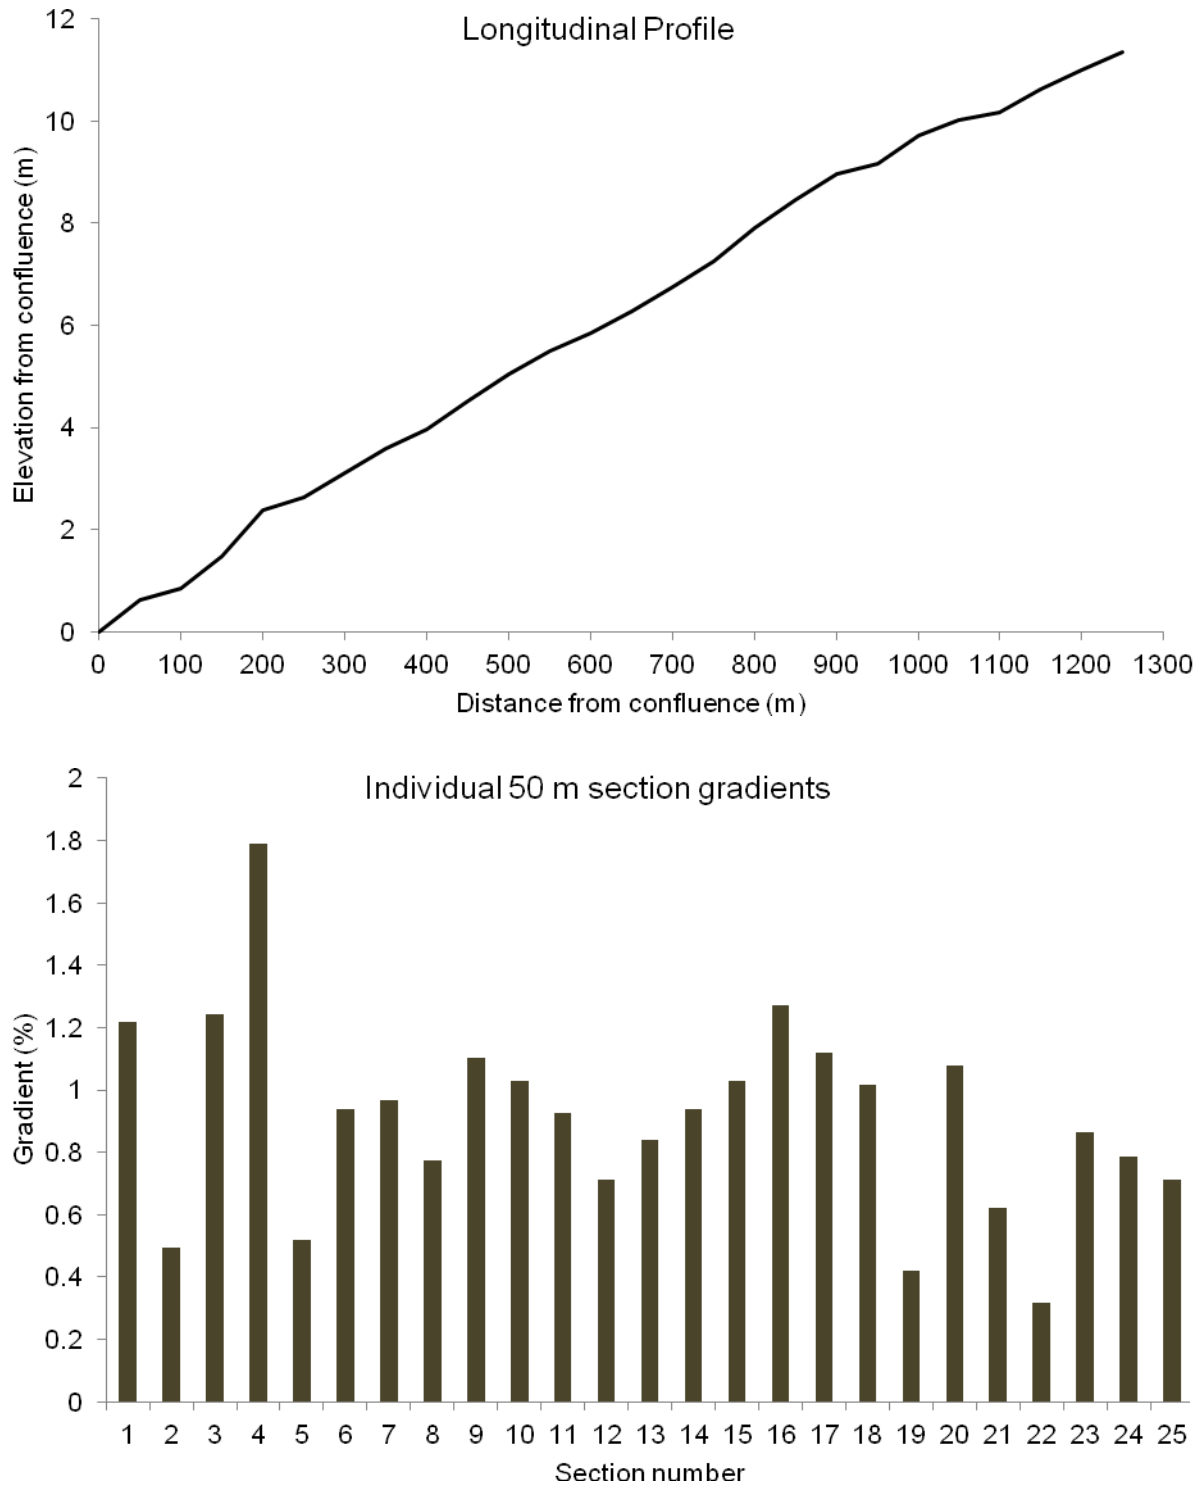
Figure 5: Longitudinal profile and individual 50 m section gradients for 1,250 m of Campbell's Brook surveyed in 2011.

(Figure 5). There is a change in elevation of 11.4 m over the 1,250 surveyed distance. Mean depth across 26 measured transects was 17.6 cm (SD=0.04). This is low variation (Coefficient of Variation= 22%) in depth among transects, indicating they are all very similar in being shallow. Cross section transects are presented in Appendix 1.

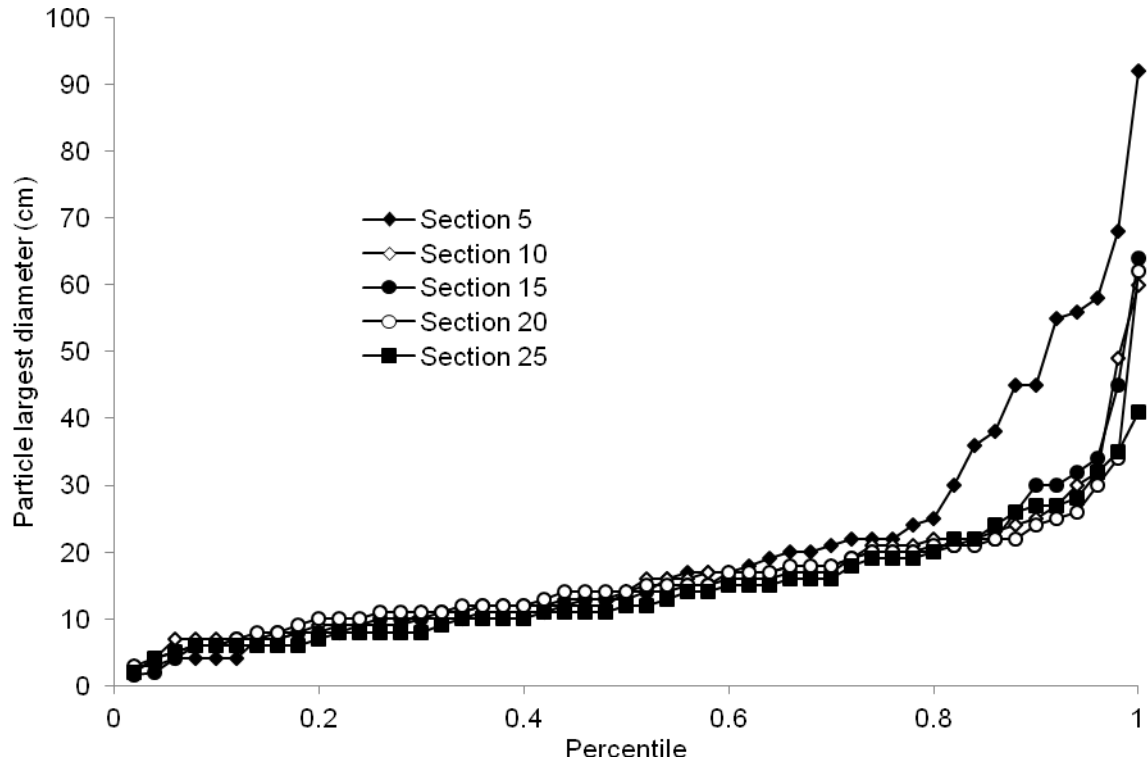
Figure 6: Frequency distribution of substrate particles in five sections (Section 5, 10, 15, 20, 25) of Campbell's Brook, 2011. Diameter of the largest axis of the stone was measured for 50 stones in each section in accordance with Wolmann pebble count methodology.

Within Campbell's Brook, visual estimates indicate that the substrate is predominately and equally distributed among small gravel, small cobble and large cobble (Table 2) with each of these three classes representing means of 22% of the substrate. Quantitatively, from the Wolmann pebble count, median particle size (D_{50}) is 12-14 cm among five sampled sections (Figure 6). Cobble⁴ (small and large; size range 64-256 mm) comprises 76% of the substrate averaged across the five pebble counts (SD=8.1%), with boulder and large gravel each comprising, on average, 11%-12%. The distribution of substrate is remarkably uniform, with the possible exception of Section 5 which departs at the upper size range from all other samples. Section 5 has a lower gradient (0.52%) than the other four samples (0.71%-1.08%), but indicates a greater abundance of large material in this section. It must be borne in mind that pebble counts are biased toward larger size substrate and do not take into account small (fines, sand) substrate. But the visual estimates corroborate the pebble counts showing a large substrate dominance.

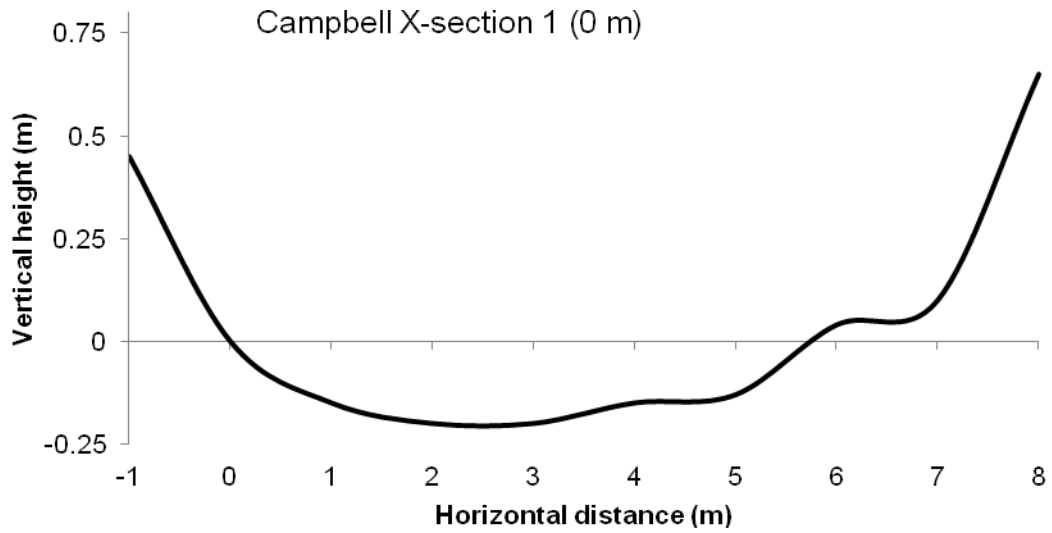
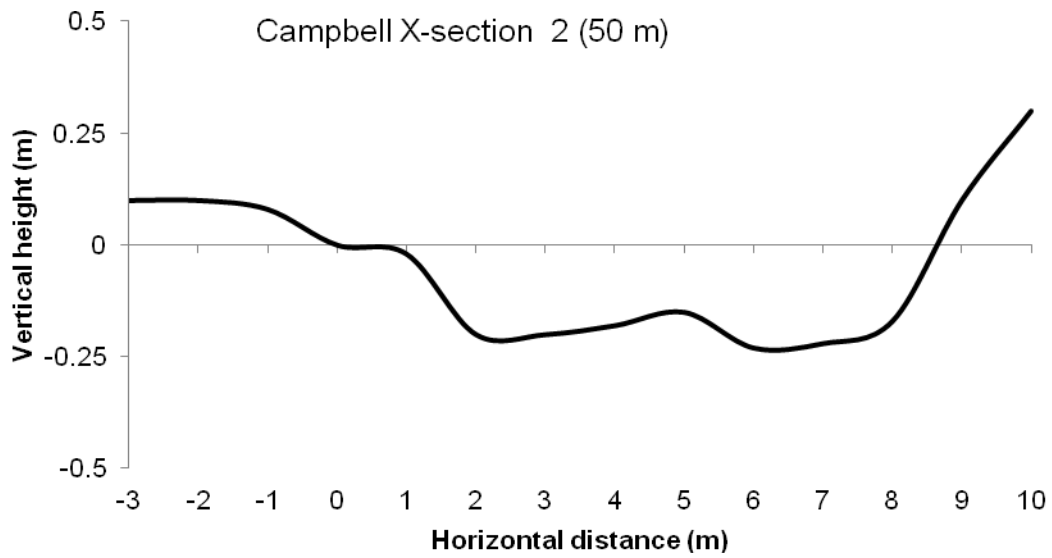
CAMPBELL'S BROOK CROSS SECTIONS.

Cross sections are presented as though looking downstream with left bank on left and right bank on right.

All measurements made from water's edge on left bank (0, 0) with depths presented as negative values and elevations above water (banks) as positive. Negative values (horizontal) of left bank represent distance from water's edge.
