# Restoration of the West Branch of the St. Mary's River

Report prepared for the Atlantic Salmon Endowment Fund of Fisheries and Oceans Canada

November 26, 2014 St. Mary's River Association Prepared by: Charlie MacInnis and Andrea Flynn

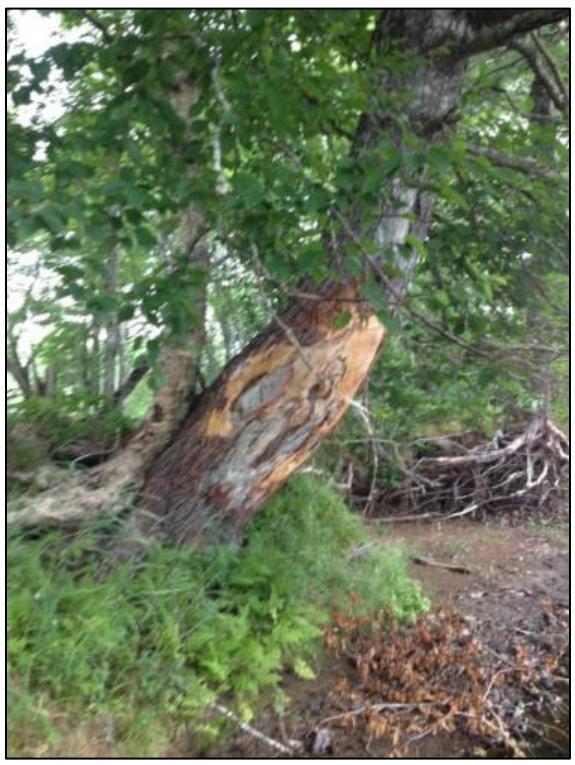
Figure 7. Ice scour on a tree in the upper West branch.

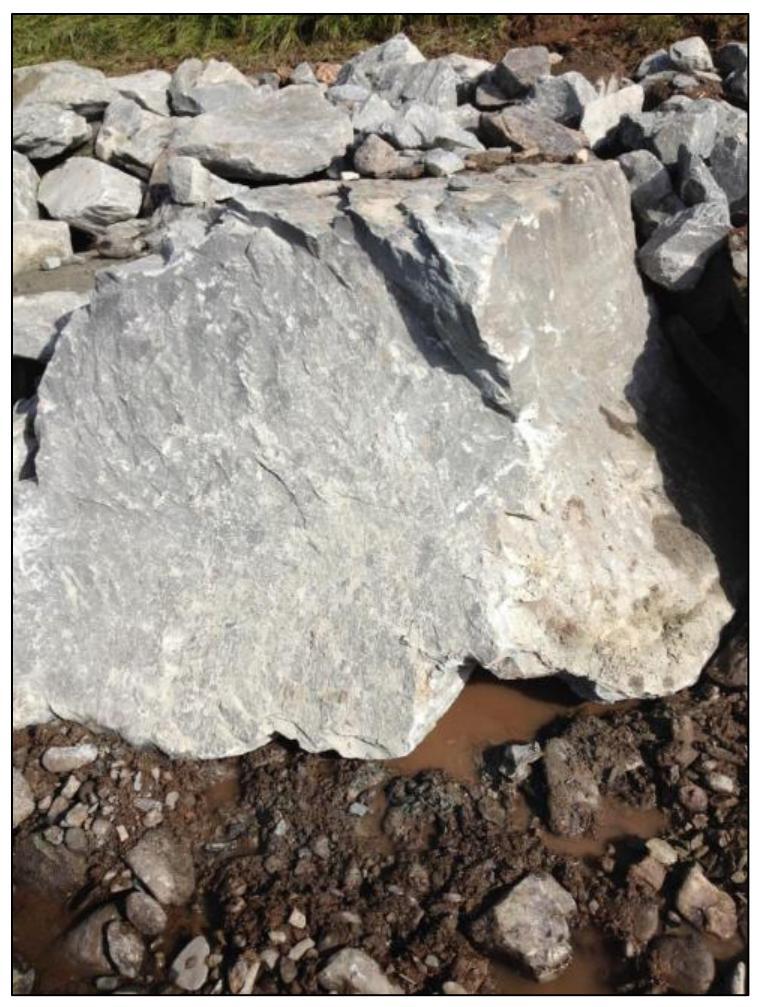
Figure 11. Example of two ton rock used at Site 4 to key in bank protection.

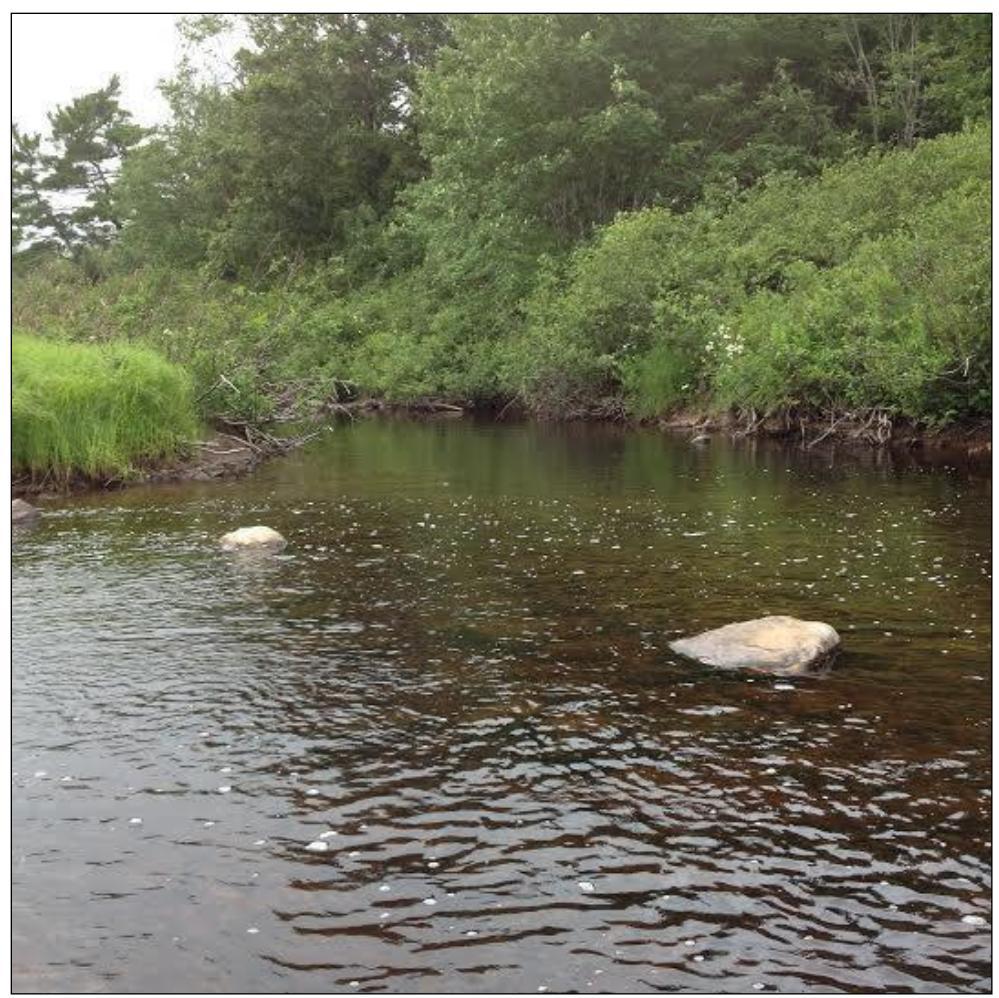
Figure 3. Outlet pool at Upper Bryden Brook.

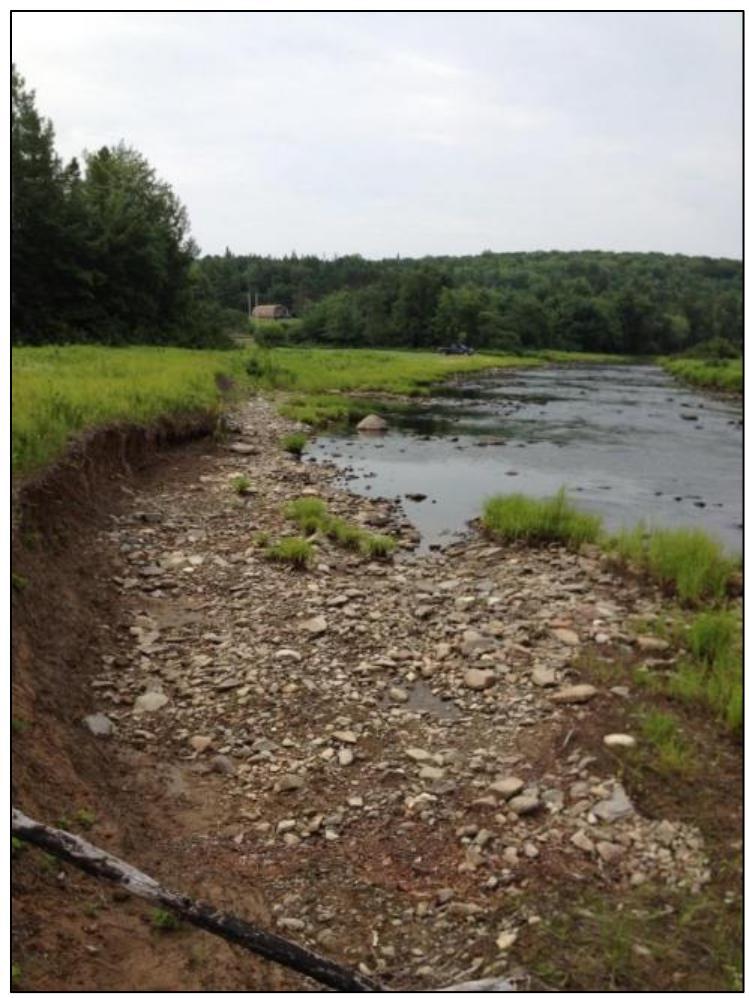
Figure 6. Erosion of the bank at the MacKay site.

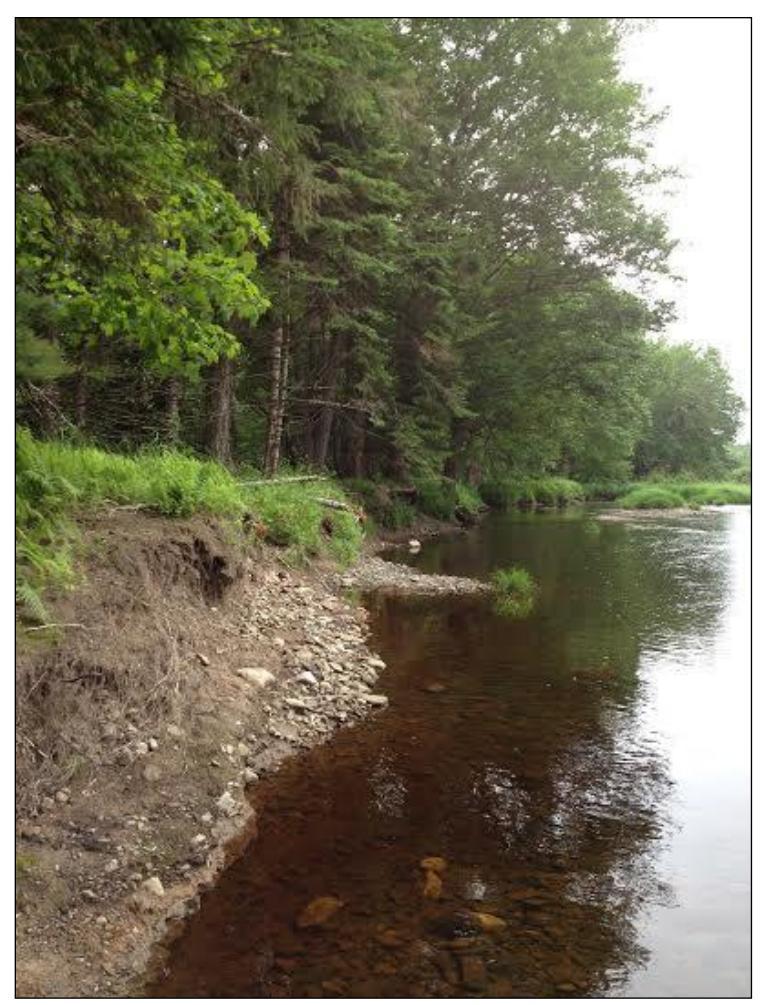
Figure 11. A treatment will be required at this site, including a rock sill blended into some bank protection. The sill will be 28 metres wide.

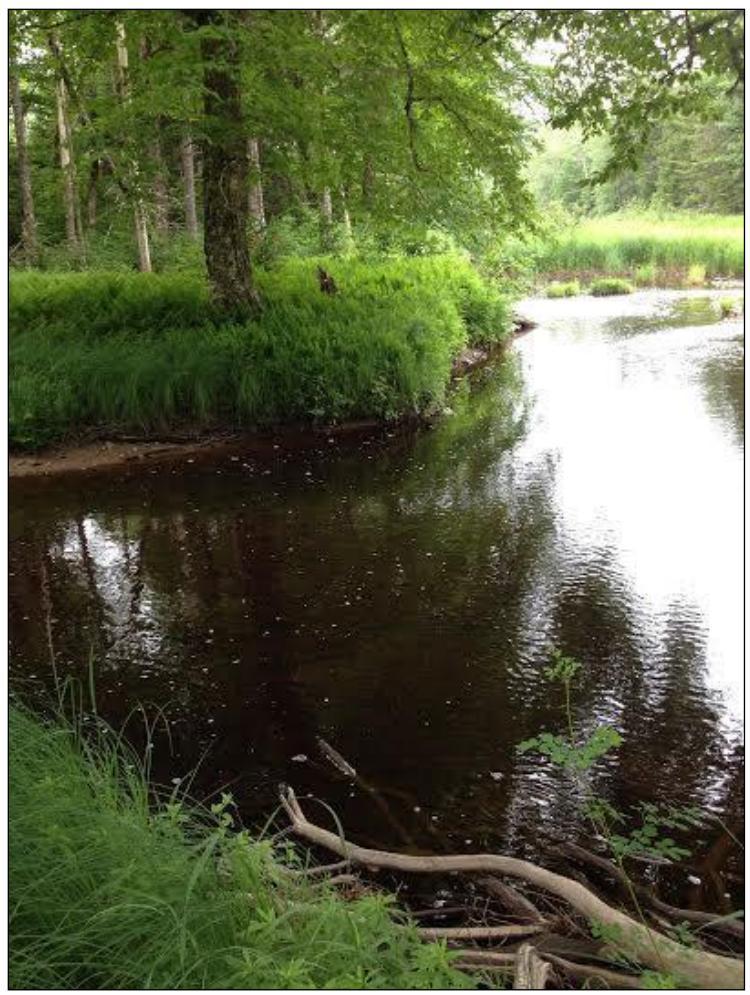
Figure 12. This is a typical channel breech. A Newbury channel blocker will be constructed at this location. Around two hundred tons of rock will be required. The structure will tie into banks at both ends. The structure will only contain a 1 in 2 year flood, which will not prevent bank-full discharges from accessing the floodplain.

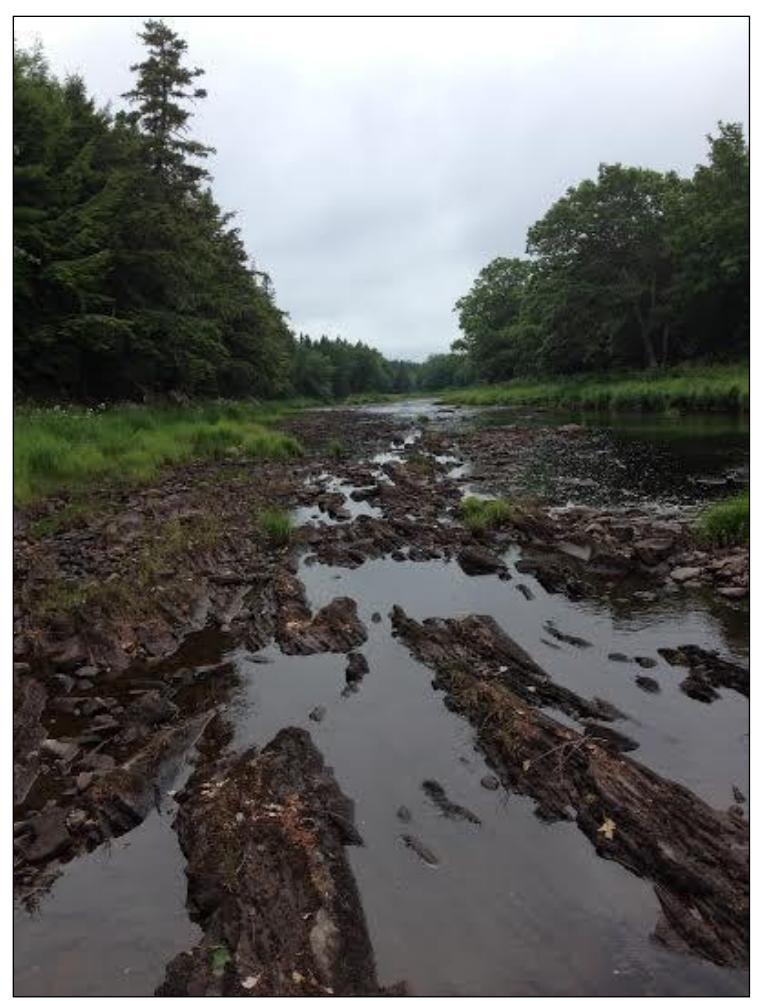
Figure 13. This picture was taken below Site 2. It is a typical bedrock outcrop, which dominates the channel between Site 1 and Site 2.

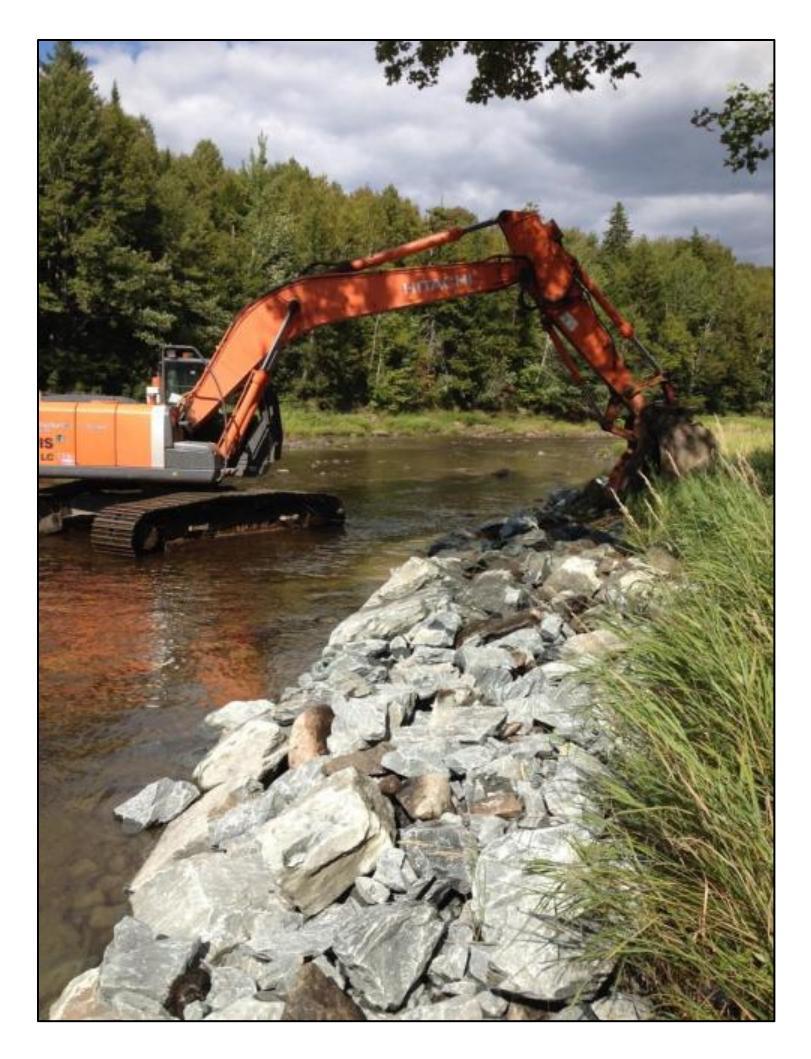
Figure 8. During construction, below sill five, looking downstream toward sill four.
